Seaspan Vancouver Shipyards Outfitting Pier Extension

**Pre-Demolition Hazardous  
Building Materials Assessment**

T-Dock Outfitting Pier,  
Seaspan Vancouver Shipyards,  
50 Pemberton Avenue,  
North Vancouver, BC

October 5, 2020

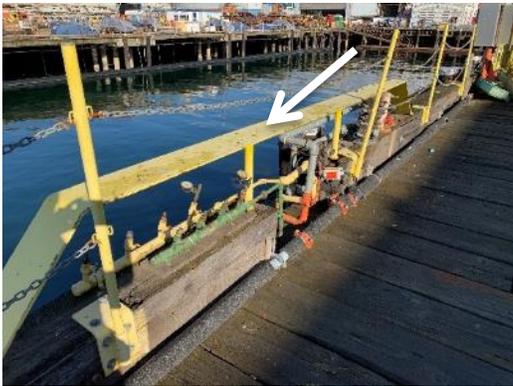
LCP Description		Photo
Paint colour	Yellow

Substrate	Metal	
Location/approx. extent	Railings, south	
Lead content	46,000 ppm	
Condition	Good	
Paint colour	White

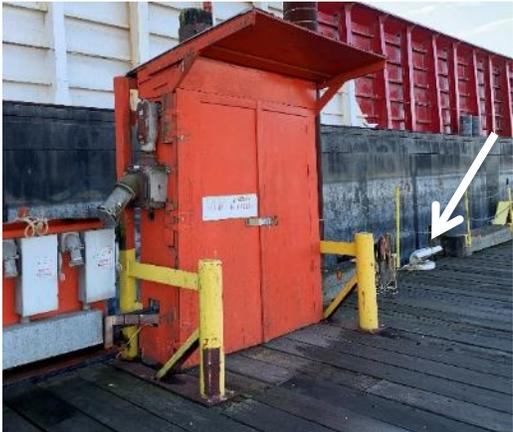
Substrate	Concrete	
Location/approx. extent	Rope anchor tie-off, south	
Lead content	3,700 ppm	
Condition	Good	
Paint colour	Light blue

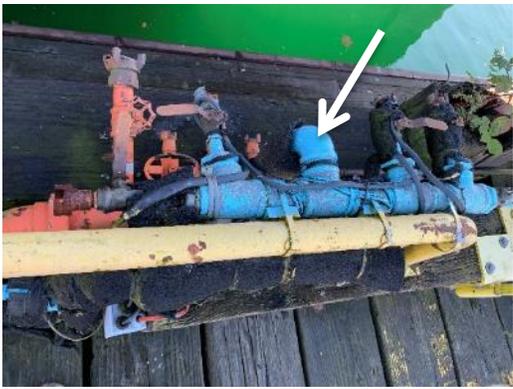
Substrate	Metal	
Location/approx. extent	Pipes, central	
Lead content	Presumed to be LCP	
Condition	Good

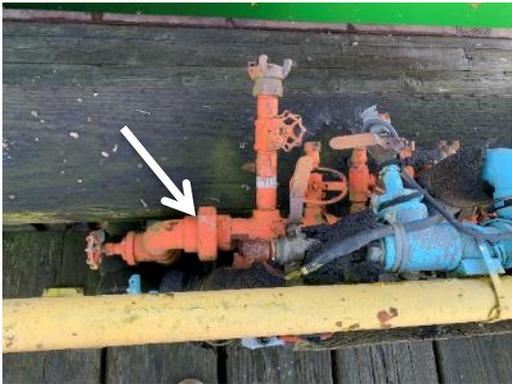
LCP Description		Photo
Paint colour	Orange

Substrate	Metal	
Location/approx. extent	Pipes, central	
Lead content	Presumed to be LCP	
Condition	Good	
Paint colour	Green

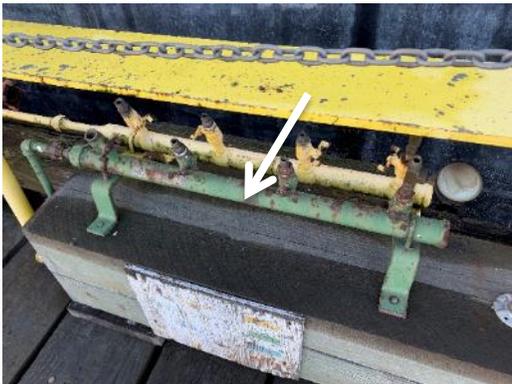
Substrate	Metal	
Location/approx. extent	Pipes, central	
Lead content	Presumed to be LCP	
Condition	Generally good, minor chipping/flaking observed	
Paint colour	Off-white

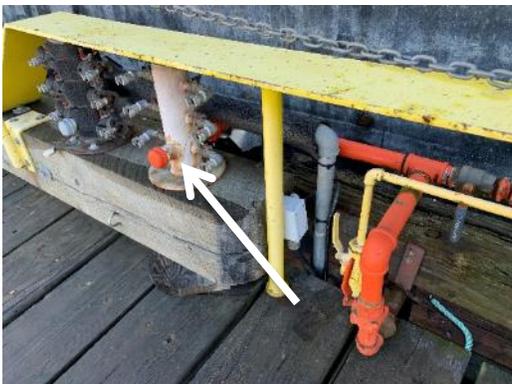
Substrate	Metal	
Location/approx. extent	Pipes, central	
Lead content	Presumed to be LCP	
Condition	Good

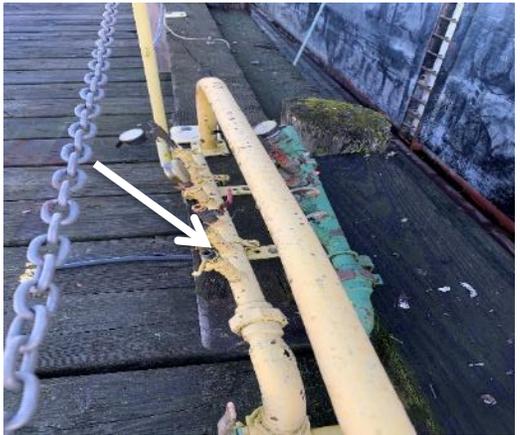
LCP Description		Photo
Paint colour	Yellow

Substrate	Metal	
Location/approx. extent	Pipes, central	
Lead content	Presumed to be LCP	
Condition	Good
