RE: Stormwater Pollution Prevention Plan Update for Infrastructure Demolition at Western Cleanwood Preservers LP, 9815 Robson Road, Surrey, BC

Western Cleanwood Preservers LP
Stormwater Pollution Prevention Plan
9815 Robson Road, Surrey, British Columbia
SLR Project No.: 201.88819.00000

RE: *STORMWATER CONTAINMENT BERM CONDITION ASSESSMENT RESULTS FOR WESTERN CLEANWOOD PRESERVERS LP, 9815 ROBSON ROAD, SURREY, BC*

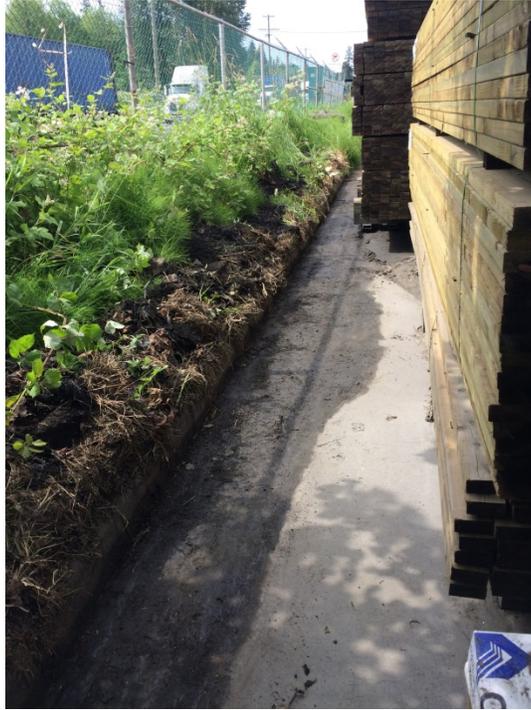
Photograph 1:

Between the northeast corner of the Main Gate off Robson Road (0 m) and the Northeast Gate (127 m) – Concrete Berm (looking south), 10 m to 30 m – Debris and vegetation removed from berm area.

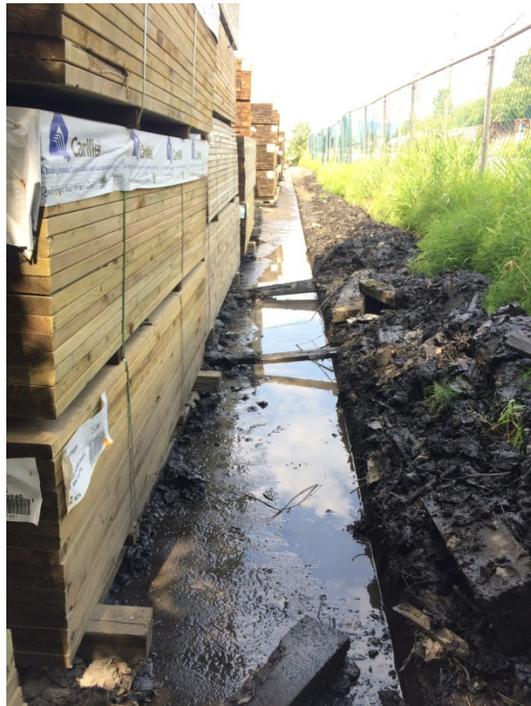
Photograph 2:

Between the northeast corner of the Main Gate off Robson Road (0 m) and the Northeast Gate (127 m) – Concrete Berm (looking north), 44 m to 82 m – Debris and vegetation removed from berm area.

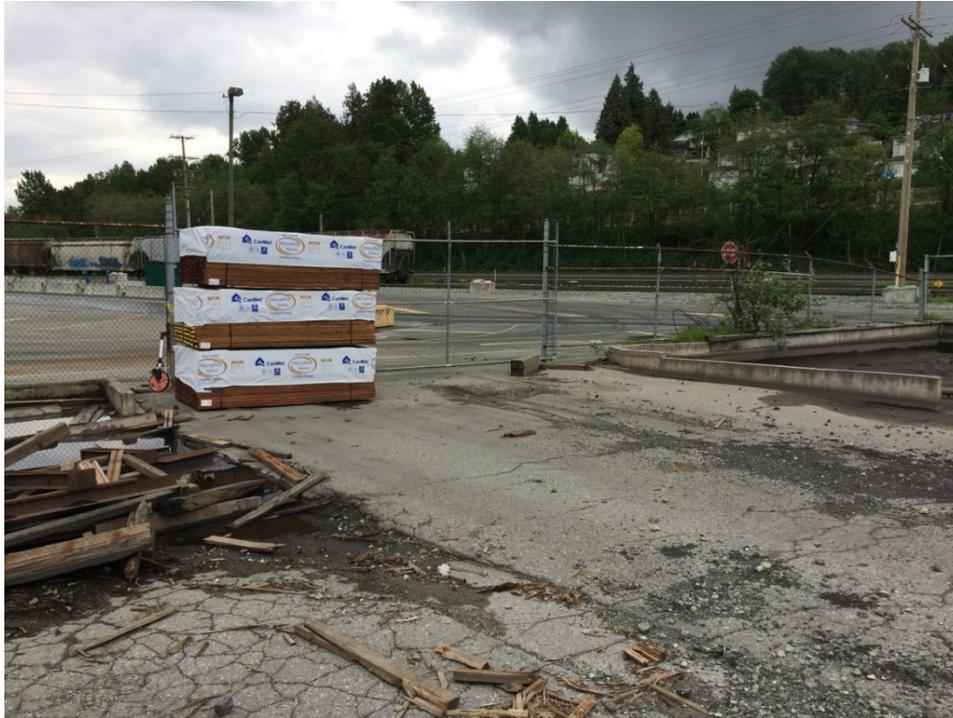
Photograph 3: Northeast Gate (looking north) – No containment present between Concrete Wall 1 and Concrete Wall 2.

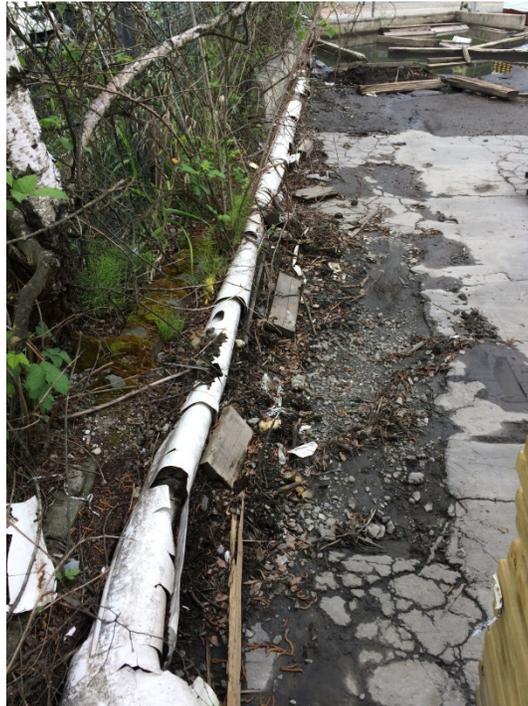
Photograph 4: Between the east end of the northern site perimeter (0 m) and the west end of the northern site perimeter (154 m) – Concrete Berm (looking east), 0 m – 6 m - Alligator cracking and missing asphalt sections noted along the berm (immediately south).

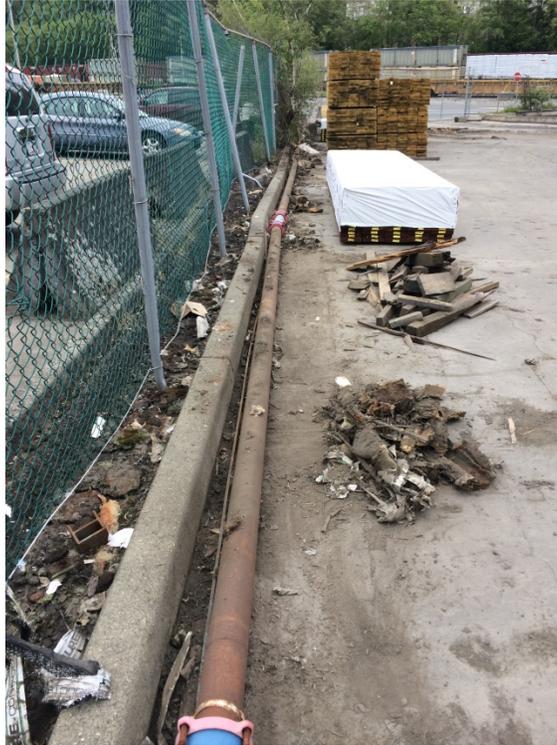
Photograph 5:

Between the east end of the northern site perimeter (0 m) and the west end of the northern site perimeter (154 m) – Concrete Berm, (looking east), 6 m – 100 m - Debris cleared from berm area.

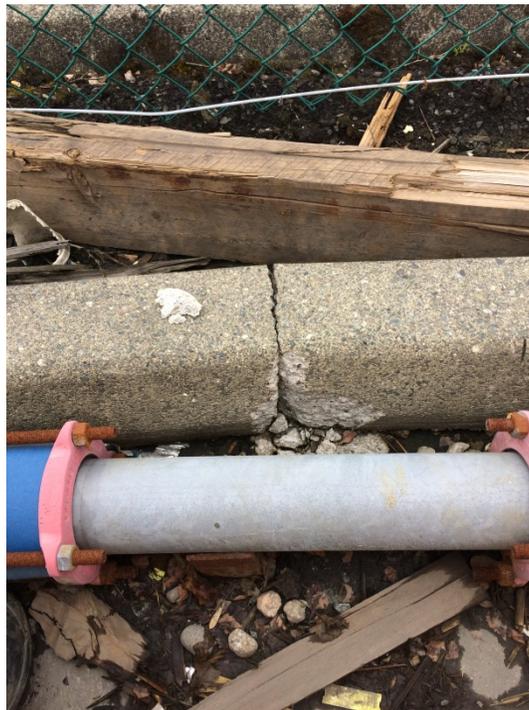
Photograph 6:

Between the east end of the northern site perimeter (0 m) and the west end of the northern site perimeter (154 m) – Concrete Berm, 26.8 m – Transverse Crack, >0.1 cm wide, minor spalling along crack.

- Conduct regular future cleaning/ maintenance activities of the concrete berms to prevent build-up and overgrowth;
- Perform maintenance on sections of the earth berm area along the western site perimeter where the berm has been washed out and extend the earth berm along the western perimeter where the berm tapers out (between the AST containment area and the southwest corner, minimum berm height of 0.17 m); and
- Repair significant berm and asphalt cracking as needed.

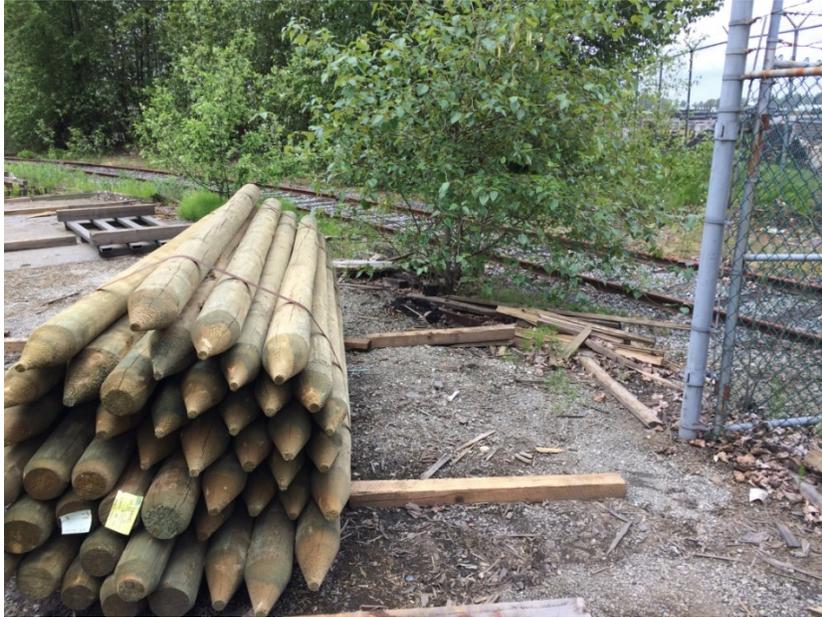
Photograph 7: Between the west end of the northern site perimeter (0 m) and the west end of the southern site perimeter, west of the water treatment facility (56 m) – No containment present.

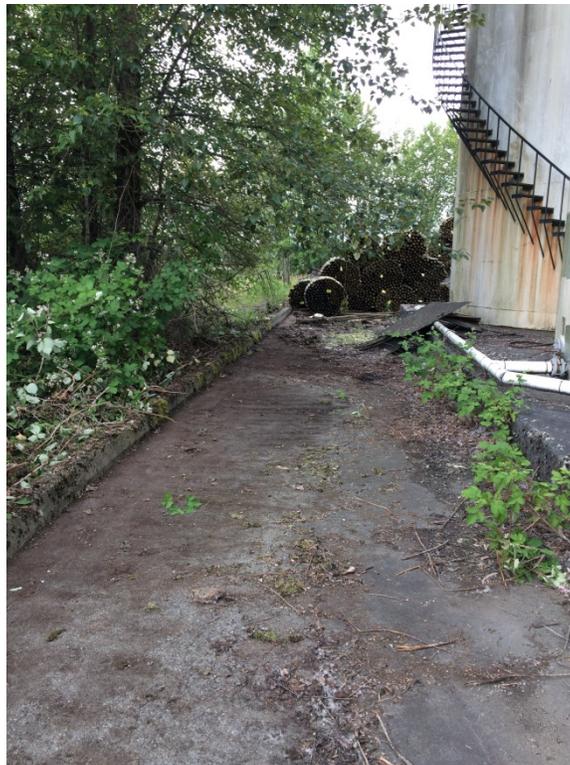
Photograph 8: Between the west end of the southern site perimeter, west of the water treatment facility (0 m), and the end of the concrete berm along the eastern site perimeter, west of the AST containment area (109 m) – Concrete Berm (looking west), 6 m – 25 m – Debris and vegetation removed from berm area.

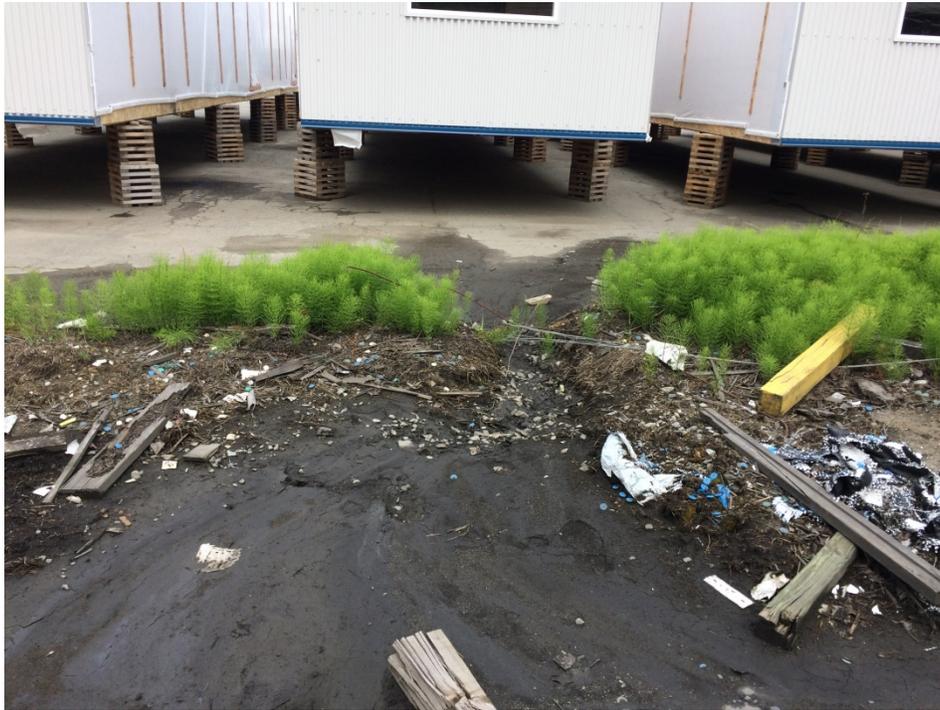
Photograph 9:

Between the end of the concrete berm along the eastern site perimeter, west of the AST containment area (0 m) and the southwest corner of the site (175 m) – Earth Berm (looking west), 20 m – A small portion of the earth berm has been washed out.

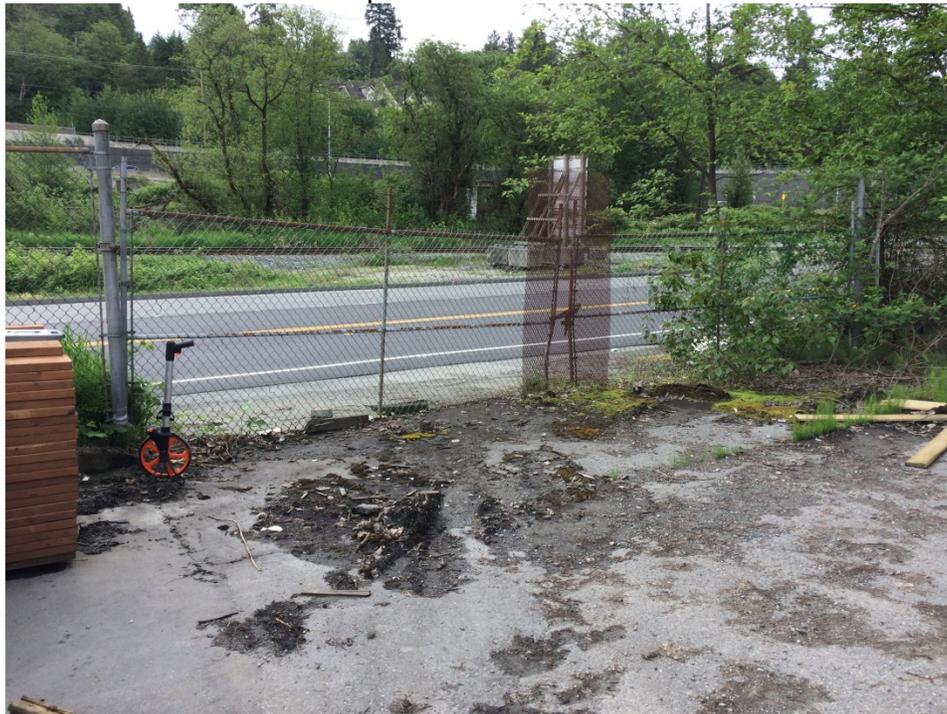
Photograph 10:

Southeast Gate (looking south) – No containment present, sediment and debris on the ground shows evidence of flow of surface water under the gate (low point in pavement).

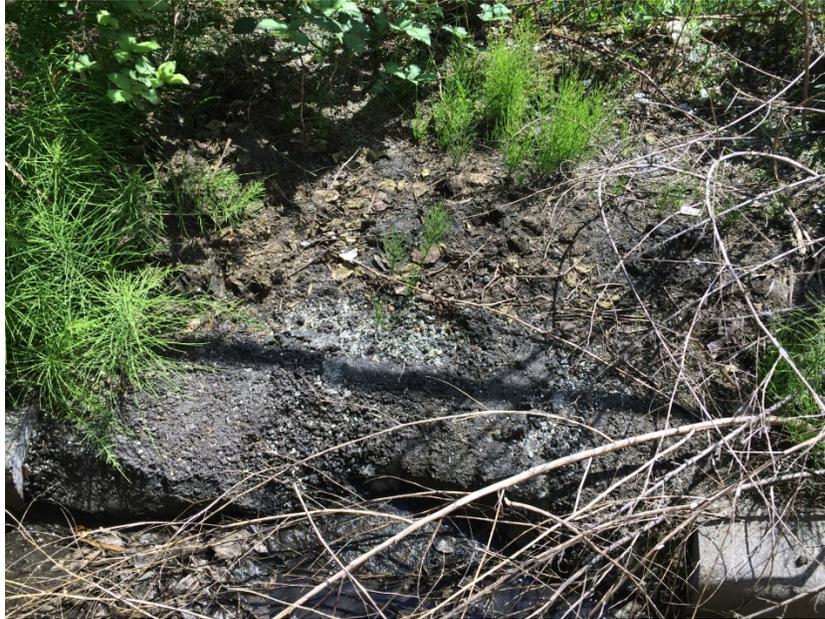
Photograph 11:

Between the corner of the Southeast Gate (0 m) and the southeast corner of the Main Gate off Robson Road (220 m) – Concrete Berm, 168 m – 169 m - A 1 m (approx.) segment of the berm appears to have been missing/ removed and has been replaced with asphalt patching, sediment and debris on the ground shows evidence of flow of surface water over the patch (low point in berm).
