**Date:** April 8, 2024 Hatfield Ref No.: PKS11466

**Subject:** Western Painted Turtle Critical Habitat Assessment - 1950 Brigantine Drive, Coquitlam BC

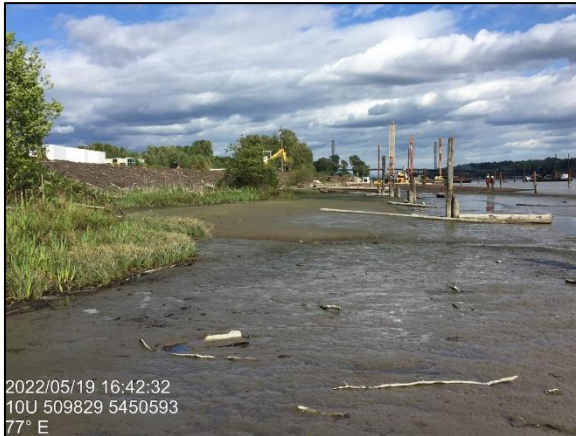
**Photo 1 Terrestrial and intertidal foreshore habitats looking east from the eastern end of the proposed marsh habitat.**

Terrestrial areas on the western end of the VFPA lease area possess these attributes and are critical habitat for painted turtle. These areas consist of intact mature deciduous forest bordered by upland bench riparian habitat (Photos 1 to 4) (Hatfield 2022). Riparian benches have flat, gently sloping ground, meeting the criteria of open terrestrial habitat, while deciduous forest is an additional natural terrestrial habitat feature and is also considered critical habitat.

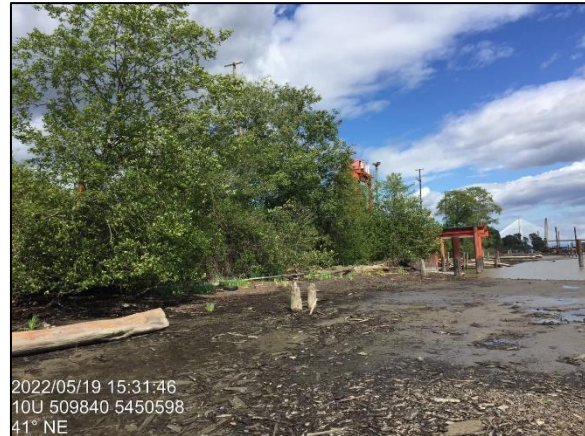
**Photo 2 Terrestrial and intertidal foreshore habitats looking east from the western end of Project Site.**

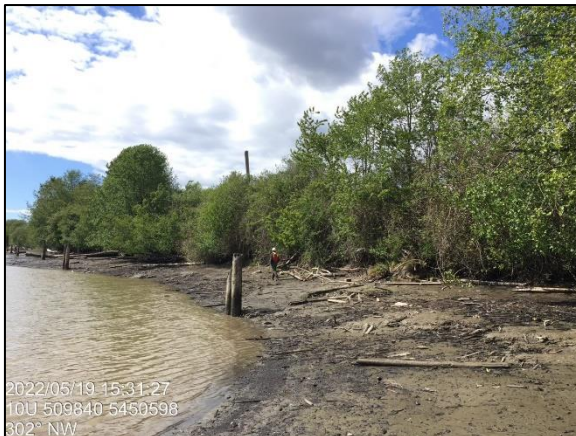
**Photo 3 Terrestrial and intertidal foreshore habitats looking west from the eastern end of the proposed marsh habitat.**

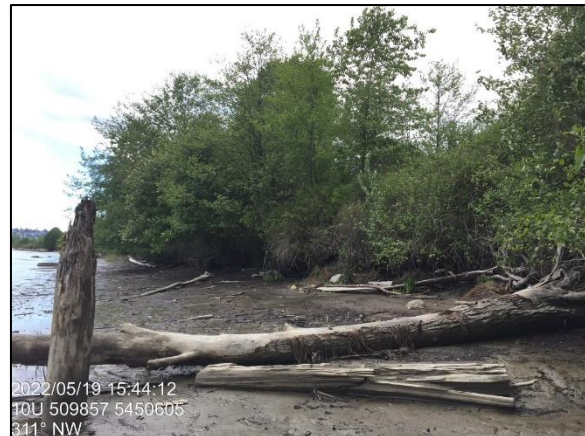
**Photo 4 Terrestrial and intertidal foreshore habitats looking west towards the mouth of Como Creek from within the proposed marsh habitat.**
