Existing Ecological Conditions at Proposed New Brighton Park Habitat Enhancement Project PMV Habitat Enhancement Program

Prepared for:
Port Metro Vancouver
100 The Pointe, 999 Canada Place
Vancouver, BC V6C 3T4

Prepared by:
Hemmera Envirochem Inc.
18th Floor, 4730 Kingsway
Burnaby, BC V5H 0C6

File: 302-035.04
June 2015

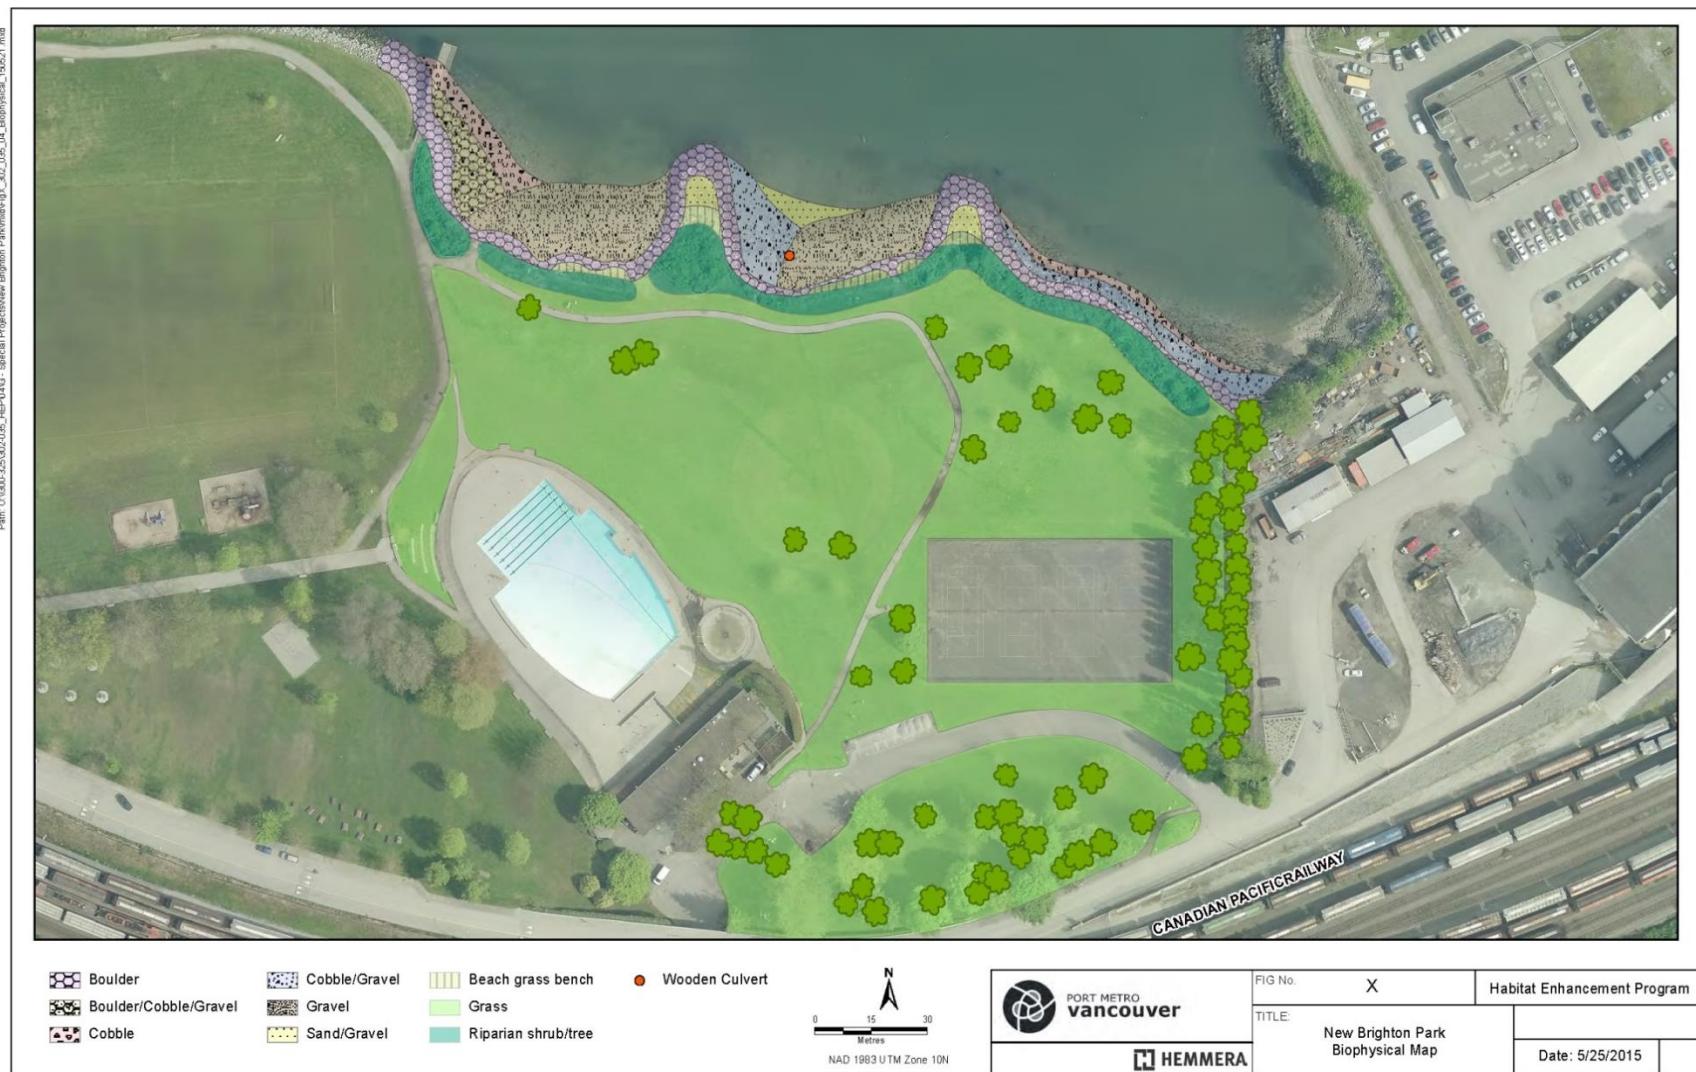
Figure 7 New Brighton Park Biophysical Map

The upland park area is relatively flat, sloping up to an overpass at New Brighton Road near the southern bounds of the park. Organic soil, covered with grass and the occasional landscaped tree, is interspersed with gravel pathways and an access road to New Brighton Pool (**Figure 7, Photo 3; Appendix B**). A section of the newly enhanced Renfrew Creek (**Section 3.1**) at Creekway Park is located along the southern edge of New Brighton Road. The Creekway Park water feature receives water flow from stormwater in the Hastings Park catchment. This section of the water feature consists of a series of weirs to retain storm water. Flows in the cobble lined stream channel were low during the biophysical assessment. The stream channel follows a steep gradient to a corrugated steel half arch culvert that discharges into a storm drain on the north side of the New Brighton Road overpass. From this location, the stormwater is culverted under the park and discharges through a wooden outlet into the intertidal beach in Burrard Inlet (**Figure 7; Appendix B**).

Burrard Inlet is an industrial port that is heavily developed with armoured slopes, bulkheads and ship loading facilities, which reduces fish and wildlife habitat values. Due to prior shoreline stabilization and creation of marine riparian habitat (**Section 3.1**), the shoreline of the proposed enhancement area consists primarily of large boulders and elevated dune grass benches (**Figure 7, Photo 4 and Photo 5**).

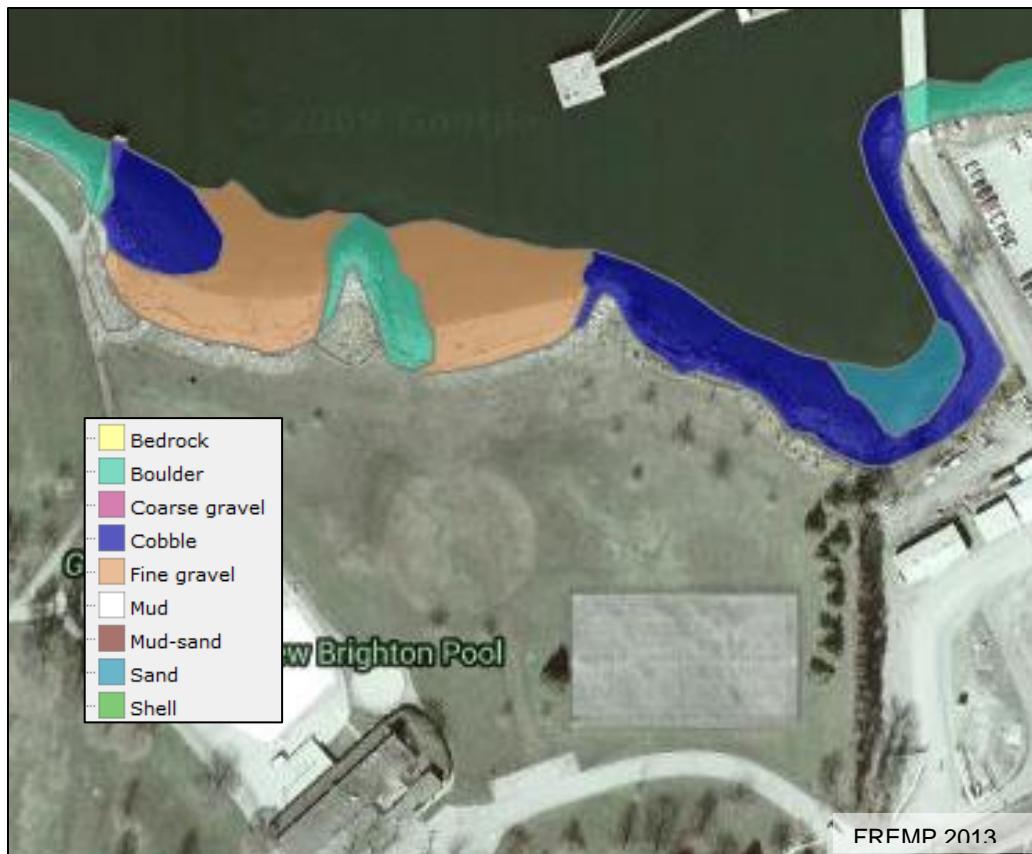
Figure 8 Physical Substrate of the Intertidal Habitat Surrounding the Project Site

Three moderately sloping intertidal beaches, separated by two rock groynes, run along the waterfront in the eastern portion of New Brighton Park. The Burrard Inlet Environmental Action Program (BIEAP) Atlas characterizes intertidal substrate types along Burrard Inlet. According to the atlas, the intertidal beaches at the eastern end of the park are comprised of cobble, fine gravel, and sand with some boulder (**Figure 8; FREMP 2015**). This characterization was confirmed during the biophysical assessment (**Figure 7, Photo 4; Appendix B**). Tides along New Brighton Park are semi diurnal and the tidal range exceeds 5 m (**Appendix B, Table 1; Figure 9**).

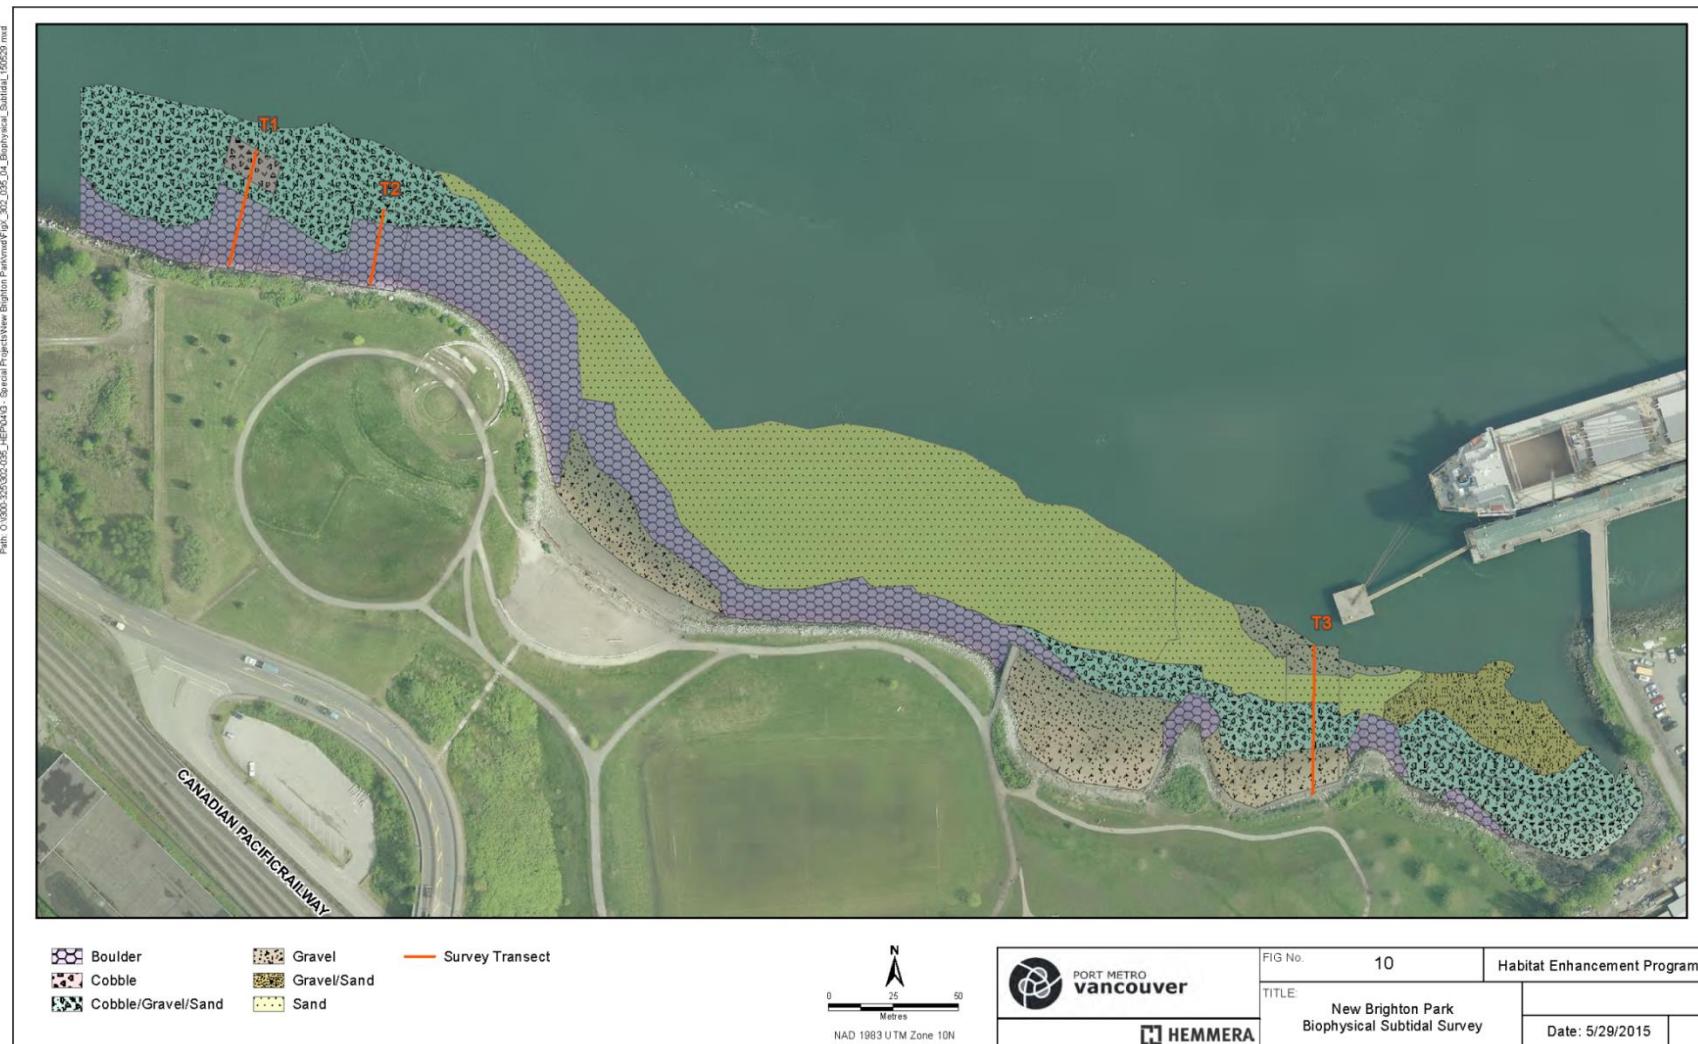
Figure 10 New Brighton Park Biophysical Subtidal Map

SCUBA survey results (west and east) characterized the sediment types present in the nearshore area (**Figure 10**). To the west, the deeper subtidal zone (9 m – 5 m) is characterized by coarser sediments (cobble to gravel). The shallower portions were predominantly rip rap, which is described as boulders (from 5 m depths and shallower). There was a greater proportion of boulder habitat along the west side of the park. The eastern transect followed a shallower grade, typical of a coarse sediment beach (sand, gravel, cobble, and shell debris). The shallow grade resulted in a longer transect than was required to survey the western transects. At depth (4 m), substrate was primarily comprised of a gravel, sand, and shell debris mix, which transitioned into coarser materials (cobble and larger shell debris) at approximately 0 m CD (**Photo 6, Appendix C: Hemmera Biophysical Assessment: Dive Survey Results**). The random swim survey at the west end indicated that the nearshore was made up of large sediment (boulder), while a mix of cobble, gravel, and sand sediment was observed in areas deeper than approximately 4 m CD. The random swim survey at the east end of the site determined the presence of softer sediments, gravel, and sand, mixed with cobbles.

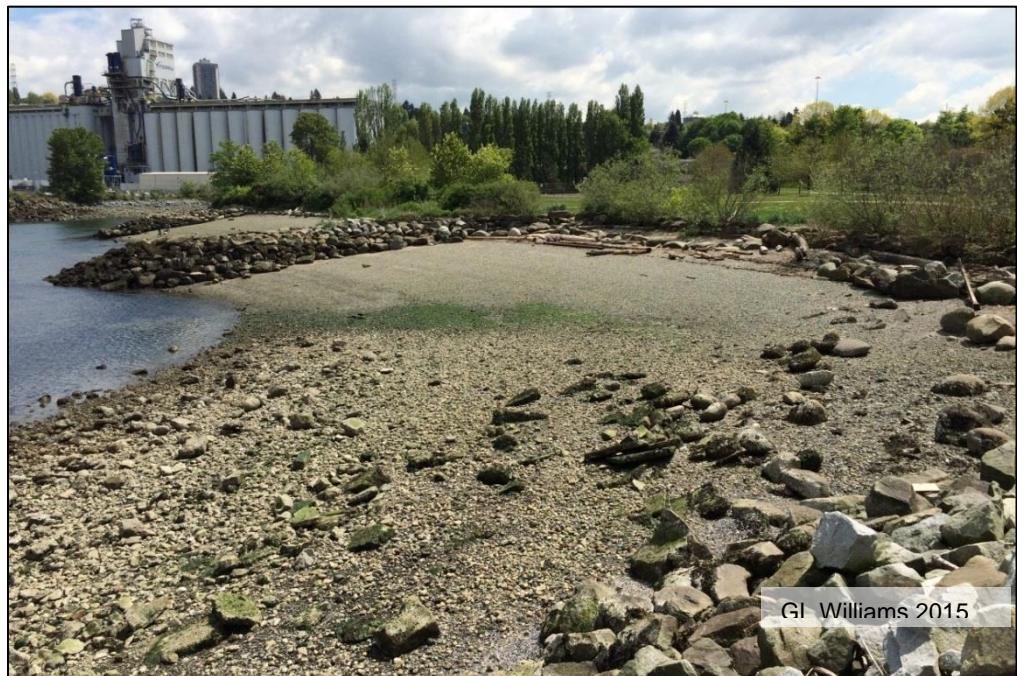
Photo 4 Rock Groynes Separating Scalloped Intertidal Beaches with Varying Substrates and Boulder Banks Looking East

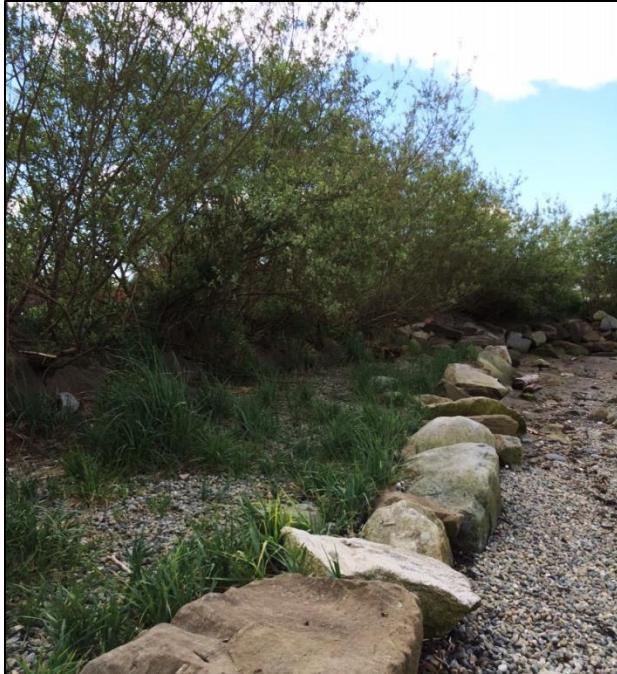
Photo 5 Dune grass Bench Created with Boulders and Sand Fill below Riparian Shrub Backshore Habitat

The riparian shrub and tree habitat bordering the shoreline bank (above HWM) consisted of native species, many of which were planted during shoreline stabilization works in 2006-2007 (**Section 3.1; Photo 7**). A full list of native shrub species is presented in **Appendix B Table 2**. Black cottonwood (*Populus balsamifera*) and red alder (*Alnus rubra*) were interspersed in this band of habitat. Several narrow dune grass benches were observed during the biophysical assessment (**Photo 5**).

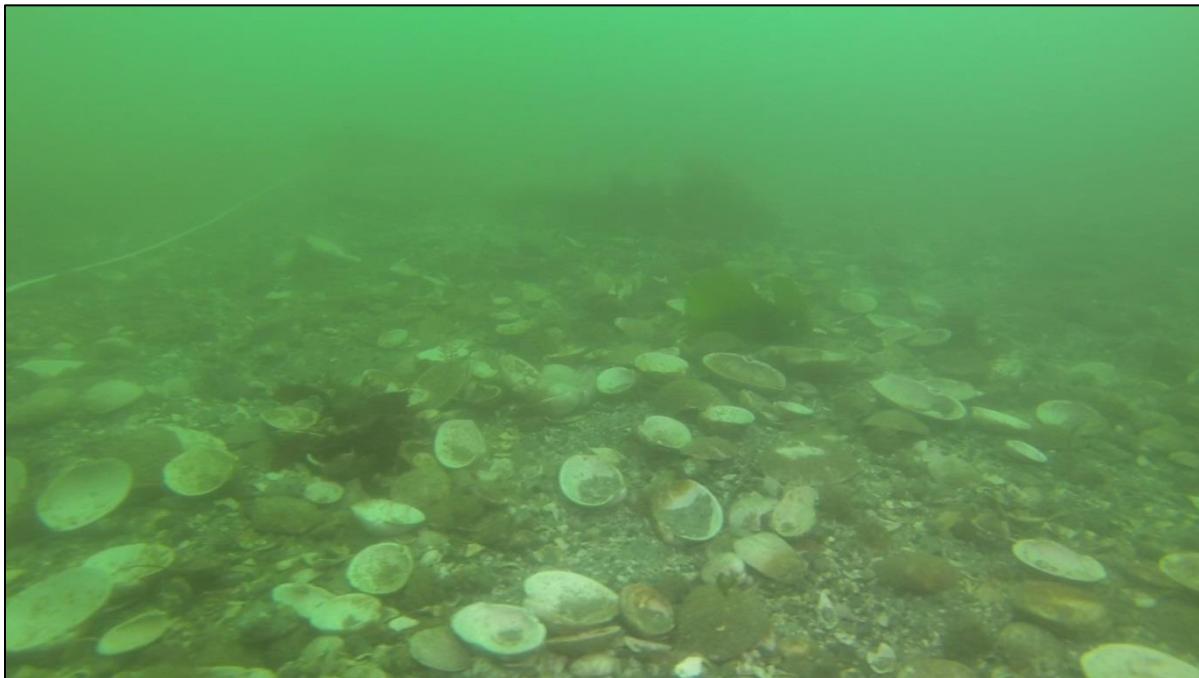
Photo 6 Gravel, Cobble, Shell Debris Sediment Nearshore of Intertidal Beach from Transect 3

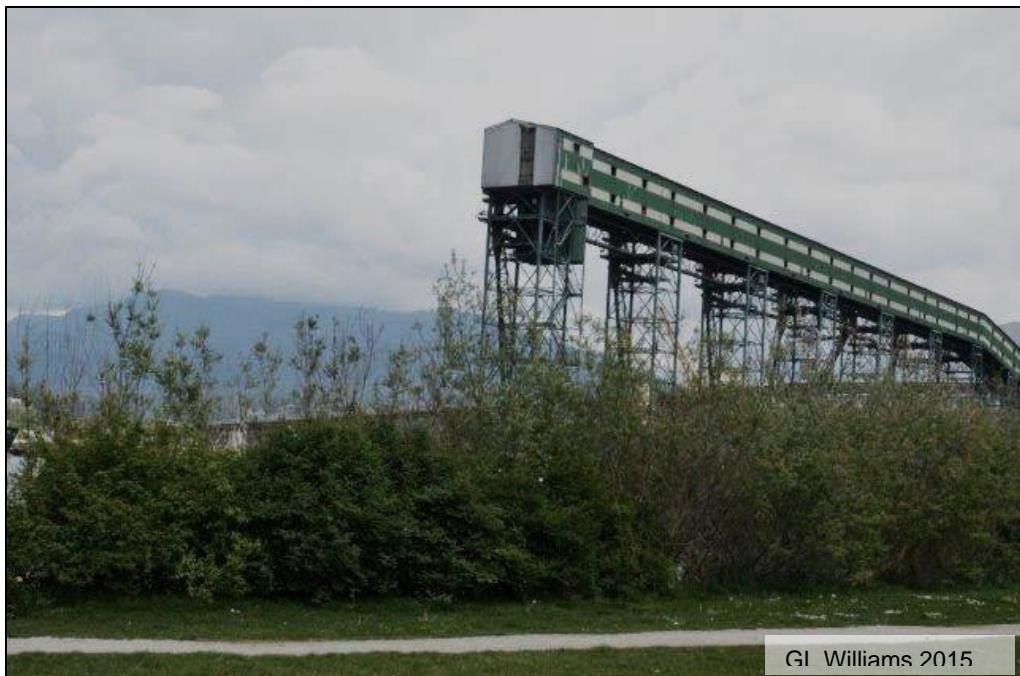
Photo 7 Riparian Shrub and Tree Habitat along the Shoreline Bank at New Brighton Park

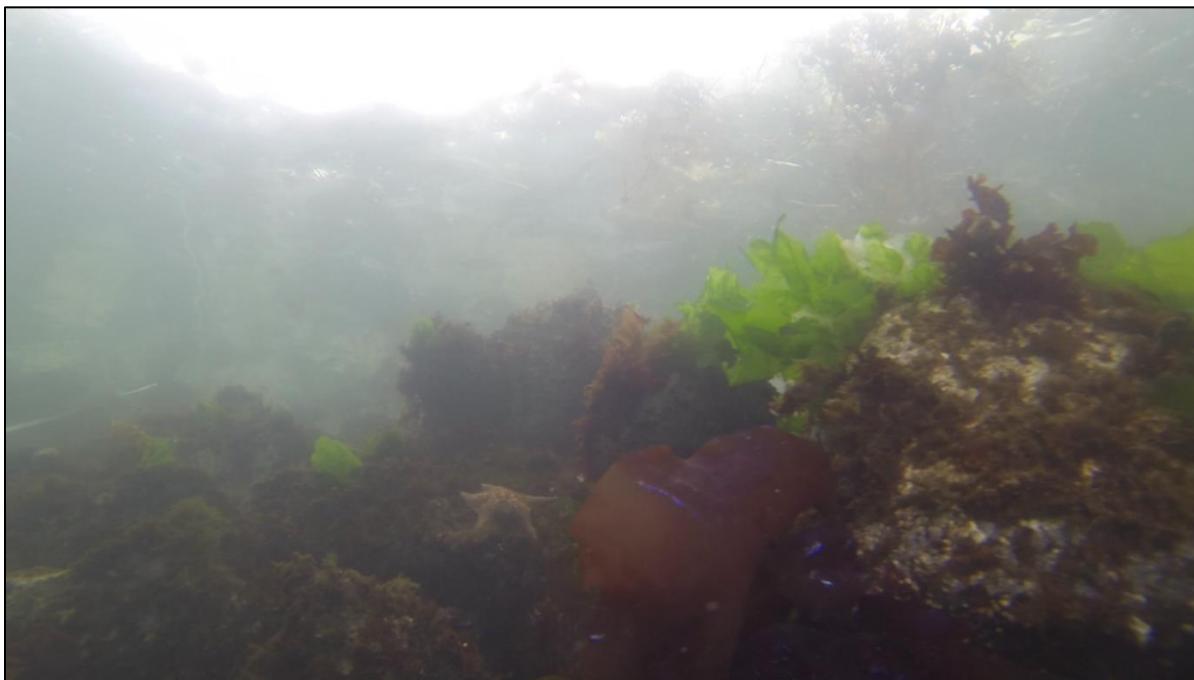
Photo 10 Marine Vegetation in Shallow Subtidal Zone Transect 2 (West side of Park)

The subtidal marine assemblages observed within the Site are typical of those commonly occurring on hard substrates in Vancouver Harbour (Morris 2001, FREMP 2013, **Appendix C: Table C1**). The shallow subtidal zone with coarse sediments was characterized by a mix of brown kelp species including: bull kelp, seersucker kelp (*Costa costaria*), and sugar kelp (**Photo 9**). Other common algal species including: splendid iridescent seaweed, rockweed, sea lettuce, red bladed and red filamentous species were also present within the subtidal zone. The western area transects were dominated by kelp forest species and smaller red and green algal communities (**Photo 10**). In all transects, deeper subtidal areas were

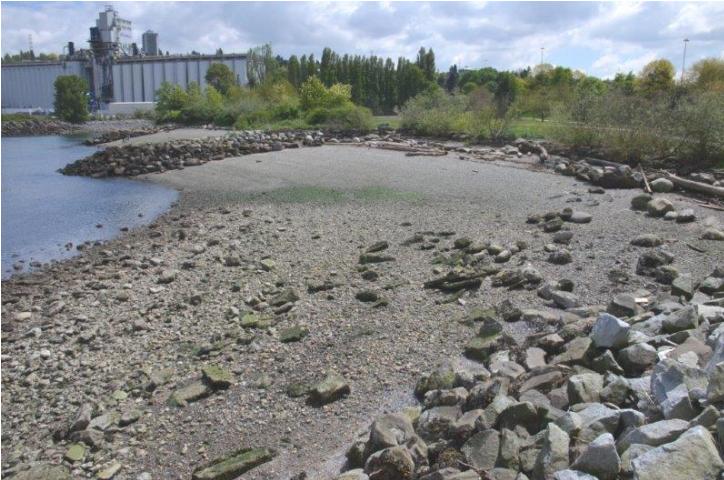
Photo 1. Extended rounded rock groins separating scalloped intertidal beaches.

The entire Burrard Inlet shoreline within the study area has been reconstructed for shoreline protection purposes, with large diameter rounded rock groins constructed to create three scalloped beach areas (Photo 1). The existing intertidal habitat consists of a wide, moderately sloping beach covered in unconsolidated cobble, gravel, and sand beach sloping up to an upper intertidal rock berm (Photo 2). A beach grass bench is situated just above the higher high water level and a band of native shrubs planted along the top of bank (Photo 3). At the western limit of the study area, a timber pile supported observation deck exists (Photo 4).

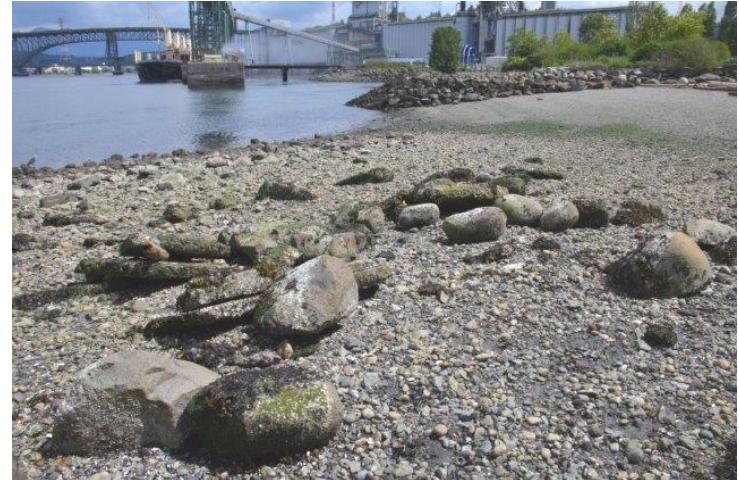
Photo 2. Boulder, cobble, gravel, and sand beach substrates.

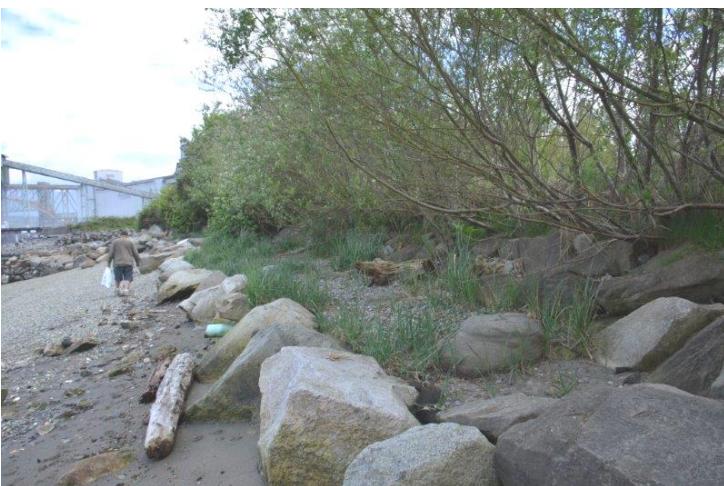
Photo 3. Beac grass bench located below backshore shrubs.

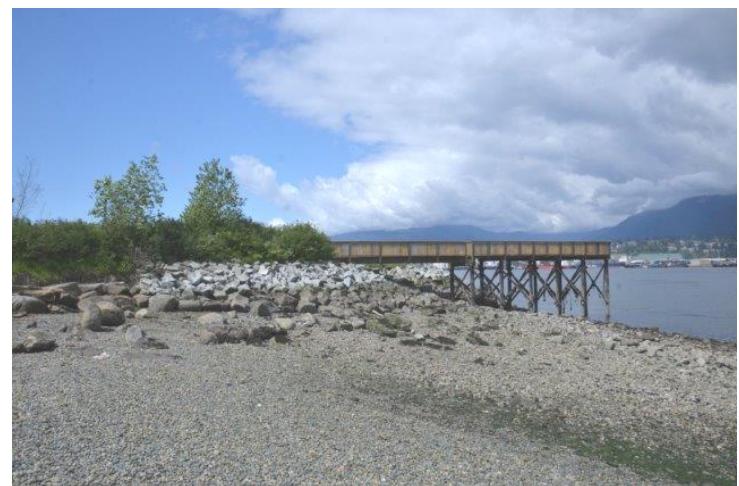
Photo 4. Timber pile supported observation deck at the western limit of study area.

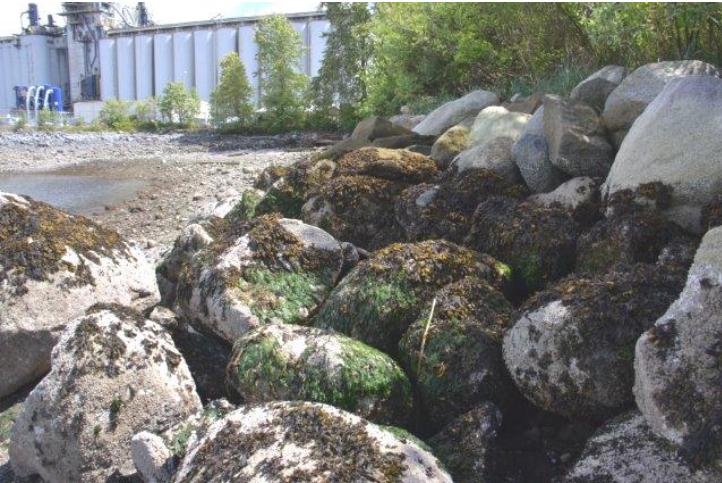
Photo 5. Luxuriant growth of macroalgae on large rounded rock installed for bank armouring.

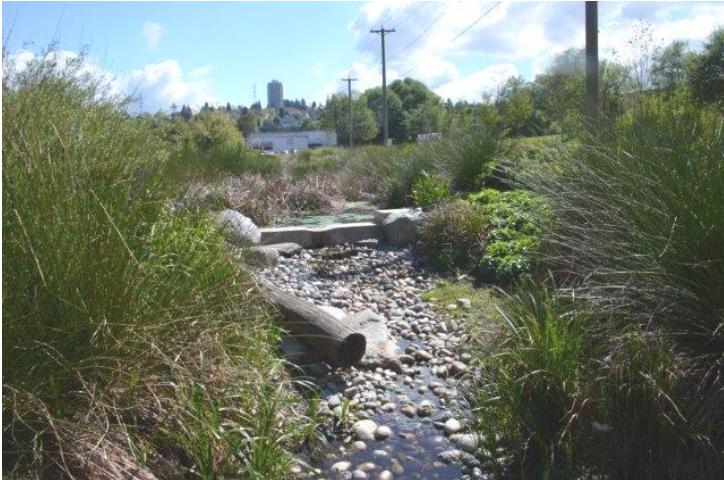
Photo 13. Daylighted Renfrew Creek showing weir and cobble-gravel lined channel in Creekway Park.

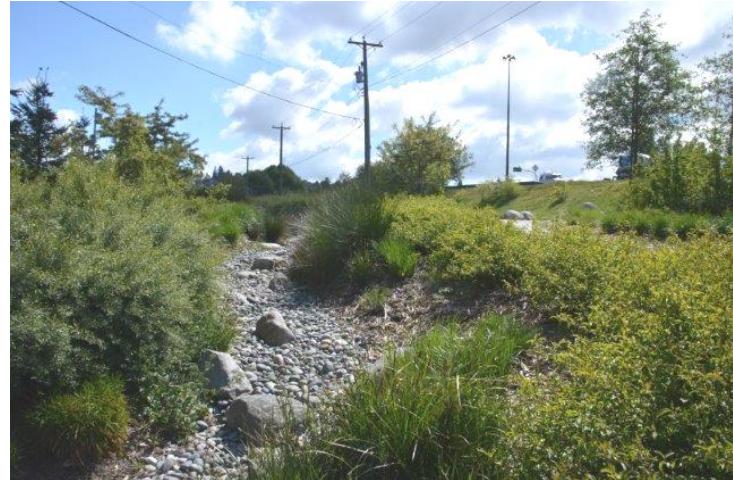
Photo 14. Steep section of daylighted stream channel with minimal waterflow in May 2015.

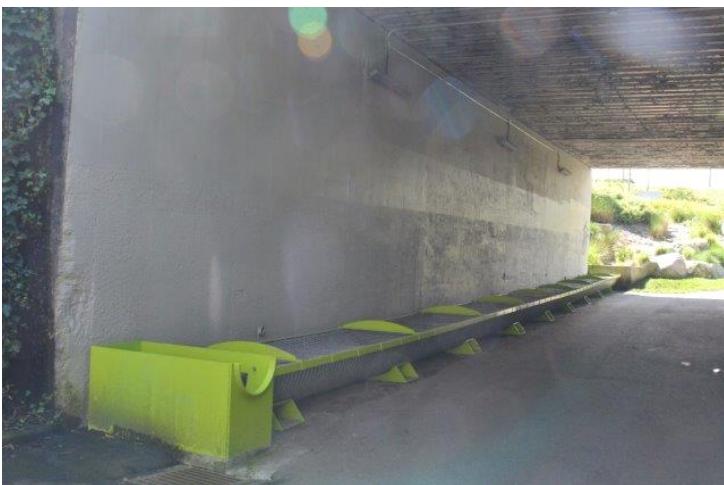
Photo 15. Aboveground flume transports flows from daylighted stream to underground culvert that discharges into Burrard Inlet.

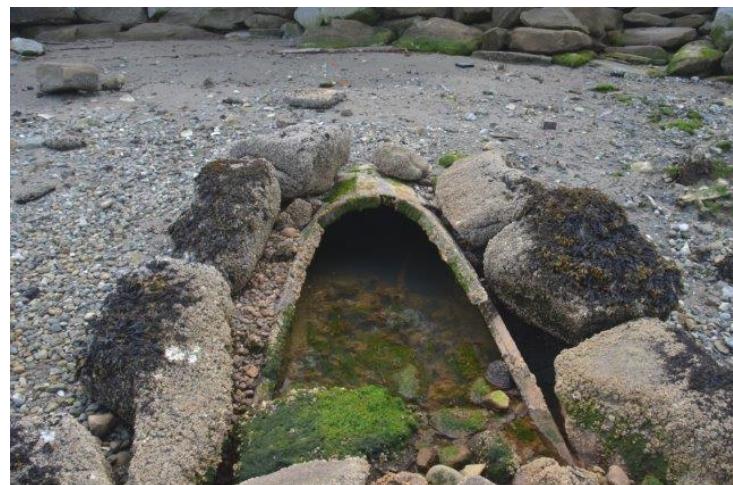
Photo 16. Wooden culvert beach outlet of Renfrew Creek that discharges into Burrard Inlet.
