Riverfront Park Tidal Marsh Project

Description, location and size

Overview of completed project

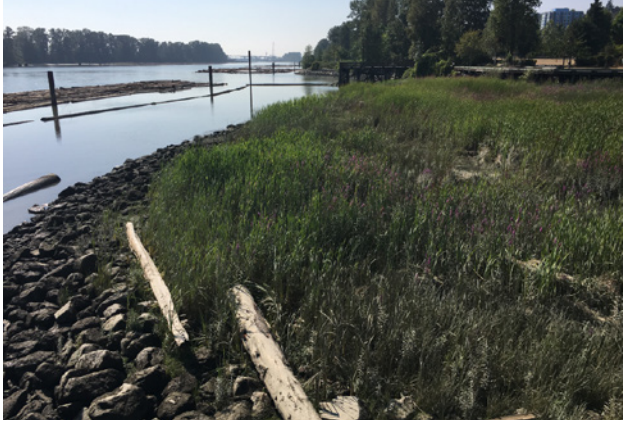
Site conditions, looking downstream (2018)

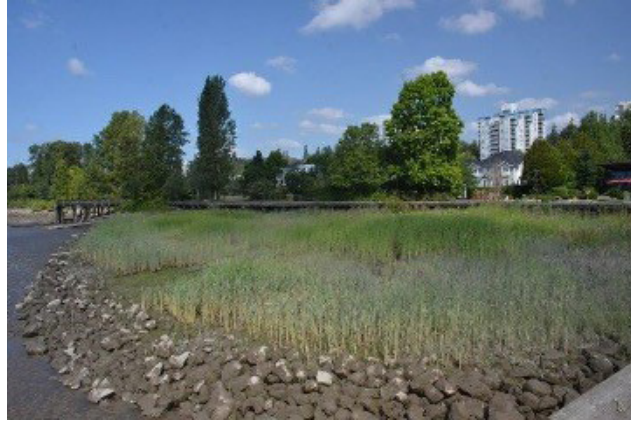
Site conditions, looking north (2022)

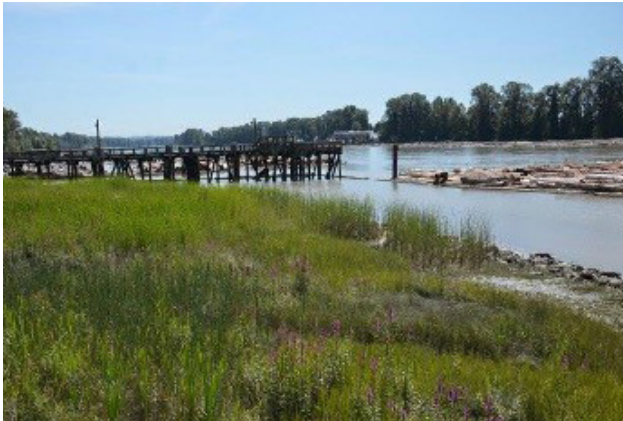
The project site in the foreground, looking southeast (2020)

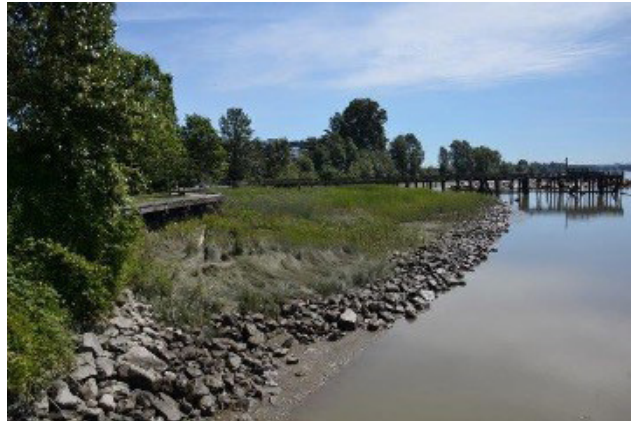
View of the project area from the downstream end of the site (2020)
