# Existing Ecological Conditions

## Proposed Tsawwassen Eelgrass Enhancement Project

File: 302-035.04  
May 2015

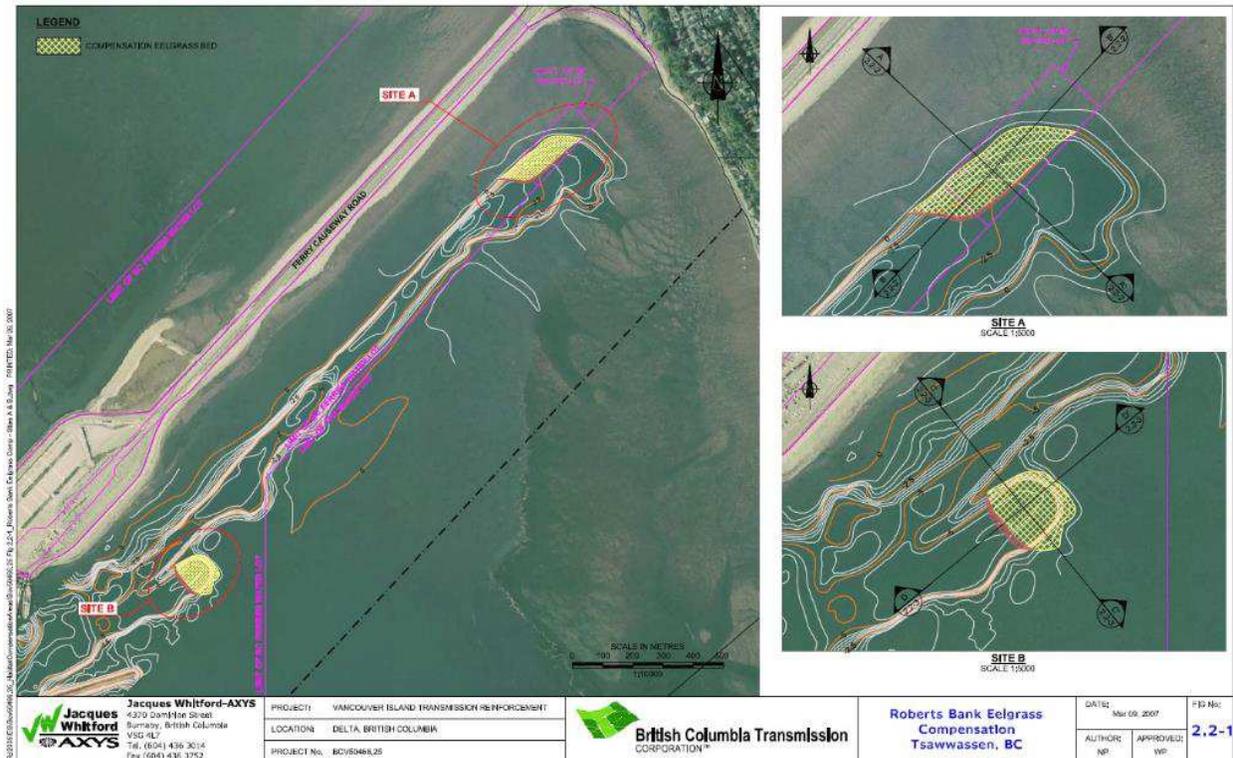
**Figure 3 BCTC Eelgrass Compensation Sites near the Proposed Tsawwassen Eelgrass Enhancement Sites**

Eelgrass habitat was previously created in close proximity to the proposed Project. In 2008, British Columbia Transmission Corporation (BCTC) constructed two eelgrass beds totalling 2.09 ha as fish habitat compensation for the Vancouver Island Transmission Reinforcement (VITR) project (**Figure 3**). Post-construction monitoring results from 2010 demonstrated that bed density had increased three-fold from the original transplant density (Golder Associates Ltd. 2011).

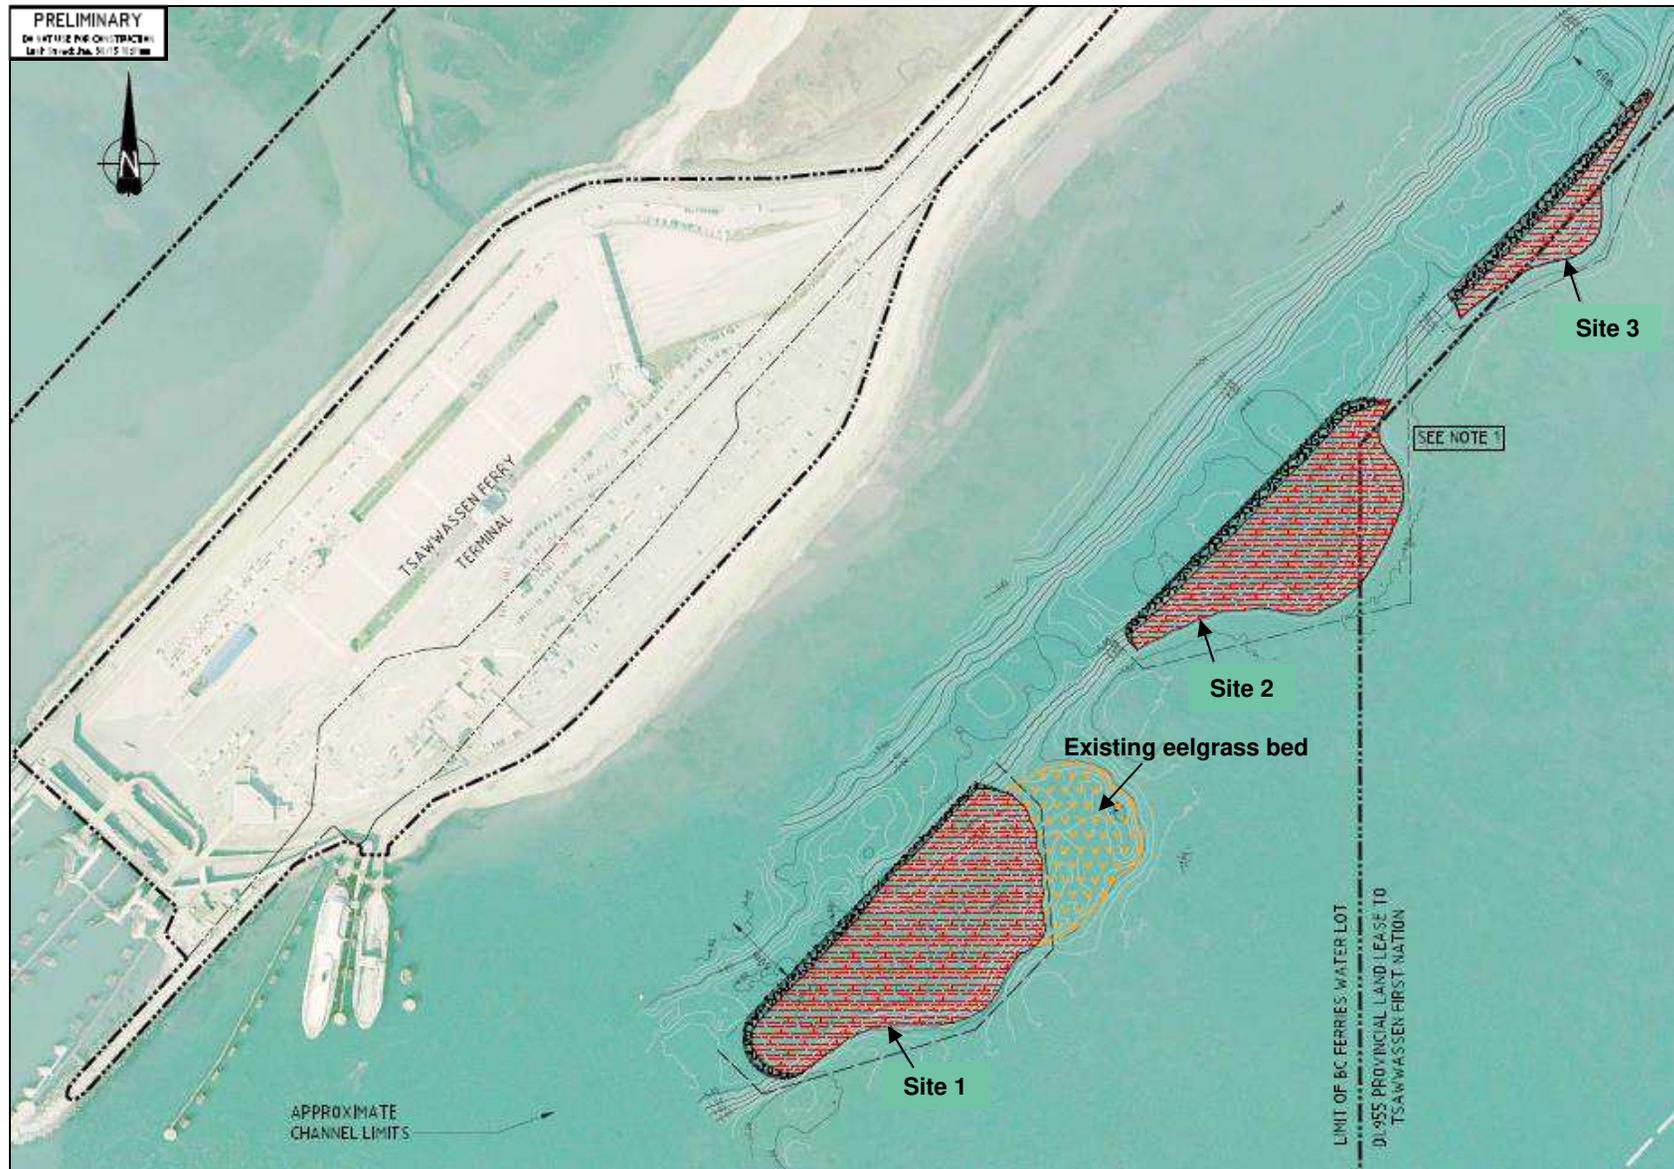
Figure 4 Proposed Tsawwassen Eelgrass Project sites (Moffatt & Nichol 2015)

The Project proposes to create three subtidal eelgrass beds southeast of the Tsawwassen ferry terminal causeway. Approximately 4.8 ha of habitat enhancement could be undertaken at three sites (**Figure 4**). Sites 1, 2 and 3 would encompass 2.63 ha, 1.73 ha, and 0.46 ha respectively.

The proposed Project will raise the seabed elevation at three subtidal depressions (approximately -4.0 m to -6.0 m CD) formed by historic dredging activities, to elevations suitable for the establishment and persistence of native eelgrass (*Zostera marina*; approximately -2.25 m CD to -1.0 m CD). Perimeter berms will be created along the western edge (adjacent to the deep channel) of each proposed site to reduce erosion along the outer edges of the eelgrass beds and to contain fill added to the depressions. The eastern edges of the proposed eelgrass enhancement sites will be blended (e.g. elevations will match) with the adjacent eelgrass beds, with reasonably even and uniform substrate surfaces. After a substrate settlement period, the raised seabed will be transplanted using plants from a nearby suitable donor site.

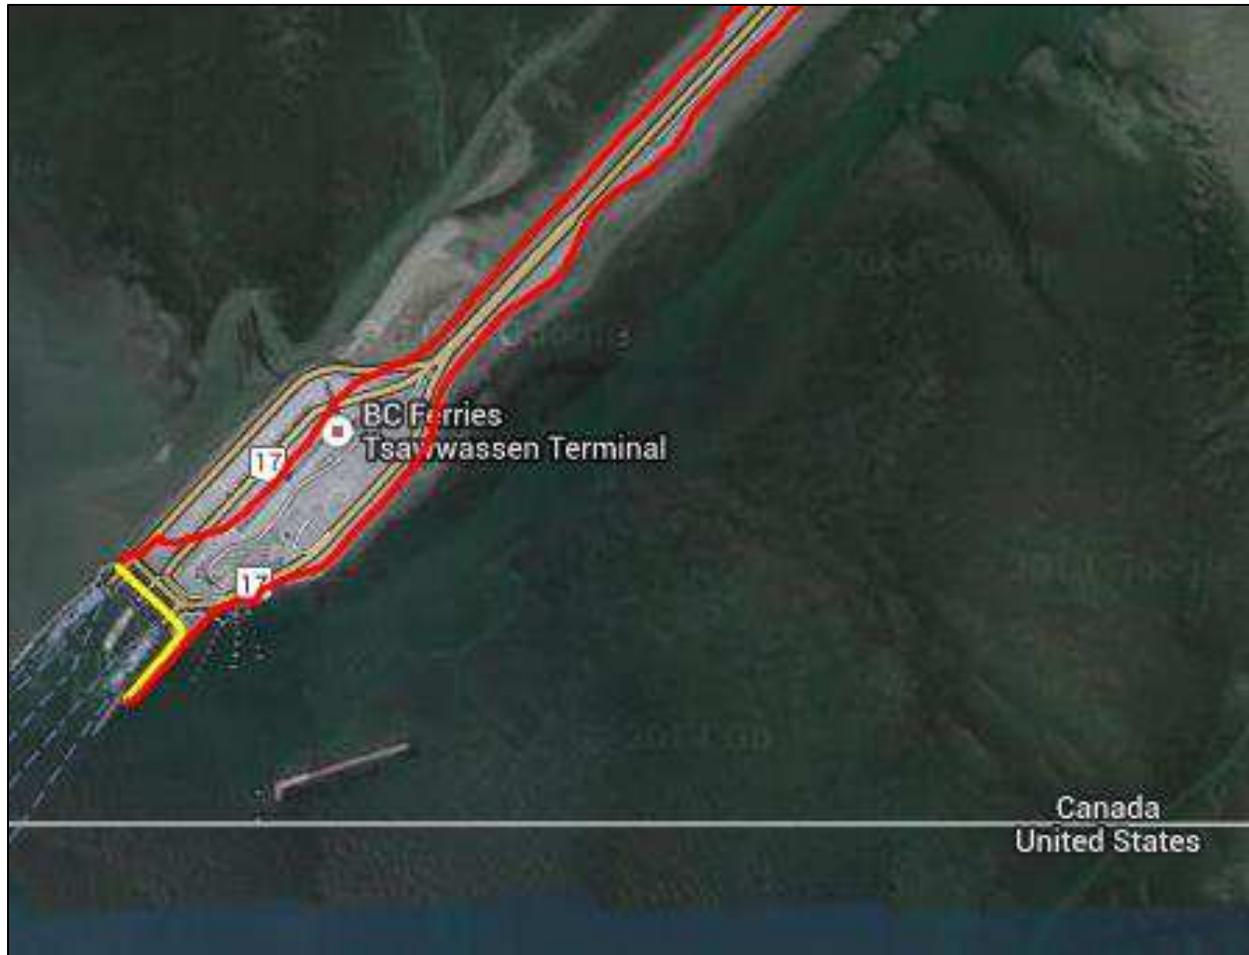
**Figure 7 FREMP Habitat Classification nearby the Project, Delta, BC**

The shoreline close to the proposed Project (along the Tsawwassen Ferry Terminal causeway) is coded Red, indicating that this is a highly productive habitat (**Figure 7**). As FREMP did not include subtidal habitat classifications, the Project is not classified. The proposed enhancement will not affect the FREMP coding for the nearby shoreline and will ultimately enhance local productivity.

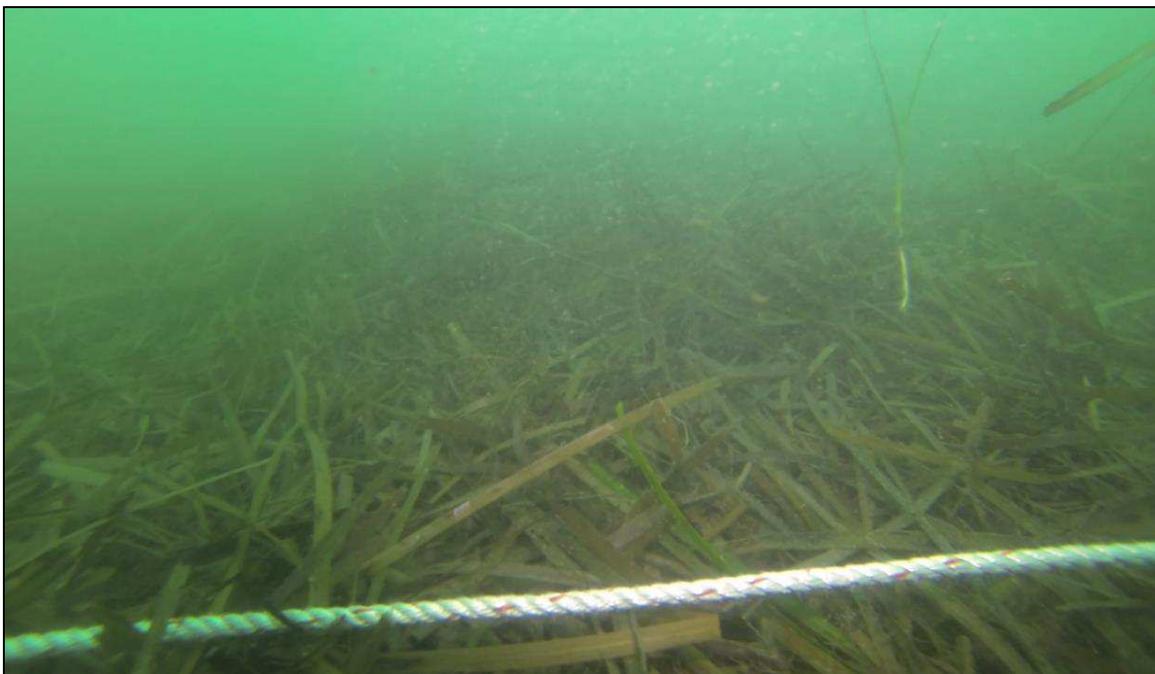
**Photo 1 Dense Eelgrass Detritus Along Transect 1 in Proposed Site 3**

Aside from native eelgrass detritus (**Photo 1**), which was widely distributed over the bottom of the dredge basin, no vegetation was noted during dive surveys. A large sandflat populated with native eelgrass is located southeast of the site at elevations between -1.4 m to 0.0 m CD (**Photo 2**). A continuous bed of eelgrass was present beginning at approximately -1.4 m CD depths.

Similar to Sites 1 and 2, the depression at Site 3 appears to be both limiting eelgrass expansion and acting as a sink for detritus, lowering its overall productivity and not providing significant fisheries habitat value. The adjacent eelgrass bed is very productive and provides significant habitat values for fisheries species. The biophysical characteristics of the neighboring eelgrass bed indicate the viability of eelgrass enhancement opportunities if suitable elevations, slope and sediment type can be established at Site 3 (**Appendix B: Section 5.0**)

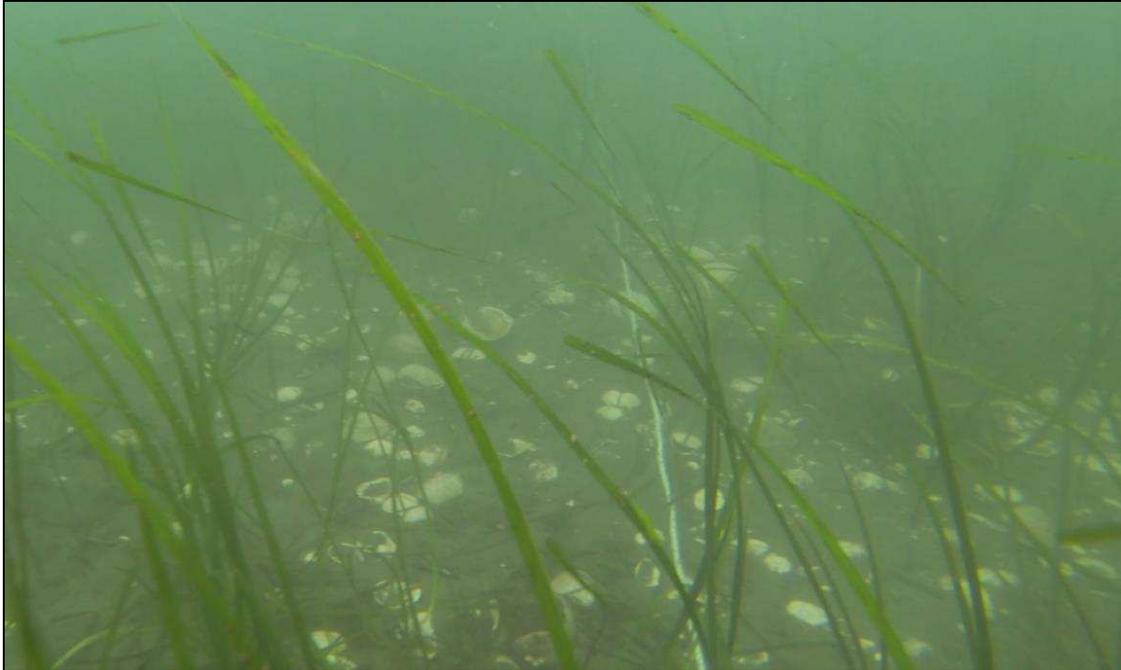
**Photo 2 Eelgrass with Shells on Sandy Bottom Substrate Adjacent to Proposed Site 3**

A single juvenile common sunstar (*Crossaster papposus*) was observed at Site 3. Site 3 dive survey transects extended from within Site 3 into adjacent eelgrass beds, in order to characterize conditions within and adjacent to the proposed site (**Appendix B: Section 3.0**). Marine life common to the adjacent eelgrass bed included: Dungeness crab (*Metacarcinus magister*), green anemone (*Pharamachus sp.*), eelgrass limpet (*Lottia alveus*), hooded nudibranch (*Melibe leonina*) and a high abundance of bivalve shells (**Appendix B: Section 4.0**).

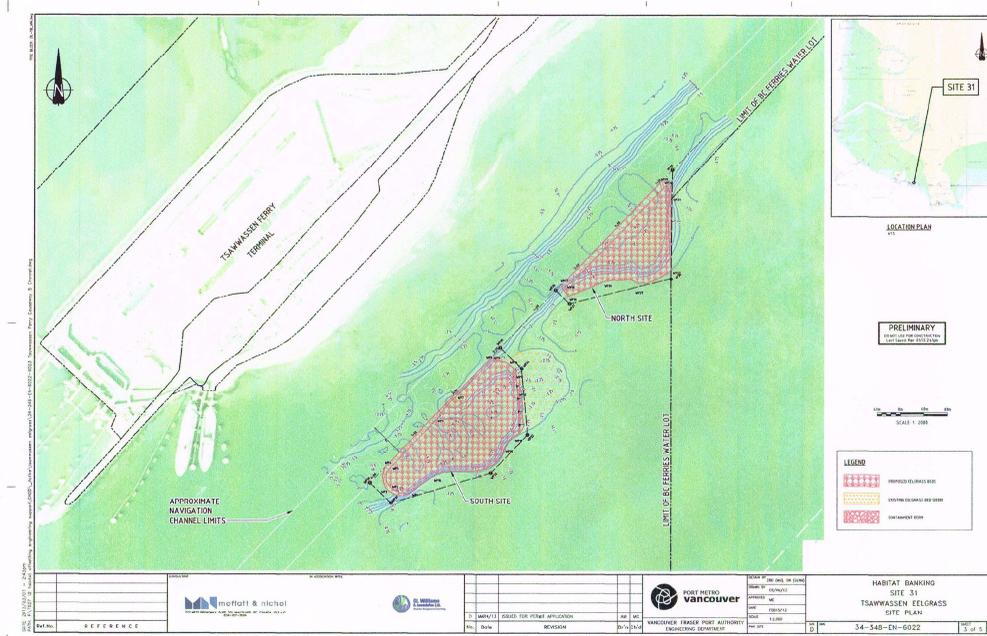
**FIGURE 1. THE SITES AT TSAWWASSEN THAT COULD BE MODIFIED TO SUPPORT EELGRASS.**

The locations of the potential eelgrass enhancement sites in Tsawwassen are shown in Figure 1.

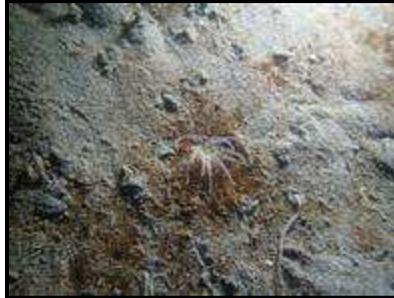
**Photograph 1.** A ten-tentacled burrowing anemone surrounded by a film of diatoms.

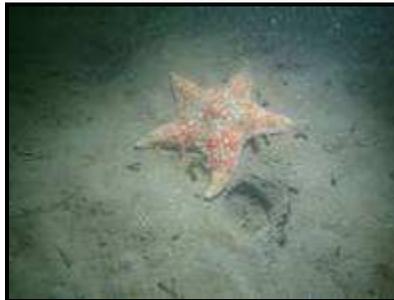
**Photograph 2.** A leather star roving the surface.

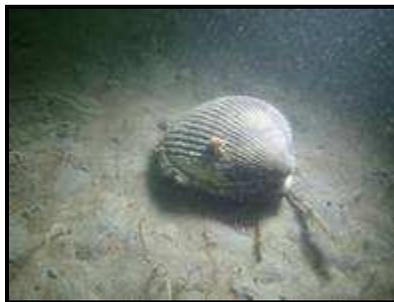
**Photograph 3.** Nuttall's cockle surrounded by tube worms.

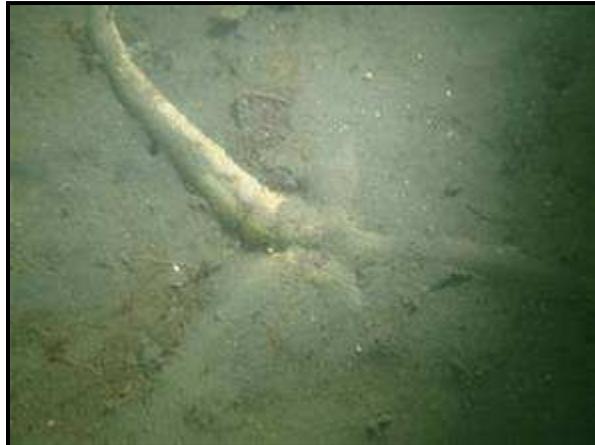
**Photograph 5.** A partially buried sand star.

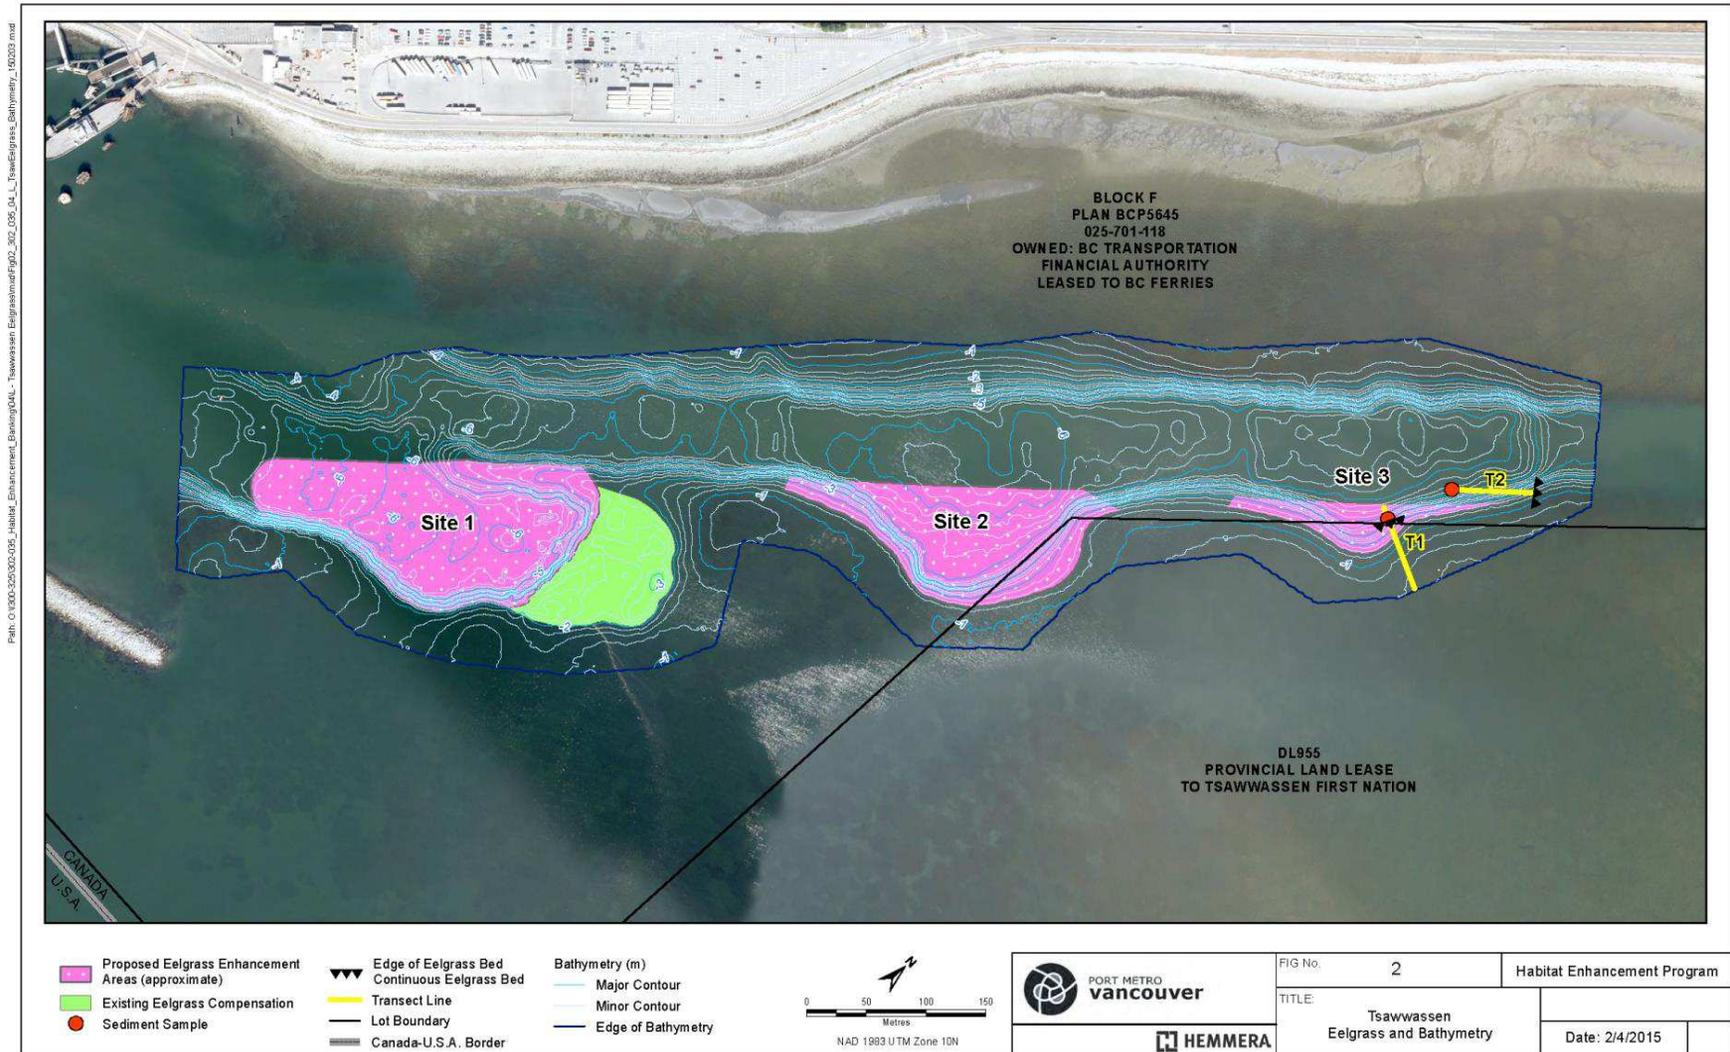
**Figure 2 Tsawwassen eelgrass transplant candidate sites 1, 2 and 3 with December 2014 bathymetry overlay and January 7<sup>th</sup> 2015 dive transects**

Two predetermined transects were completed on January 7<sup>th</sup> 2015 (**Figure 2**) with each located in the field using a Garmin GPS (+/- 4 m) and established using sinking transect lines set in advance of the dives. SCUBA surveys were conducted along each 60 m transect and extended from within Site 3 to adjacent eelgrass beds to characterise conditions within and adjacent to the proposed enhancement site. Survey methods consisted of sampling a 1.0 m<sup>2</sup> quadrat (**Photo 1**) every five metres for eelgrass presence, density, morphological features, substrate conditions, and the presence of other marine life. One sediment sample was taken along each transect, within Site 3, and sent to Maxxam Analytics for sediment grain size analysis.

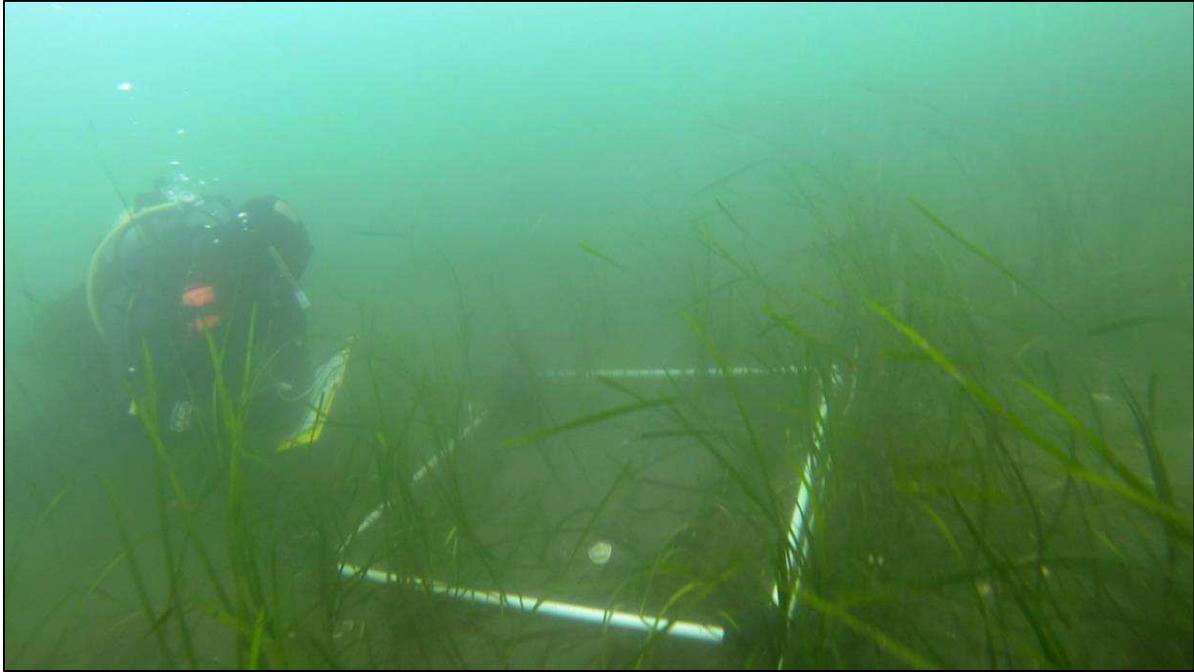
**Photo 1** Quadrat (1.0 m<sup>2</sup>) used to sample eelgrass and substrate conditions January 7th, 2015.

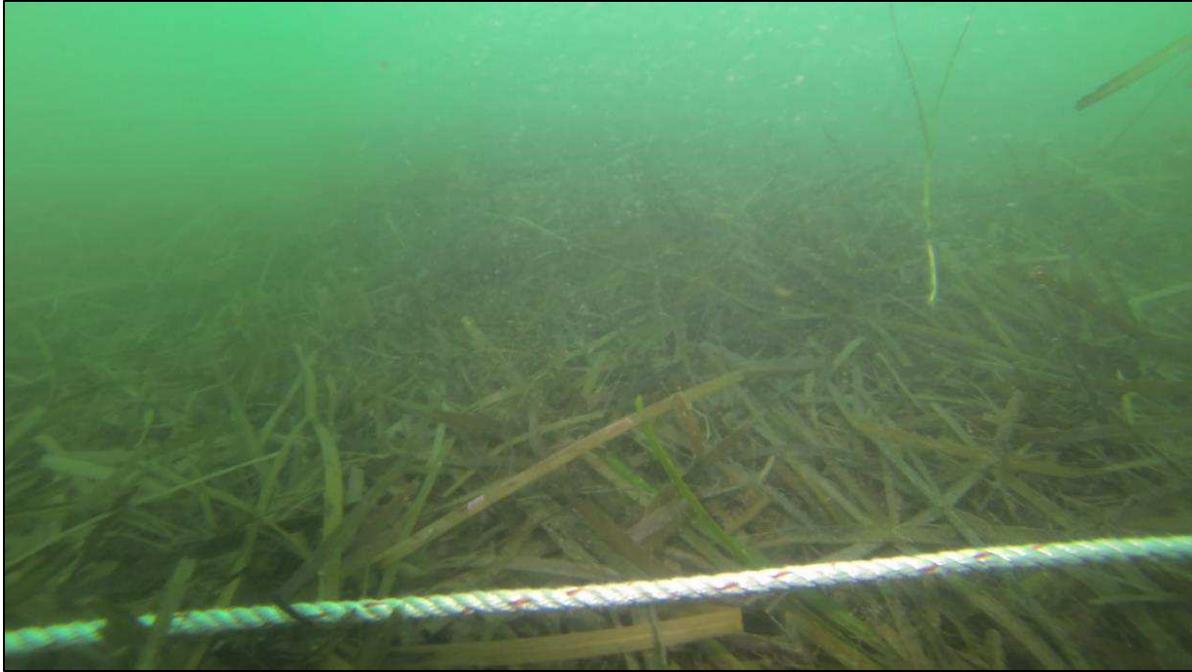
The surface substrate between 0 m and 10 m on the transect was observed to be predominantly silt (95% silt, 5% sand), and *Z. marina* detritus (piles ~0.3 m deep) were widely distributed over the surface (quadrats at 0 m and 5 m along the transect were completely covered with eelgrass debris) (**Photo 2**). A single juvenile sun star (*Crossaster papposus*) was observed in this area.

**Photo 2** Dense eelgrass detritus along Transect 1, Jan. 07 2015, dive 1.

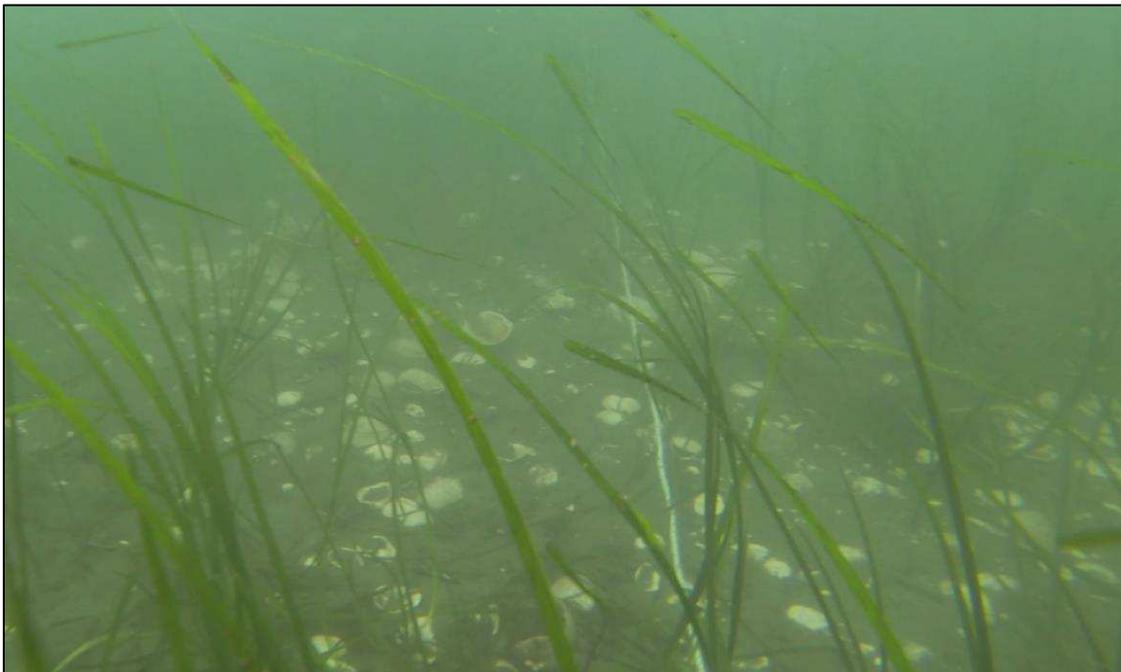
**Photo 3** Eelgrass with shells on sandy bottom substrate along Transect 1, Jan. 07 2015, dive 1.

Within the eelgrass bed (from 15 m to the end of the transect) the surface substrate was predominantly sand (30% silt, 70% sand) and became progressively sandier (95% sand at 60 m) as the transect approached 0 m CD (**Photo 3**). Average density was 19.7 shoots/m<sup>2</sup>, leaf blade width was constant at 7 mm, while average blade length averaged 1.0 m. Eelgrass covered an average of 26% of the bottom surface area, and shells (including *Macoma spp.*, corrugated clams (*Humilaria kennerleyi*), and cockle shells (*Clinocardium nuttalli*)) covered an average of 5% of bottom surface area (**Photo 3**). In the last quadrat sampled 20% of the bottom substrate surface was covered in a diatom mat.

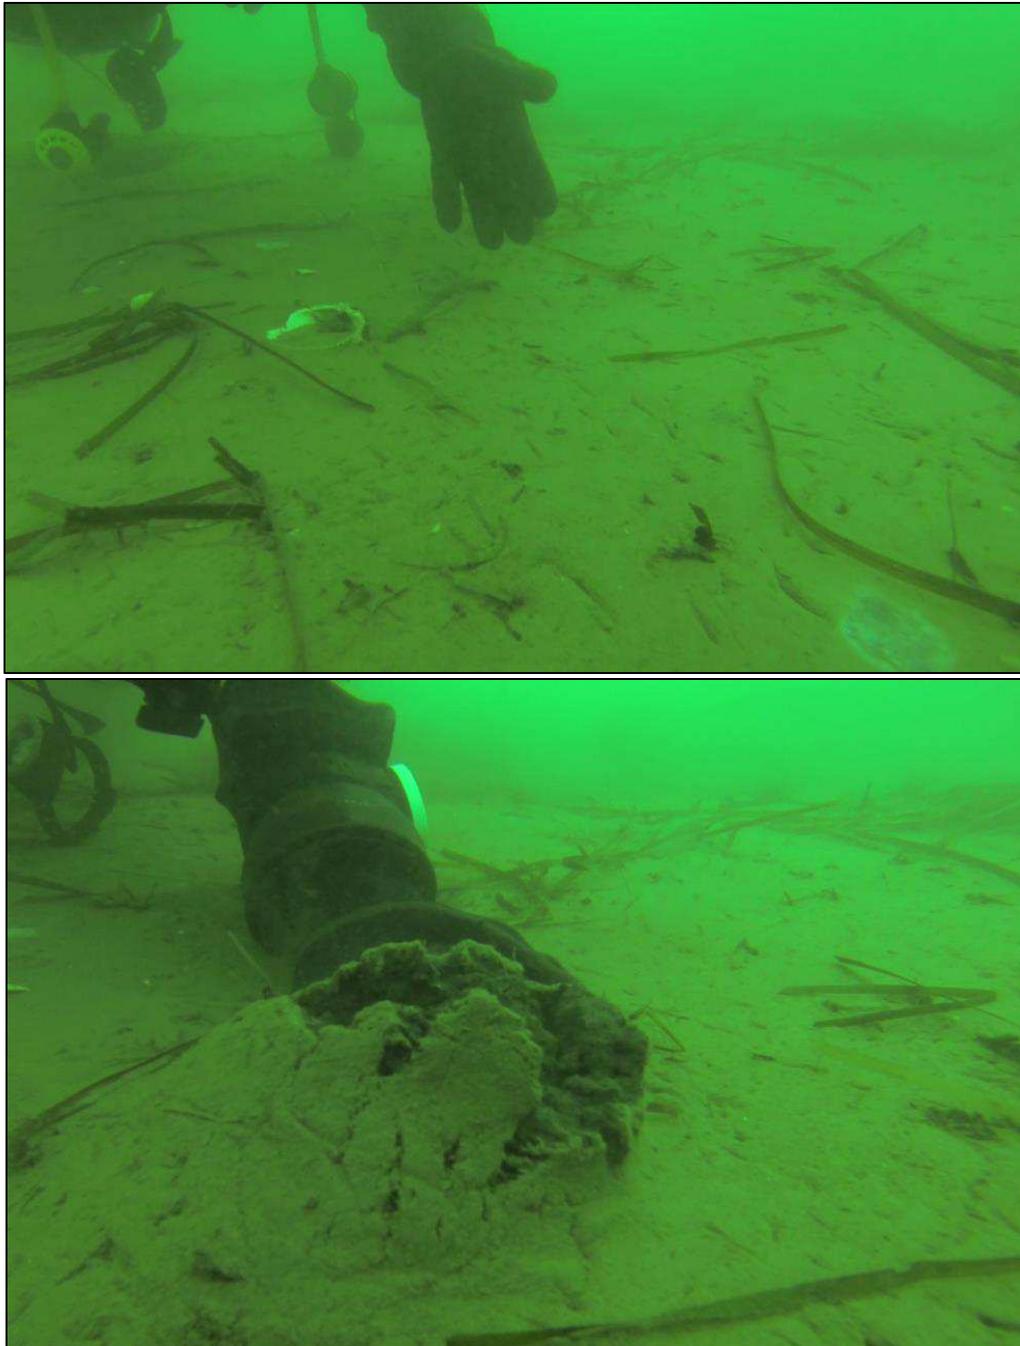
After the transect was complete, a reconnaissance of the sediment northeast of the transect was conducted to observe a greater portion of the proposed footprint. The deeper sediments appear to be a continuous silty-sand with a dark hypoxic layer deeper underneath (**Photo 4**). A few Dungeness crab were observed.

**Photo 4** Sediment with dark hypoxic layer underneath, Transect 1, Jan. 07 2015, dive 1.

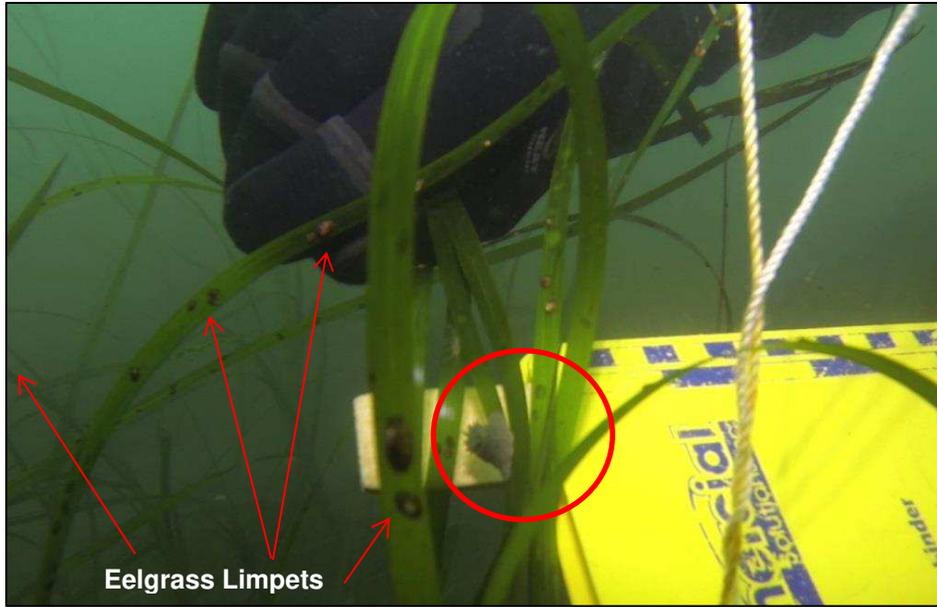
Species observed between 15 m and 60 m of Transect 1 included unidentified infauna, a green anemone (unknown species), eelgrass limpets (*Lottia alveus*) on eelgrass blades (**Photo 5**), a smoothhead sculpin (*Artedius lateralis*) (**Photo 6**), hooded nudibranchs (*Melibe leonina*) (**Photo 5**), and an adult Dungeness crab (**Photo 7**).

Photo 5 Eelgrass limpets and anemone on eelgrass blades, Transect 1, Jan. 07 2015, dive 1.

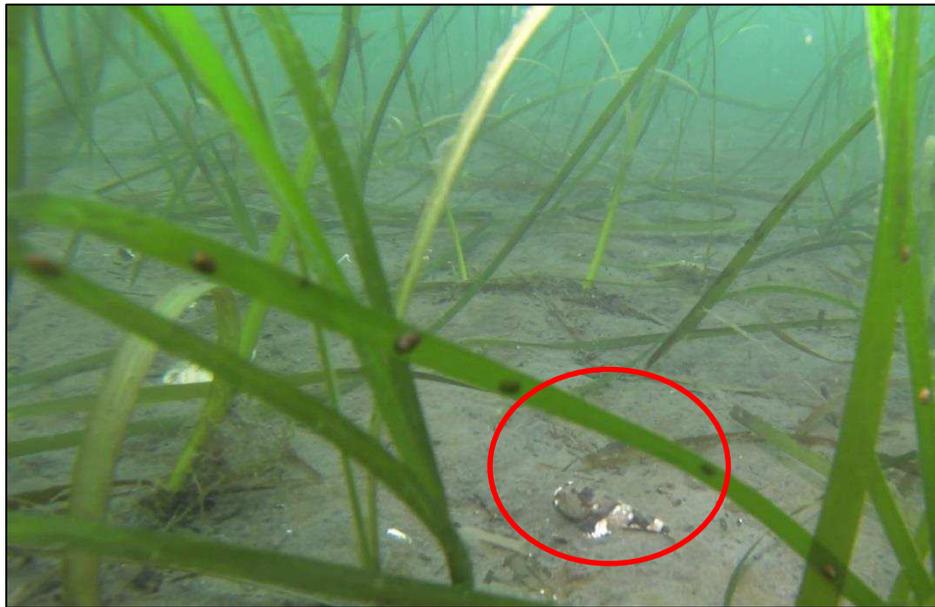
Photo 6 Sculpin in eelgrass bed along Transect 1, Jan. 07 2015, dive 1.

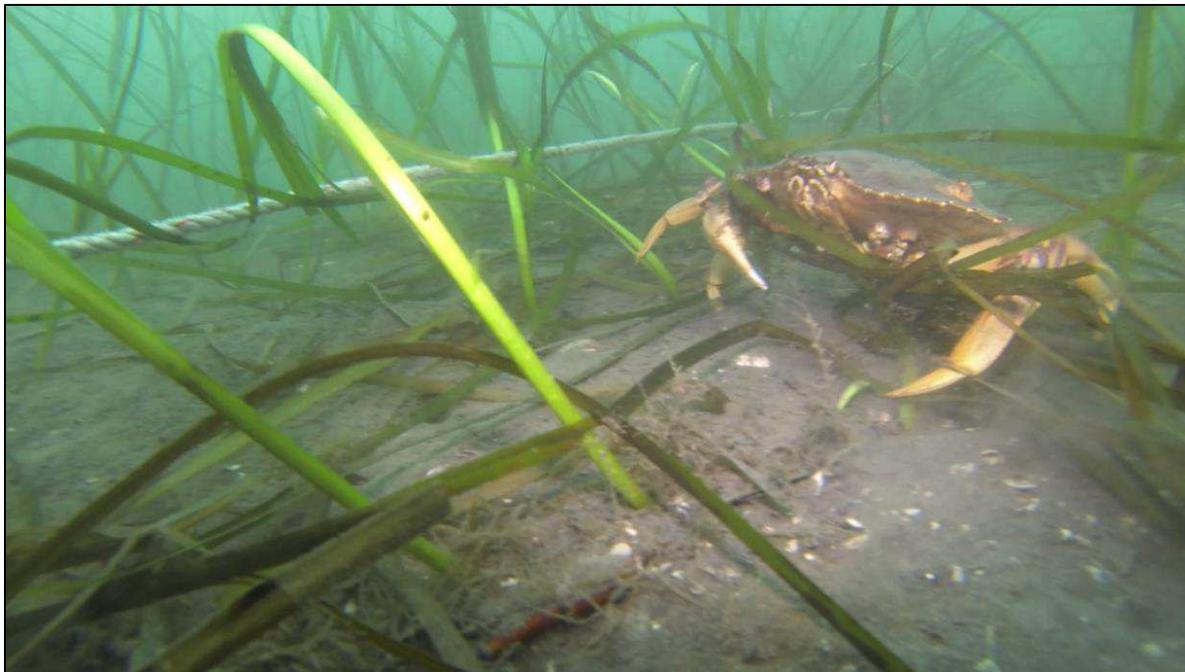
**Photo 7** Adult Dungeness crab in eelgrass bed along Transect 1, Jan. 07 2015, dive 1.

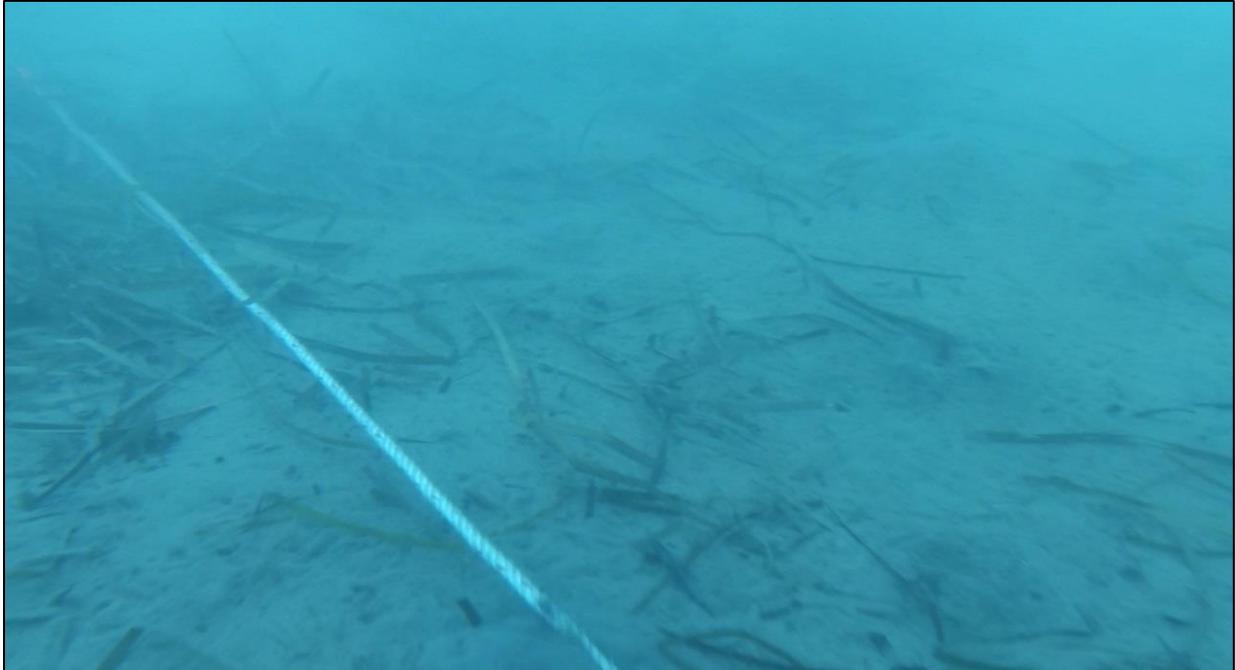
From 0 m to 20m along the transect, the proportion of silt in the substrate was estimated between 90 and 95% silt (**Photo 8**); silt content decreased with decreasing depth along the transect and the transition from the depression to the slope. On average 65% of the surface area was covered in eelgrass detritus from 0 m to 20 m, but detritus completely covered the sediment surface in some quadrats (**Photo 9**). The bottom surface substrate was observed to be almost equally silt and sand, with an average estimate of 45% silt and 55% sand, from the beginning of the slope at 30 m to the end of the transect (**Photo 10** and **Photo 11**). Eelgrass detritus covered an average of 13% of the surface of quadrats sampled from 30 m to 65 m.

**Photo 8 Silty substrate with eelgrass detritus, Transect 2, Jan. 07 2015, dive 2.**

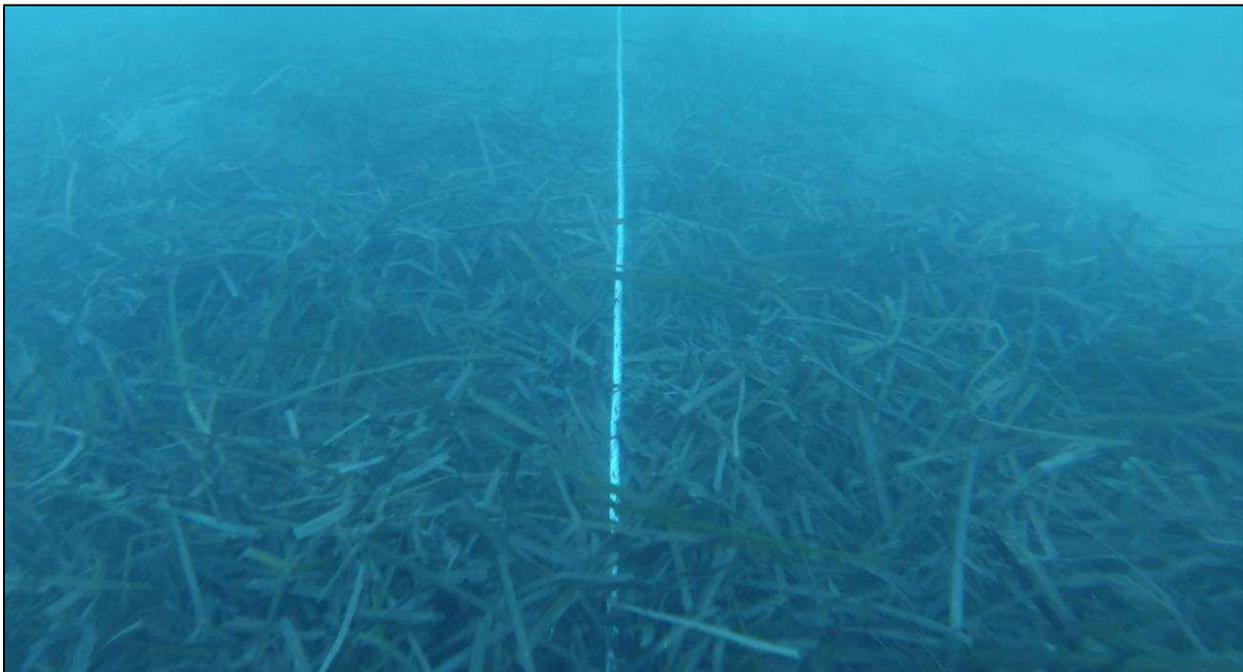
**Photo 9 Dense eelgrass detritus, Transect 2, Jan. 07 2015, dive 2.**

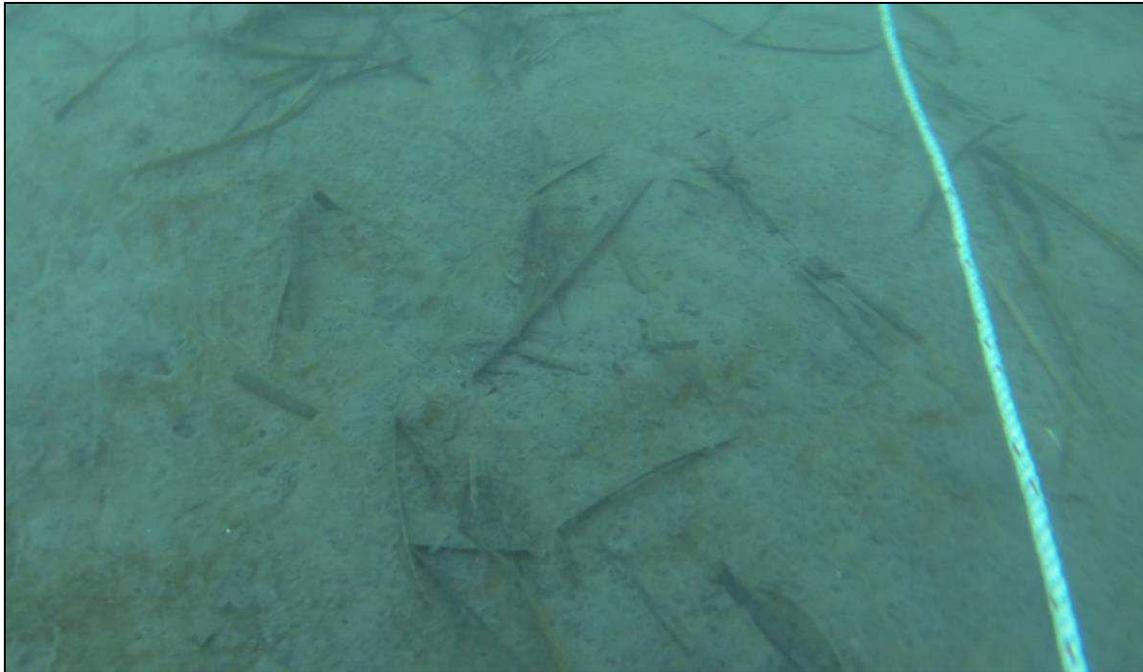
**Photo 10** Silty-Sand substrate on slope of project site, Transect 2, Jan. 07 2015, dive 2.

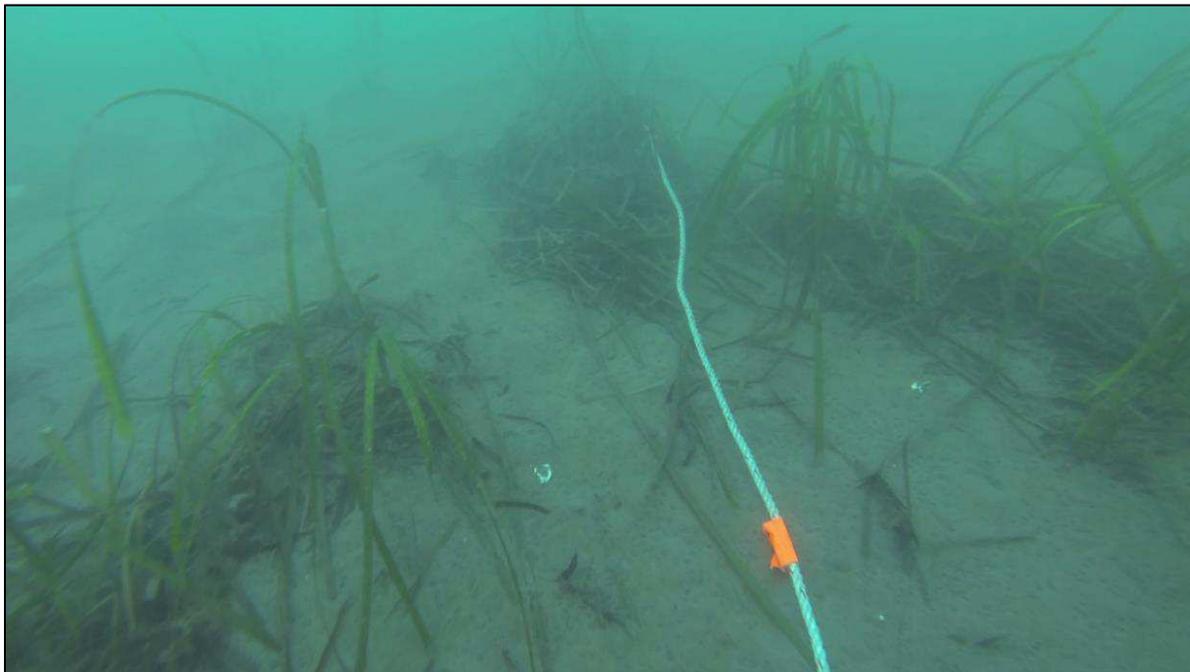
**Photo 11** Edge of continuous eelgrass bed, Transect 2, Jan. 07 2015, dive 2.
