Salt Marsh Restoration: Site 3.1

HABITAT ENHANCEMENT PROGRAM | Salt Marsh Restoration Site 3.1

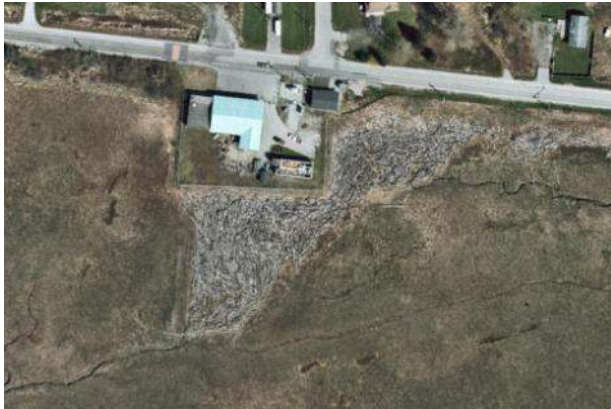
Photo 1. Pre-removal orthophotograph of Site 3.1 in 2012 (Photo Credit: DeltaMap, 2012).

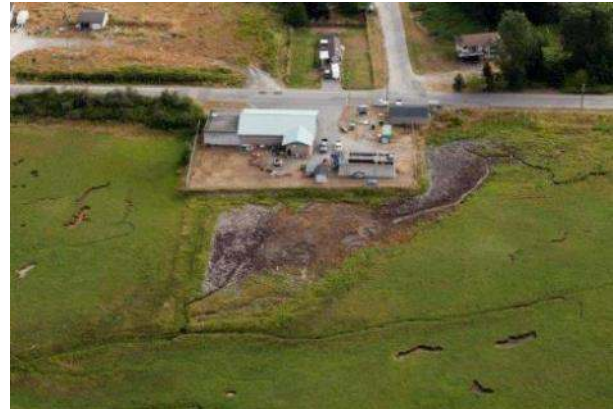
Photo 2. Post-removal photograph of Site 3.1 approximately four months after the restoration works (Photo Credit: W. Jans, July 2013).

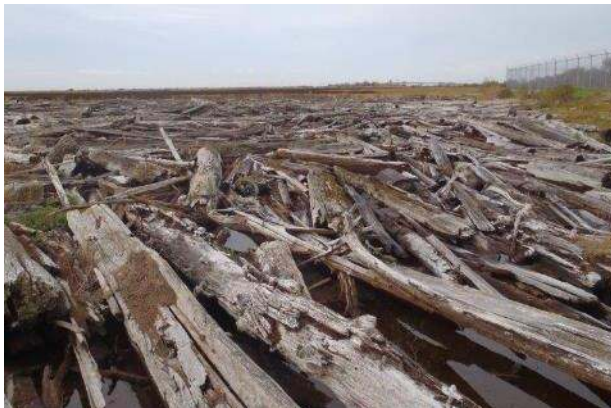
Prior to restoration works, the site was characterized by dense accumulations of historically deposited woody debris, mostly composed of saw-cut logs from the forestry sector. Based on aerial photo reviews, the vast majority of the woody debris had been present for 25 to 70 years before the restoration works were undertaken. The debris was observed to be smothering underlying salt marsh vegetation and had compacted the sediments preventing the associated salt marsh from achieving its full productive capacity.

Photo 3. Pre-restoration photograph of Site 3.1, view facing west (October 2012).

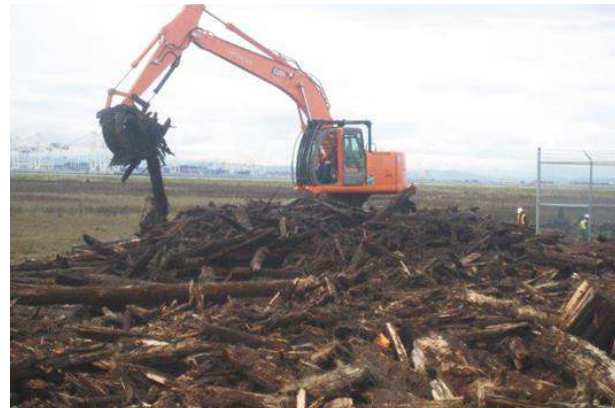
Photo 4. Excavator shifting woody debris toward the load-out area during restoration works (March 2013).

Restoration works were undertaken in March 2013 with support from the Tsawwassen First Nation, on whose lands the works occurred, and was completed through efforts from the Tsawwassen First Nation/Matcon Joint Venture. Work involved the careful removal and proper disposal of excessive woody debris and litter with an additional clean up undertaken

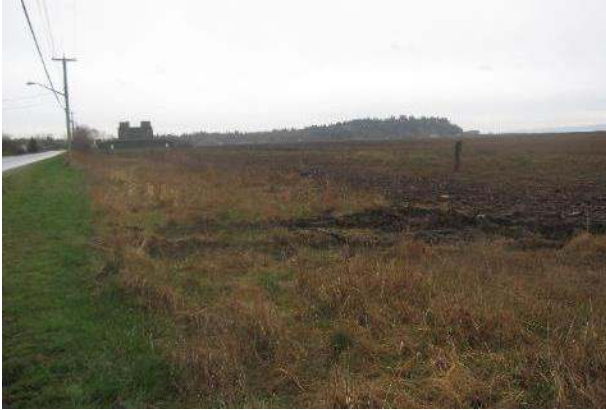
Photo 5. Site conditions at Site 3.1 immediately following restoration works (March 2013).

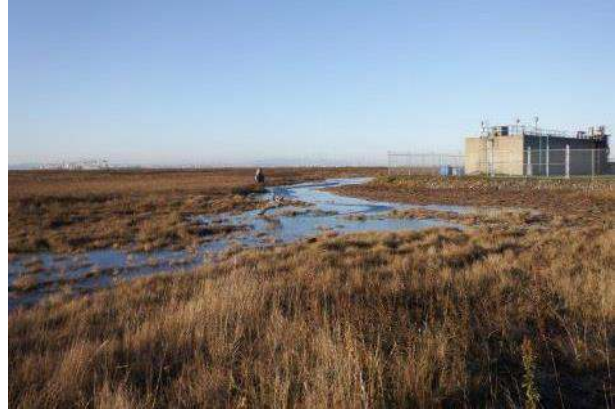
Photo 6. Inundation of Site 3.1 following restoration works during the highest tide of 2013 (December 2013).

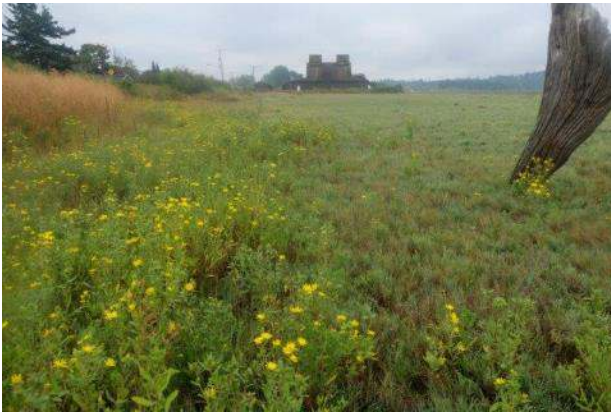
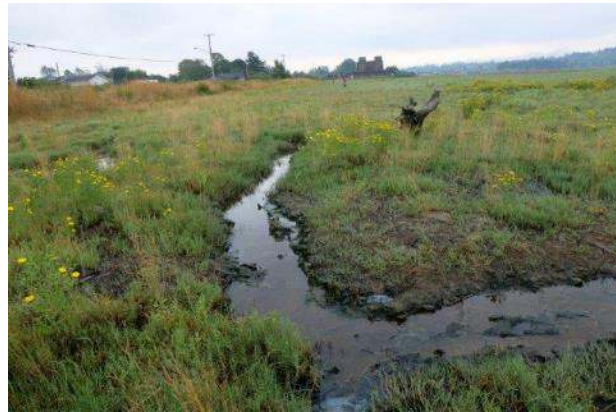
Photo 7. Site 3.1 approximately a year and a half after log removal works (Photo Credit: G.L. Williams, August 2014).

Photo 8. Site 3.1 approximately a year and a half after log removal works (Photo Credit: G.L. Williams, August 2014).
