Salt Marsh Restoration: Site 3.2

HABITAT ENHANCEMENT PROGRAM | Salt Marsh Restoration Site 3.2

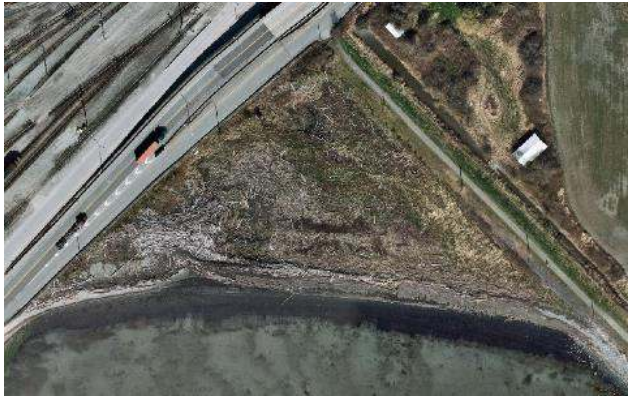
Prior to restoration works, the site was characterized by dense accumulations of historically deposited woody debris, mostly composed of saw-cut logs from the forestry sector. Based on aerial photo reviews, the vast majority of the woody debris had been present for 25 to 70 years before the restoration works were undertaken. The debris was observed to be smothering underlying salt marsh vegetation and had compacted the sediments preventing the associated salt marsh from achieving its full productive capacity.

Photo 1. Salt Marsh Restoration Site 3.2 prior to the woody debris removal works (Delta Map 2012).

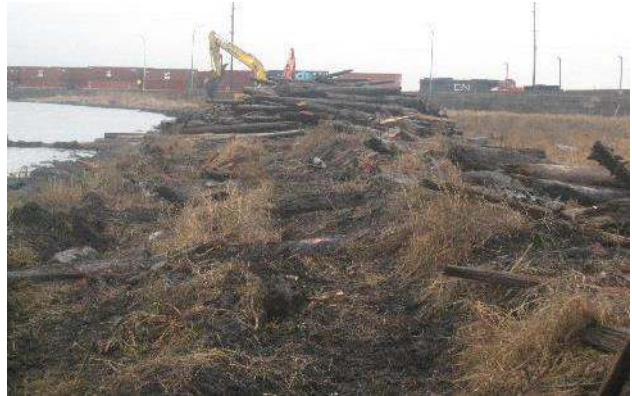
Photo 2. Excavator shifting woody debris towards the load-out area during restoration works (January 2014).

The restoration works were undertaken in January 2014 with support from Tsawwassen First Nation and was completed through efforts from the Tsawwassen First Nation/Matcon Joint Venture. Work involved the careful removal of woody debris and litter. Wildlife snags were installed to provide enhanced wildlife habitat features, including perching and roosting habitat for raptors.

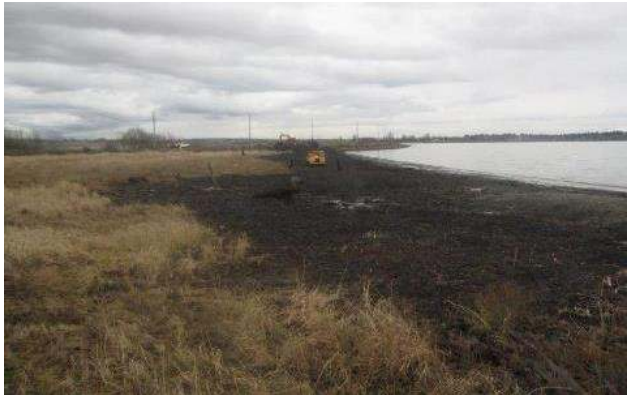
Photo 3. Salt Marsh Restoration Site 3.2 following the woody debris removal works (January, 2014).

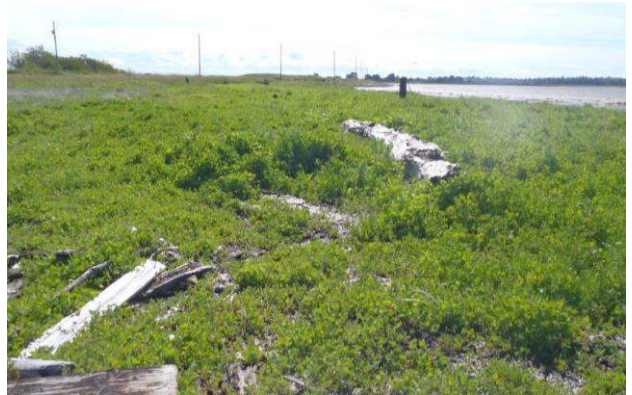
Photo 4. Site conditions at Site 3.2 approximately five months after the restoration works (June 2014).

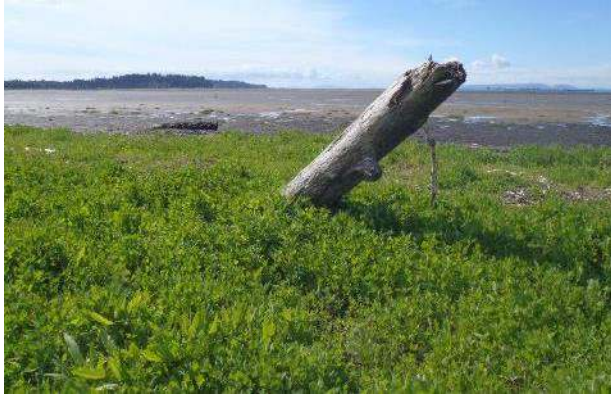
Photo 5. Site conditions at Site 3.2 approximately five months after the restoration works (June 2014).

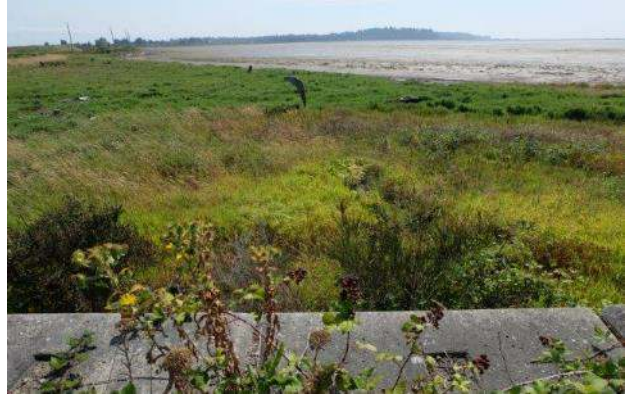
Photo 6. Site conditions at Site 3.2 approximately seven months after the restoration works (Photo Credit: G.L. Williams, August 2014).
