## Salt Marsh Restoration: Boundary Bay Sites 3.3, 3.4 & 3.5

## HABITAT ENHANCEMENT PROGRAM | Boundary Bay Salt Marsh Restoration

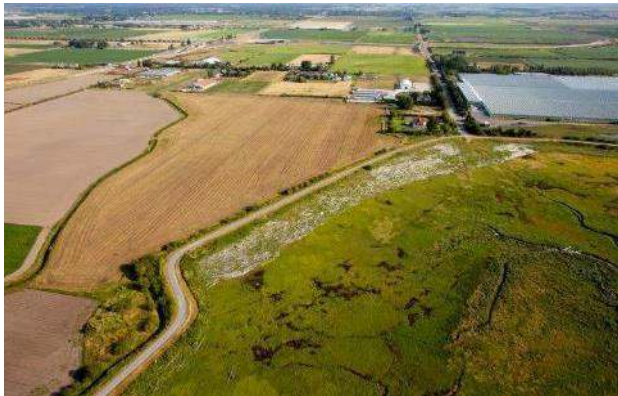
Prior to restoration works, the site was characterized by dense accumulations of historically deposited woody debris, mostly composed of saw-cut logs from the forestry sector. Based on aerial photo reviews, the vast majority of the woody debris had been present for 25 to 70 years before the restoration works were undertaken. The debris was observed to be smothering underlying salt marsh vegetation and had compacted the sediments preventing the associated salt marsh from achieving its full productive capacity.

**Photo 1.** Pre-removal photograph of Site 3.3 prior to restoration works (Photo Credit: W. Jans, July 2013).

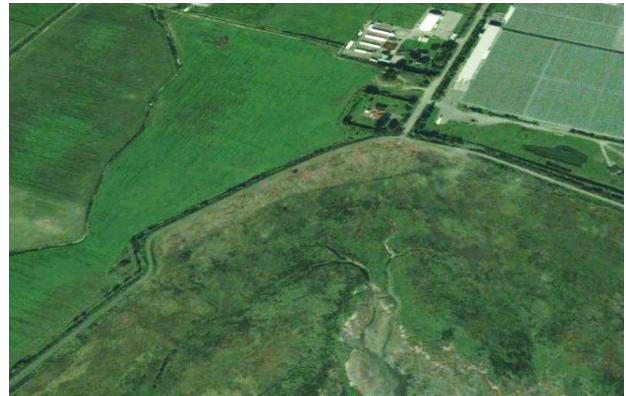
**Photo 2.** Post-removal satellite image of Site 3.3 less than one month after log removal works (Photo Credit: Google Earth, October 2013).

Port Metro Vancouver undertook restoration works in September 2013, which involved the careful removal and proper disposal of excessive woody debris and litter from approximately September 2014

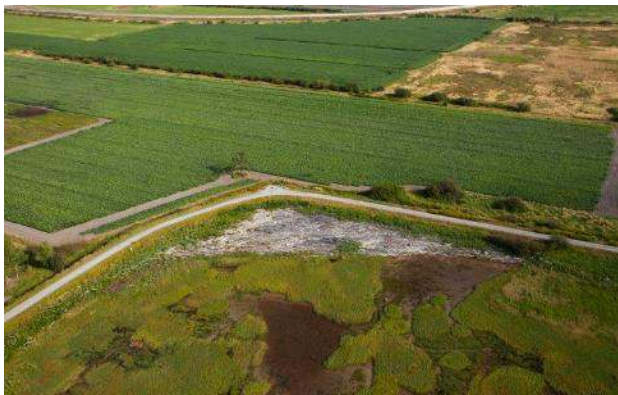
**Photo 3.** Pre-removal photograph of Site 3.4 prior to restoration works (Photo Credit: W. Jans, July 2013).

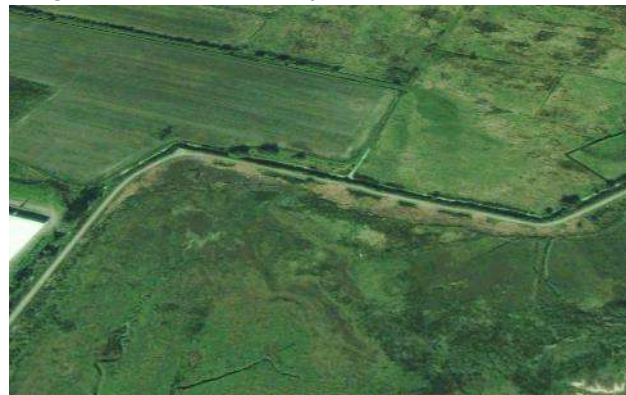
**Photo 4.** Post-removal satellite image of Site 3.4 less than one month after log removal works (Photo Credit: Google Earth, October 2013).

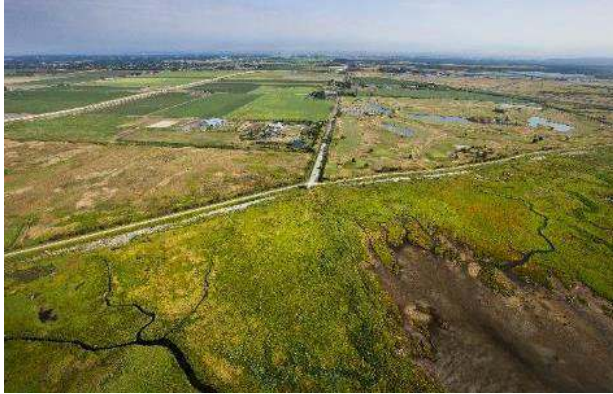
**Photo 5.** Pre-removal photograph of Site 3.5 prior to log removal works (Photo Credit: W. Jans, July 2013).

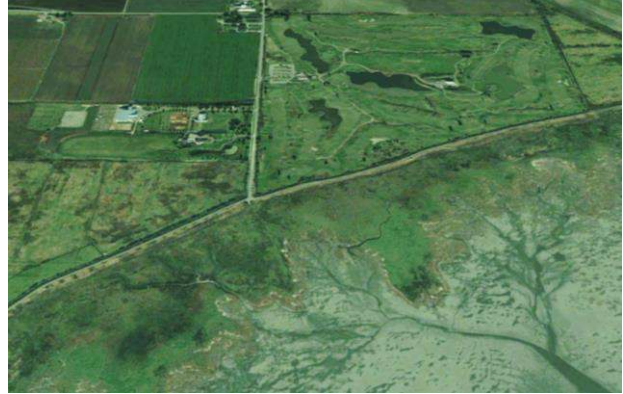
**Photo 6.** Post-removal satellite image of Site 3.5 less than one month after log removal works (Photo Credit: Google Earth, October 2013).

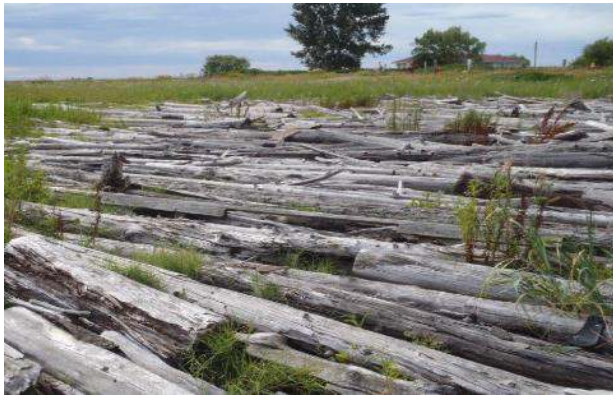
**Photo 7.** Pre-restoration photograph of Site 3.3, view facing the dike (July 2013).

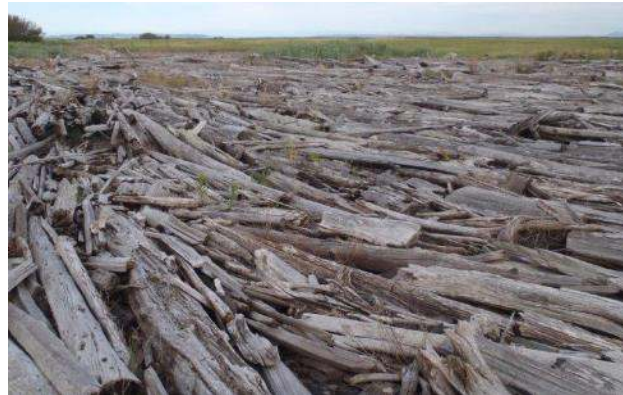
**Photo 8.** Pre-restoration photograph of Site 3.4, view parallel to the dike (July 2013).

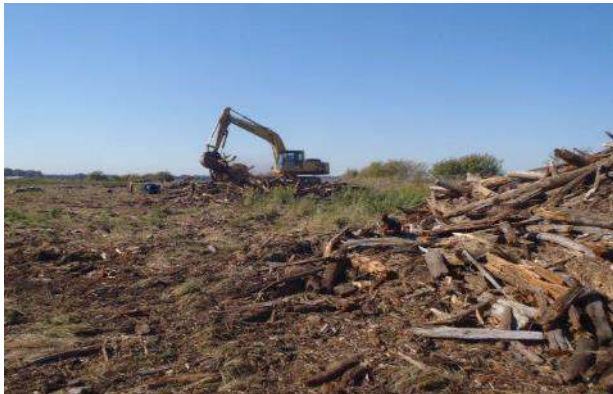
**Photo 9.** Excavator removing logs from Site 3.3 (September 2013).

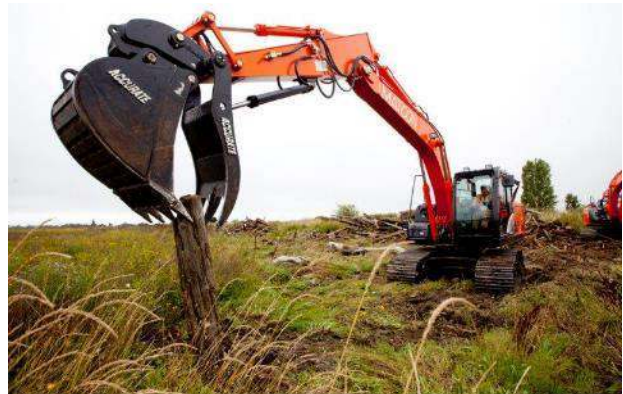
**Photo 10.** Installation of a vertical log to create a wildlife snag for a raptor perch (Photo Credit: W. Jans, September 2013).

2.5 km of shoreline. Wildlife snags were installed to provide perching and roosting habitat for raptors.

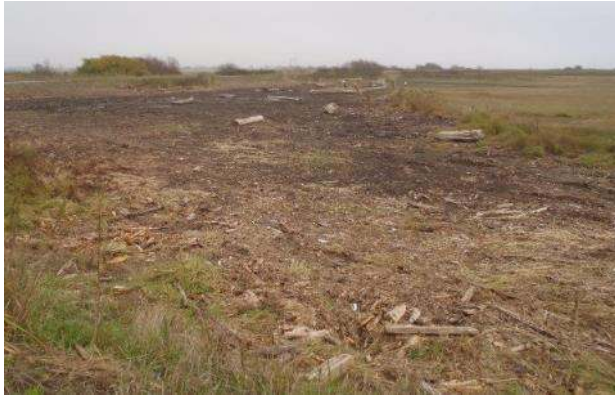
**Photo 11.** Site conditions at Site 3.4 approximately one month after restoration works (October 2013).

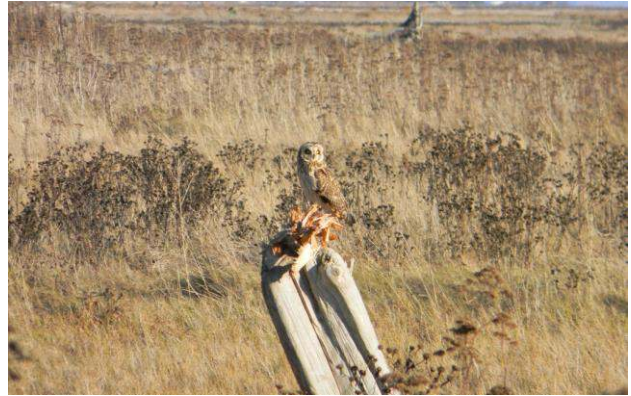
**Photo 12.** A short-eared owl perched on an installed short snag (December 2013).

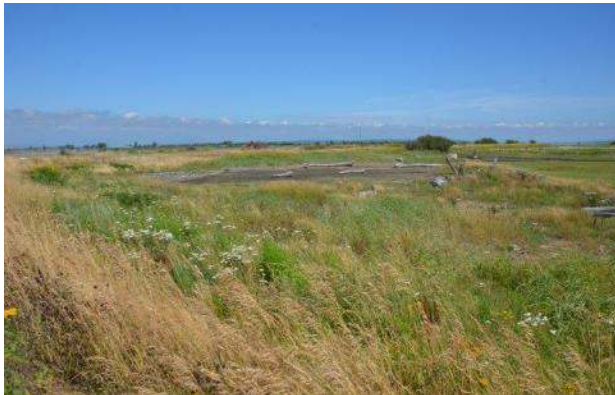
**Photo 13.** Site conditions at Site 3.4 approximately one year after the restoration works (August 2014).

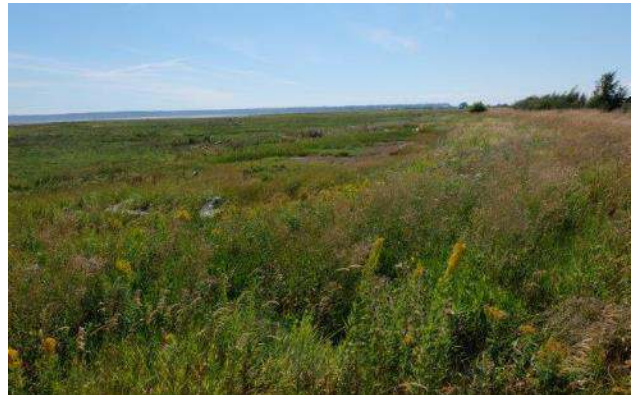
**Photo 14.** Site conditions at Site 3.5 approximately one year after the restoration works (August 2014).
