# Habitat Assessment Report

## Fraser Grain Terminal

File: 2191-001.01  
May 2018

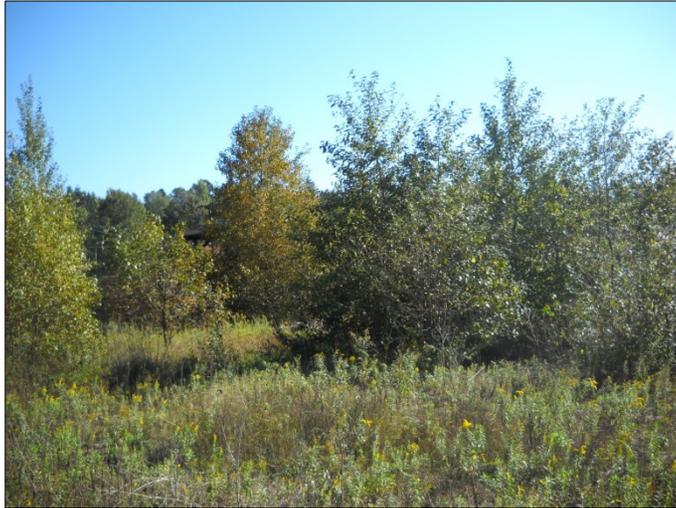
**Photo 1** Herbaceous open area surrounded by shrubs at northeast corner of site. Photo taken September 30, 2015.

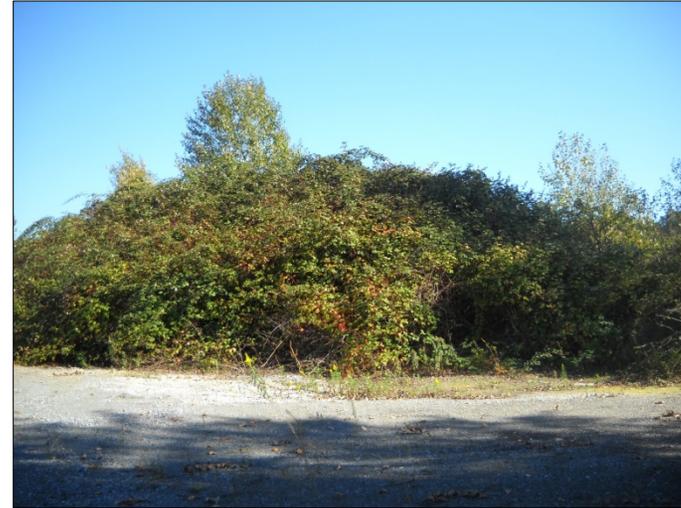
**Photo 2** Himalayan blackberry growing on fill hummock. Photo taken September 30, 2015.

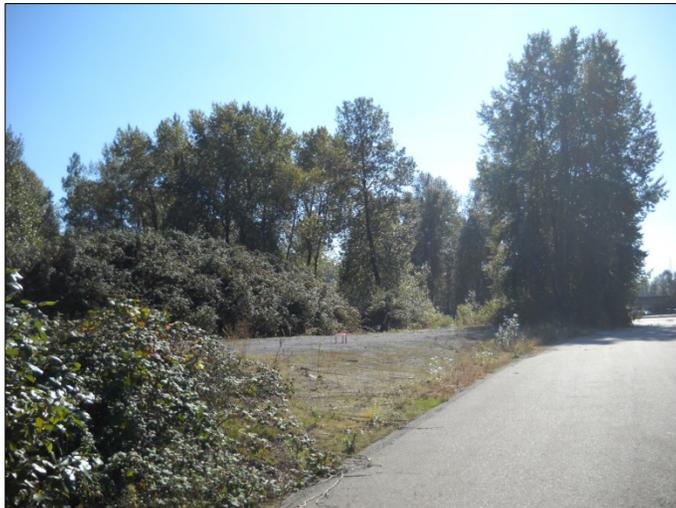
**Photo 3** Larger diameter cottonwoods within the clearing boundary (eastern boundary looking south). Photo taken September 30, 2015.

Several larger diameter (30 – 40 cm) cottonwood trees are found along the eastern edge of the Site, outside of the clearing boundaries. These are structural stage 4 and 5 (i.e. pole sapling or young forest as per BC Ministry of Forests *Describing Terrestrial Ecosystems in the Field*, 2010), that are less than 60 years old. Several cottonwood trees are also located within the clearing boundaries at the eastern edge of the property (**Appendix B, Photo 3**) and northeast corner (approx. 6 trees) (**Appendix B, Photo 4**).

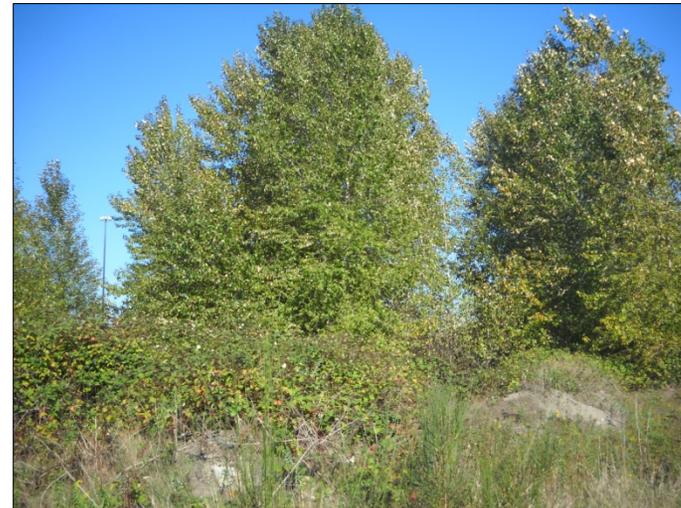
**Photo 4** Larger diameter cottonwoods within the clearing boundary (northeastern corner looking north). Photo taken September 30, 2015.

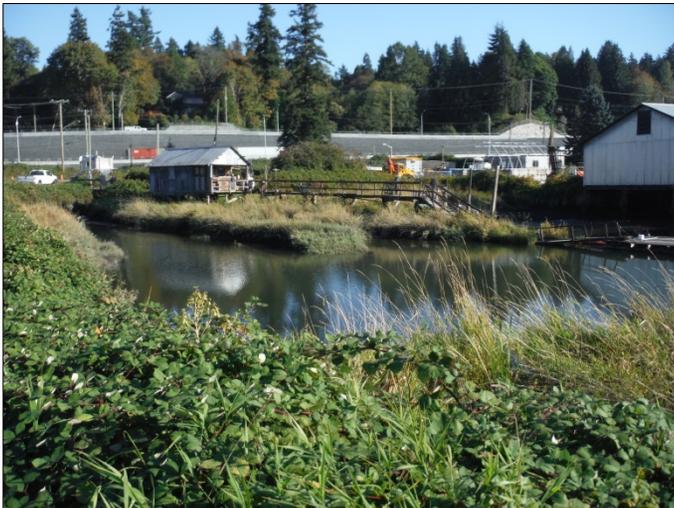
**Photo 7** Gunderson Slough. View facing south from Elevator Road. Photo taken September 30, 2015.

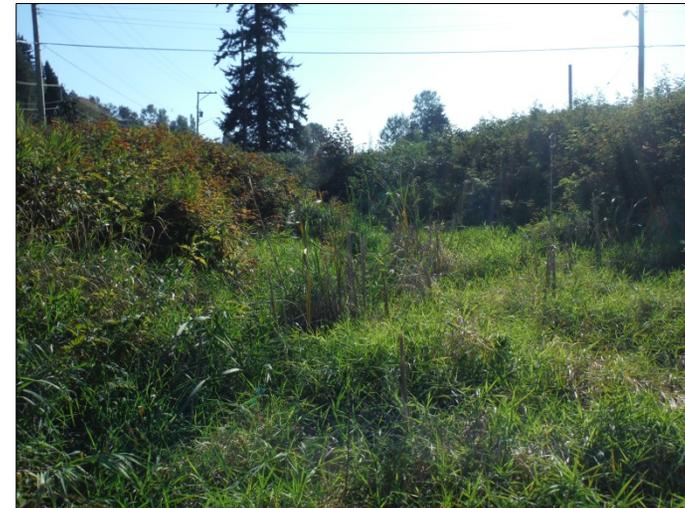
**Photo 8** Shadow Brook, upstream of Elevator Road. View facing southwest. Photo taken September 30, 2015.

Both reaches of Shadow Brook represent migration habitat to fish-bearing watercourses upstream. Rearing habitat value is considered to be high downstream of Elevator Road, and moderate upstream. Due to the lack of suitable substrate, neither of these reaches represent spawning habitat. Cutthroat trout (*O. clarki*) and coho salmon have been previously documented within Shadow Brook and its tributaries (iMap BC 2015). Two unidentified sculpins (*Cottus sp.*) were also observed in the reach upstream of Elevator Road during the site visit.

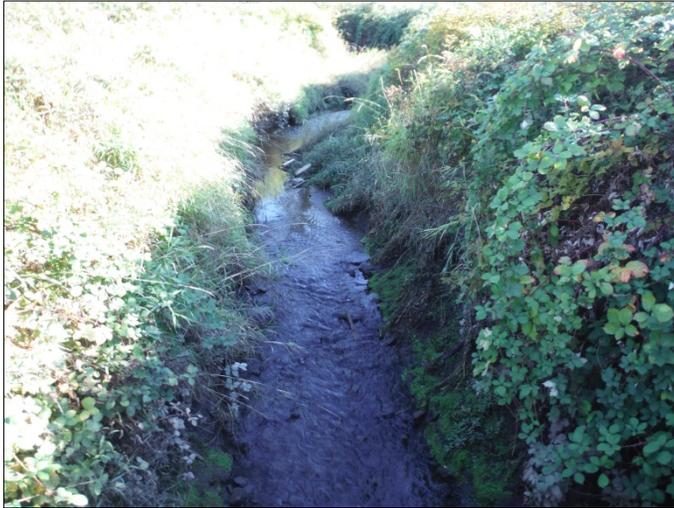
**Photo 9** Shadow Brook, downstream of elevator road. View facing upstream (southeast). Photo taken September 30, 2015.

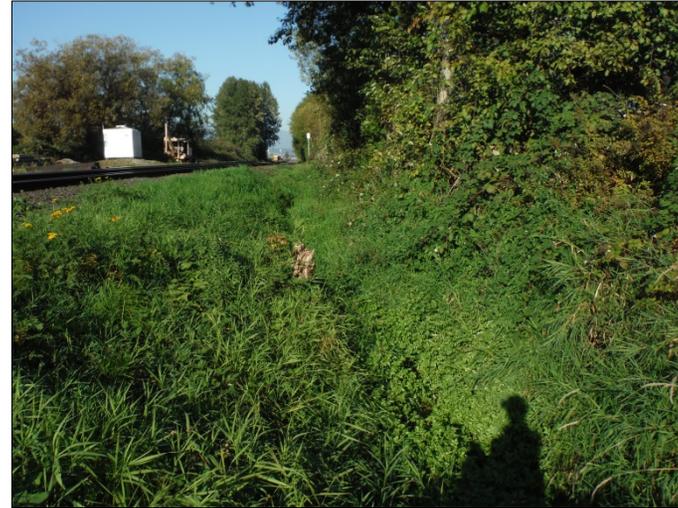
**Photo 10** Armstrong Creek/Colliers Canal. View facing upstream (northeast). Photo taken September 30, 2015.

Armstrong Creek and Colliers Canal in the vicinity of the Project are Class A habitat which is a continuous ditch approximately 2.5 m wide that parallels the southeast side of the Burlington Northern Santa Fe (BNSF) Railway tracks (**Appendix B, Photo 10**). This ditch flows under the BNSF tracks and Elevator Road via consecutive culverts, and discharges to Shadow Brook on the south side of Elevator Road (COSMOS 2015). Abundant reed canary grass was observed in the ditch at the site of the site visit. Channel substrates are predominantly fines and sands. These watercourses provide no spawning habitat but provide moderate rearing and migration habitat to upstream fish-bearing watercourses. Stickleback (*Gasterosteidae sp.*) and cutthroat trout have been documented in these waterbodies, east of the study area (iMap BC 2015).

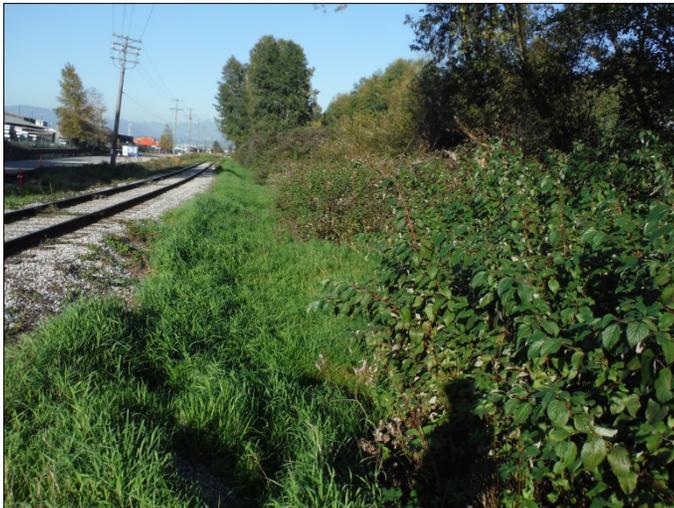
**Photo 11** Unnamed dashed red-coded Ditch. View facing upstream (northeast). Photo taken September 30, 2015.

An unnamed ditch (~ 2 m wide) flows for roughly 100 m along the southeast side of the Canadian National (CN) Railway tracks (**Appendix B, Photo 11**). According to COSMOS (2015), this ditch is classified as Class AO habitat. During the September site visit, the ditch was dry with no surface flow connection to fish-bearing watercourses. Vegetation observed in the channel (reed canary grass and red osier dogwood (*Cornus sericea*), species that are indicative of moist areas), suggests that the ditch is seasonally wetted. The BNSF access road off of Robson Road at the southern end of the ditch is not culverted and therefore prevents connection to the fish-bearing Shadow Brook to the south (**Figure 2**).

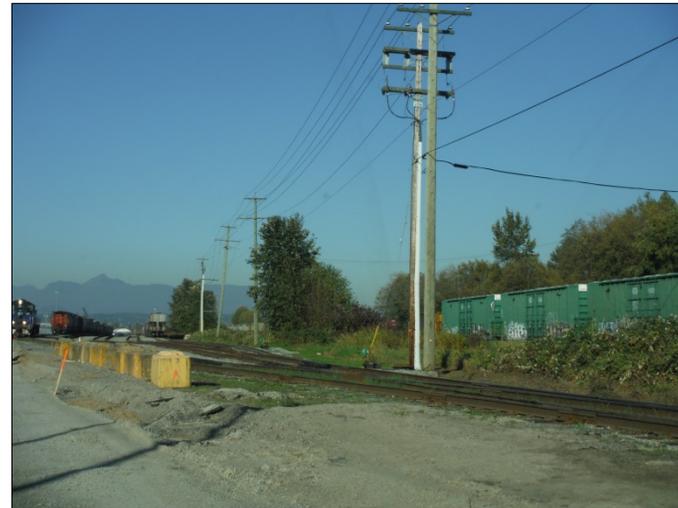
**Photo 12** Unnamed yellow-coded ditch. View facing northeast. Photo taken September 30, 2015.

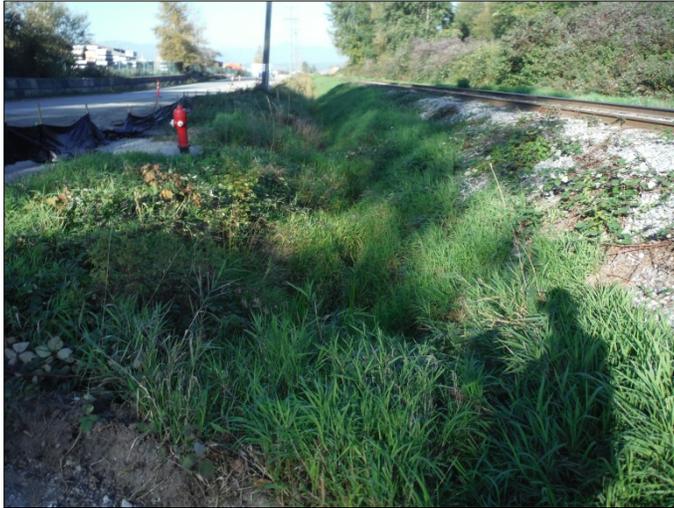
**Photo 13** Robson Rd Green-coded Ditch. View facing northeast. Photo taken September 30, 2015.

The Robson Road ditch, also Class C, is a 2 m wide and 350 m long ditch that parallels the east side of Robson Road and is connected by culverts to Ditch S and Ditch N (**Appendix B, Photo 13**). During the site visit in September 2015, some surface water and abundant vegetation was observed within the channel including reed canary grass and cattail (*Typha latifolia*).

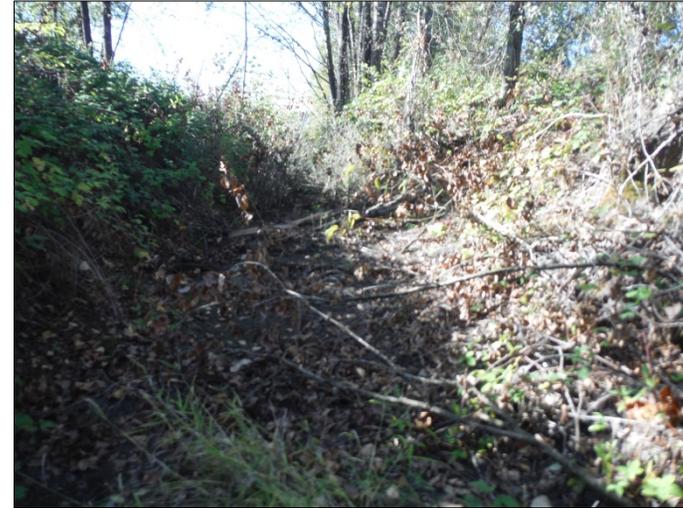
**Photo 14** Baekert Ditch-N. View facing northwest from downstream end of ditch. Photo taken September 30, 2015.

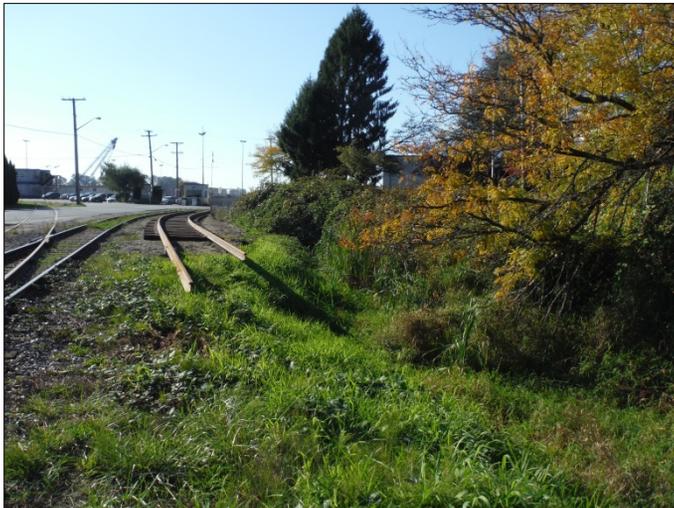
**Photo 15** Baekert Ditch-S. View facing east towards upstream end of ditch. Photo taken September 30, 2015.
