Derwent Way Soil Transfer and Barge Facility Biophysical Assessment and Vegetation Plan New Westminster, BC – Revision 4

PRESENTED TO
Summit Earthworks Inc.

JULY 18, 2019
ISSUED FOR USE
FILE: ENG.VGEO03082-01

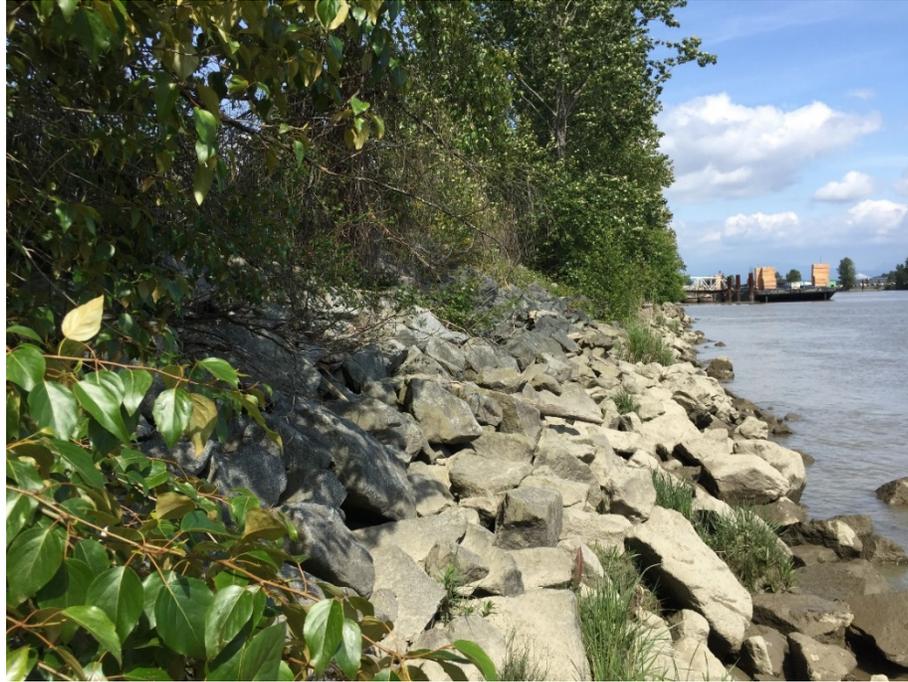
On April 28, 2016 Tetra Tech field staff assessed the fish habitat on the Fraser River adjacent to the Property. It was observed that most or all of the foreshore was heavily rip rapped with angular boulders, which may be due to the Property's proximity to a bridge crossing immediately downstream. During low tide, a very limited amount of natural river bed composed of finer sediment was observed at the base of the bank; however, overall the foreshore consisted of rip rap (Photo 1). The bank upstream of the property, and the opposite bank had little to no rip rap present.

Photo 1: Foreshore of Property consisting primarily of rip rap

The Fraser River side channel, which the Property is adjacent to, does provide suitable habitat for the fish species listed above. However, given the condition and availability of the habitat at the Property (i.e., heavily rip rapped), Project activities are unlikely to negatively affect these species.

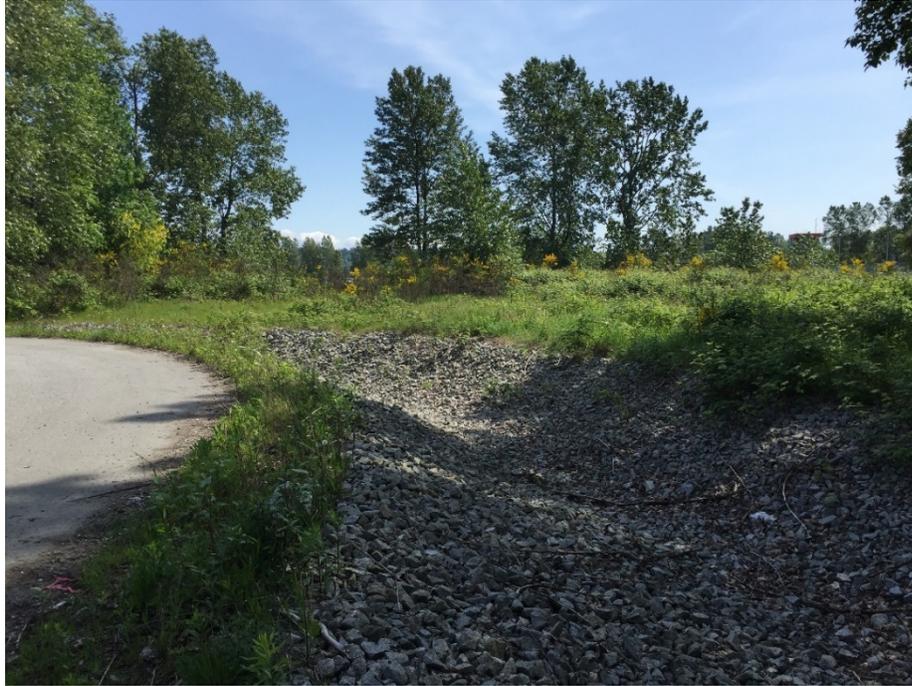
In addition to the Fraser River, there is an unnamed ditch (Photo 2) which runs along the north and east boundary of the Property. During the site visit, the ditch did not contain any water. If water was to flow through the ditch, it is expected to flow north, adjacent to the Property, until the railway tracks south of Salter Street, at which point it is culverted across the Property access road into a neighbouring site. At this point it is unknown as to where the ditch flows; however, based on a review of aerial photographs it appears it would flow east, towards the Stanley Street Greenway, which ultimately would flow south to the Fraser River.

The ditch, though it was dry at the time of the assessment, did not appear to provide suitable fish habitat. It is heavily armoured with cobble sized angular rip rap. The gradient is suitable for fish; however, the channel is uniform and does not appear to provide any niche habitat (i.e., riffles and pools), and it is unknown as to whether there is a barrier to fish passage between the Property and potential connection with the Fraser River.

Photo 2: Unnamed ditch along north and east boundary of Property

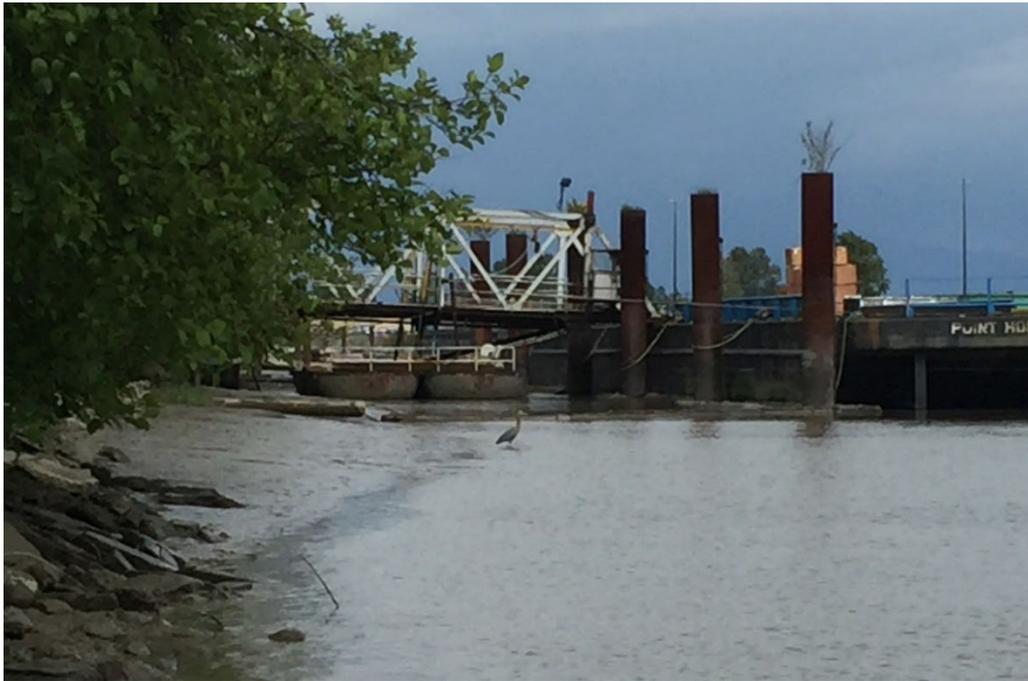
On April 28, 2016, Tetra Tech field staff assessed the Property for wildlife and wildlife habitat. Upon review of the Property, it was observed that most or all of Property has the potential to provide suitable habitat for wildlife, particularly bird species. Tetra Tech did not locate any nests during the site visit; however, non-detection does not preclude their presence. Elevated bird activity was observed within the eastern, more heavily vegetated and treed area of the Property. Two Great blue Herons (*Ardea herodias*) were observed approximately 75 m upstream of the Property on the mud flats of the Fraser River (Photo 3).

Photo 3: Great blue heron approximately 75 m upstream of Property

If vegetation clearing is required at the Property during the general bird nesting period (April 1– August 31), Tetra Tech recommends a Qualified Environmental Professional (QEP) complete a pre-clearance nest survey to verify no active bird nests will be affected prior to clearing the vegetation. The pre-clearance nest survey should be completed within one week of clearing vegetation. If clearing does not take place within this seven day period following the survey, an additional survey should be completed. Should an active nest be detected, clearing would have to stop until the nest is no longer active.

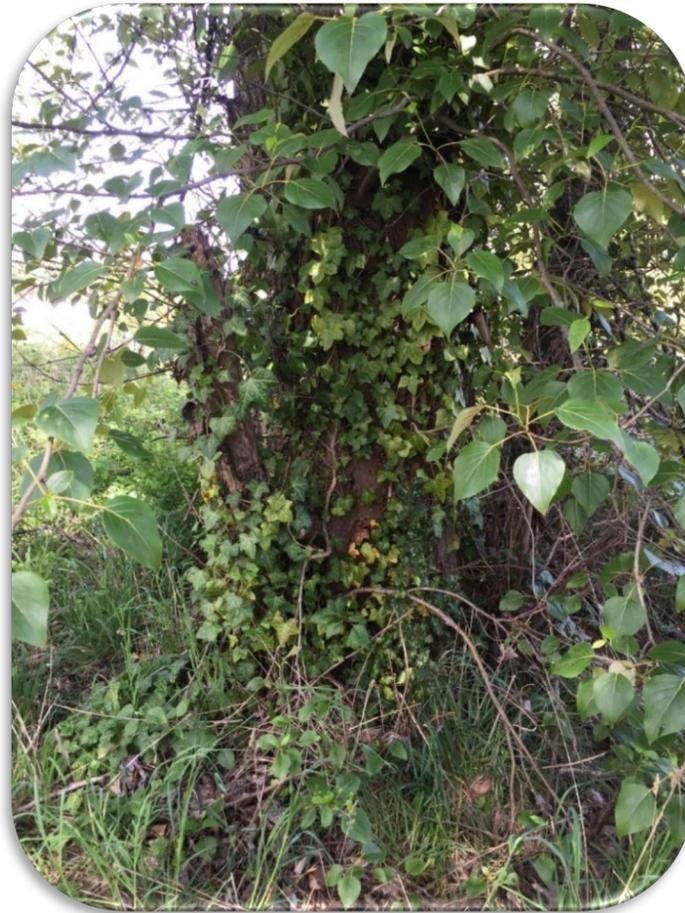
Photo 4: English ivy growing on a tree on the west side of the Property

- Manual and mechanical control method: Cutting, pulling and digging can be an effective removal method. Key steps are to remove as much ivy stem and root as possible while at the same time minimizing soil disturbance. Cut large vines at the bases of trees and pull vines from the soil and attempt to remove as much of the root as possible. Follow-up treatments will likely be needed for one year or more to pull re-sprouting ivy. Dispose of ivy cuttings at an appropriate landfill (Oregon State University, 2008).

- Chemical control method: A waxy layer is present on ivy leaves which can act as a barrier to foliar-applied herbicides. Young ivy leaves, which have not formed this thick waxy layer, will absorb more herbicide than older leaves. Applying an acid before the herbicide may increase ivy's absorption of herbicide. Winter applications generally provide more effective control than growing-season applications. Cutting woody stems of ivy vines and applying herbicide to the cut surfaces along with either foliar treatment or pulling up ivy ground cover can be a very effective means of control. When applying herbicide to ivy growing on trees, ensure overspray is not applied to the tree itself (Oregon State University, 2008).

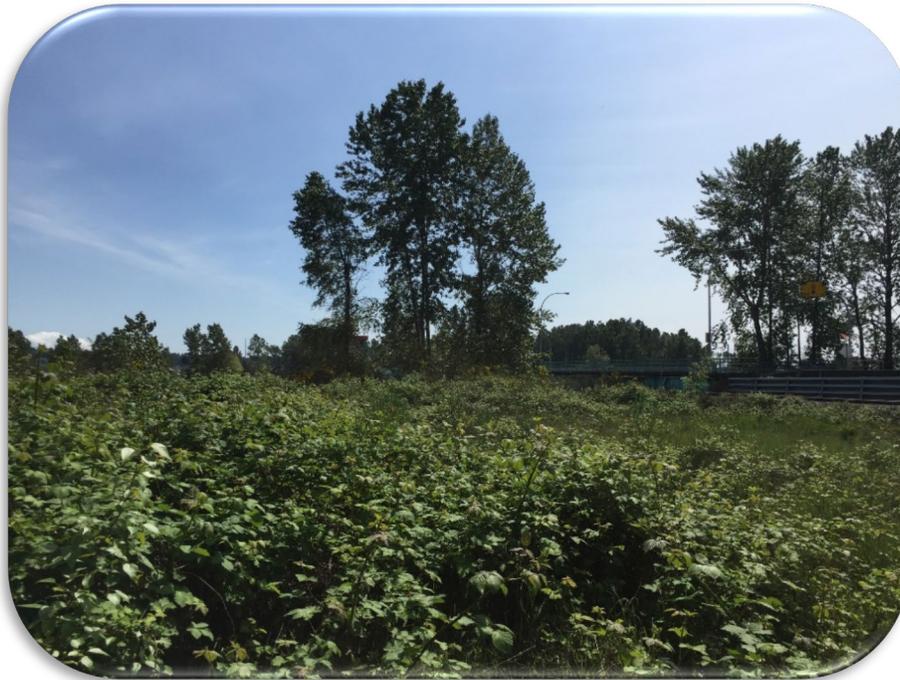
Photo 5: Himalayan blackberry growing throughout the Property

- Control method: Mowing can be a very effective control method, but can also harm desirable plant species. If roots are not manually removed, mowing several times per year over several years is necessary to exhaust root reserves. If mowing or cutting is only carried out once per year, it should be when the plants begin to flower. Do not mow where soil is highly susceptible to compaction or erosion, or where soil is very wet. Since mechanical control can stimulate strong re-growth, follow-up with either spot applications of herbicide or hand digging to remove the entire root system (ISCBC, 2014d).

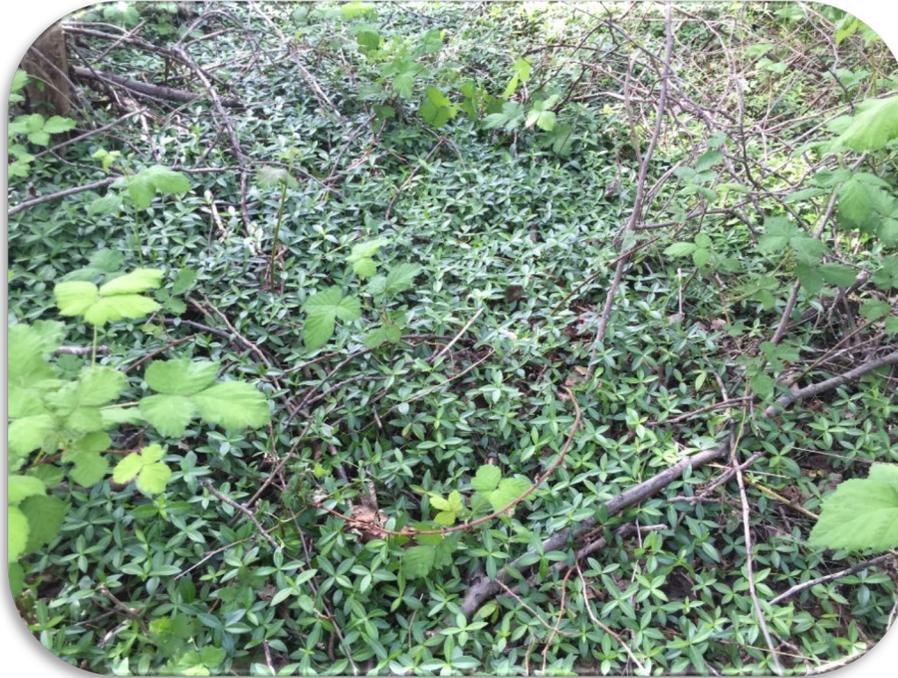
Photo 6: Common periwinkle growing on the east side of the Property.

- Control method: Periwinkle can be pulled by hand or dug up, being sure to remove underground portions. Where appropriate, mowing can be used to cut plants back but will likely have to be repeated regularly. Mowing followed by application of herbicide provides good control. Dispose of all vines at an appropriate landfill (Swearingen et al., 2010).

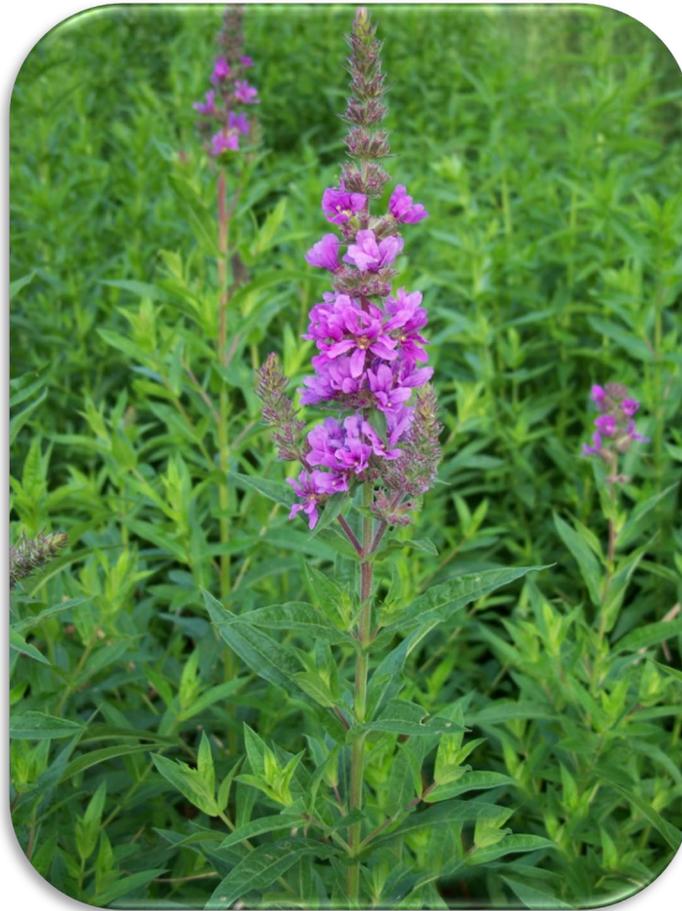
Photo 7: Purple loosestrife was identified by VFPA on site¹.

- Control method: Purple loosestrife can be effectively hand-pulled from the base of the plant or dug up. Ensure the entire plant is removed, including all roots and rhizomes, and all parts are disposed of at an appropriate facility (e.g., transfer station). Seedlings start in June and the plant flowers in July and August; therefore, the optimal time for removal is during July or August prior to seed. Ensure removal is completed within this window, as late season removal (i.e., September) the plants will likely have already gone to seed and will then proliferate the following season. Mowing is not a recommended means of controlling purple loosestrife as plant fragments can produce new shoots and may facilitate further spreading (King County, 2011).

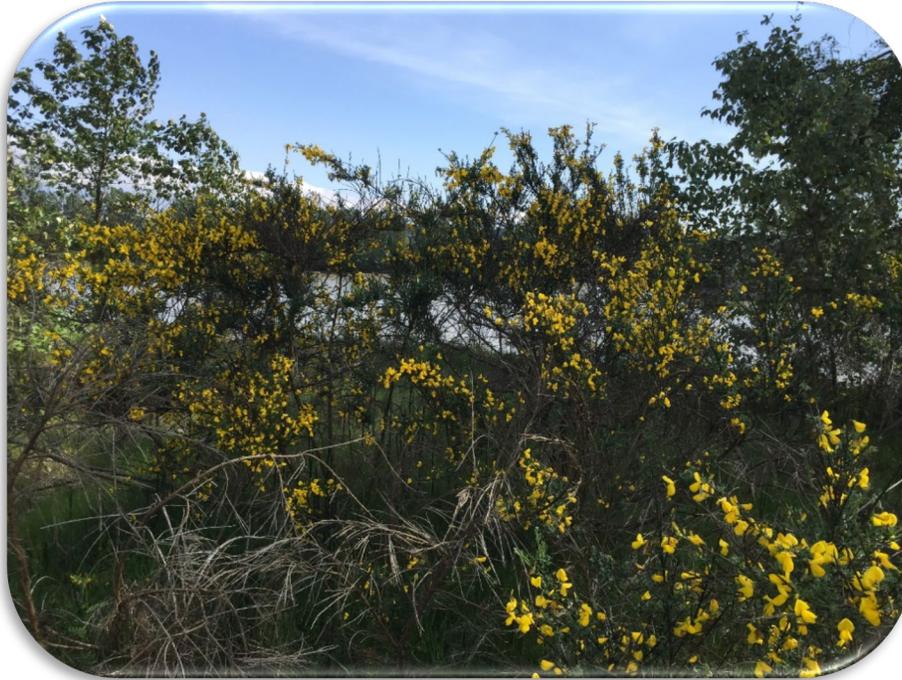
Photo 8: Scotch broom growing near the top of the bank along the southern boundary of the Property.

- Chemical control method: Herbicides have some success of control, but long seed viability in the soil requires repeated treatments over many years. Selective spot spraying, basal stem injection, or cut surface application methods are recommended to minimize non-target damage (ISCBC, 2014e).

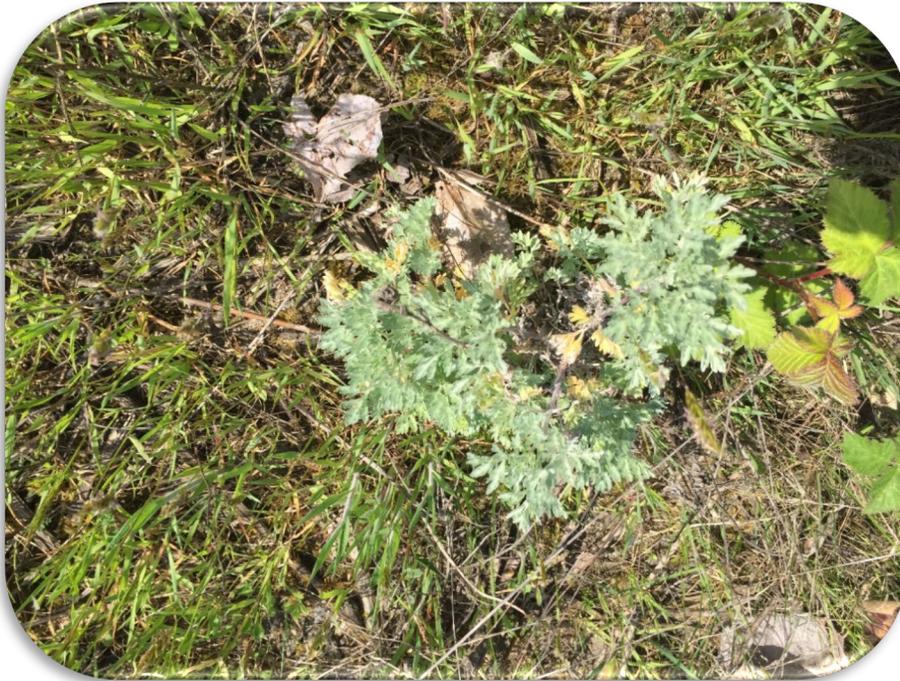
Photo 9: Tansy ragwort growing on the Property.

- Mechanical control method: This method of control is effective on established stands when the root system can be removed in its entirety or frequently removed to prevent the growth of seedlings and root sprouts. Repeated mowing before flowering can prevent seed production. While light removal can encourage growth, repeated heavy cutting can be used as a control technique. Hand pulling is only effective in small infestations. Periodic re-treatment will be necessary. Pull plants when soils are moist to completely remove root mass. Vegetative reproduction is stimulated by mowing, grazing, or poor hand removal where the rootstalk is not completely removed. If plants are hand pulled or cut prior to flowering, the plant material can be left on the site to decompose. If plants are cut post flowering, all plant parts, including flower heads, should be bagged and disposed of at the landfill (ISCBC, 2014f).

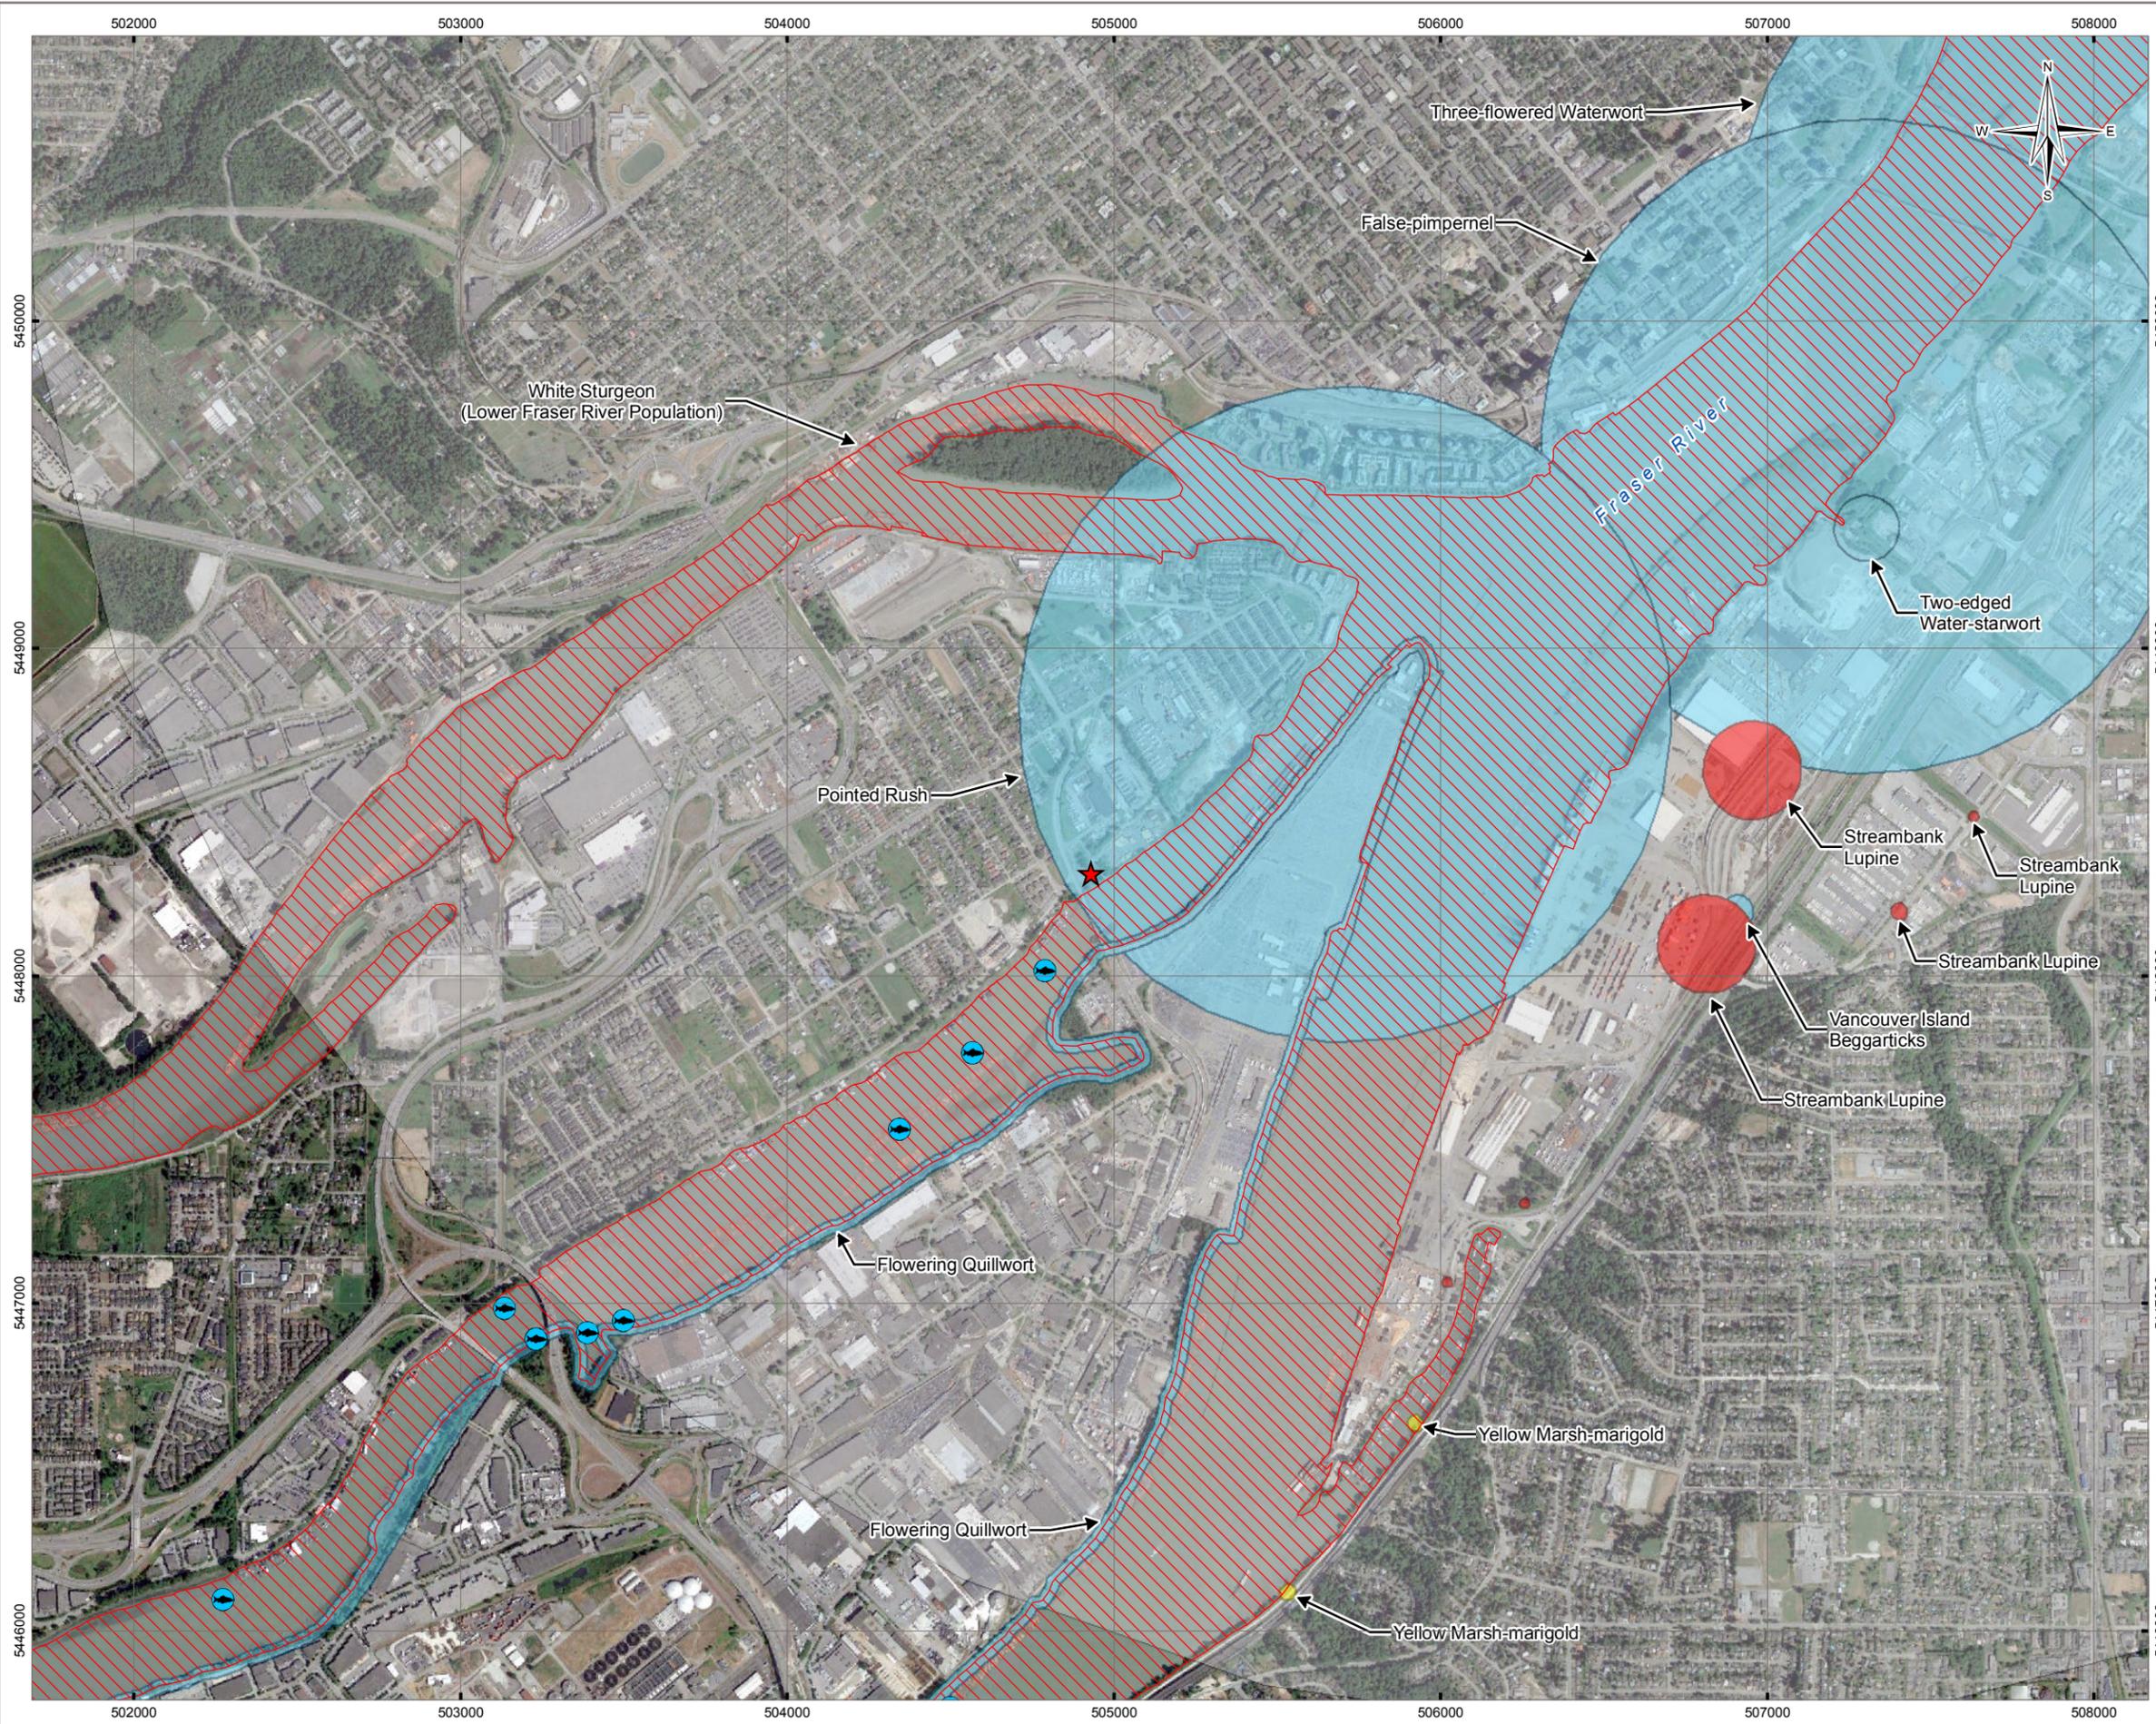
Figure 2

Prior to conducting the site visit, a search of iMapBC for information regarding sensitive fish or fish habitat at or near the Property was completed (Figure 2). According to iMapBC, one fish species at risk was identified as having the potential to occur at or near the Property:

Prior to conducting the site visit, a search on iMapBC for information regarding sensitive wildlife and wildlife habitat at or near the Property was completed (Figure 2). According to iMapBC, no wildlife species or habitat communities at risk were identified as having potential to occur on the Property.

Prior to conducting the site visit, a search on iMapBC for information regarding sensitive vegetation and ecological communities at or near the Property was completed (Figure 2). According to iMapBC, two plant species at risk were identified as having the potential to occur on the Property:

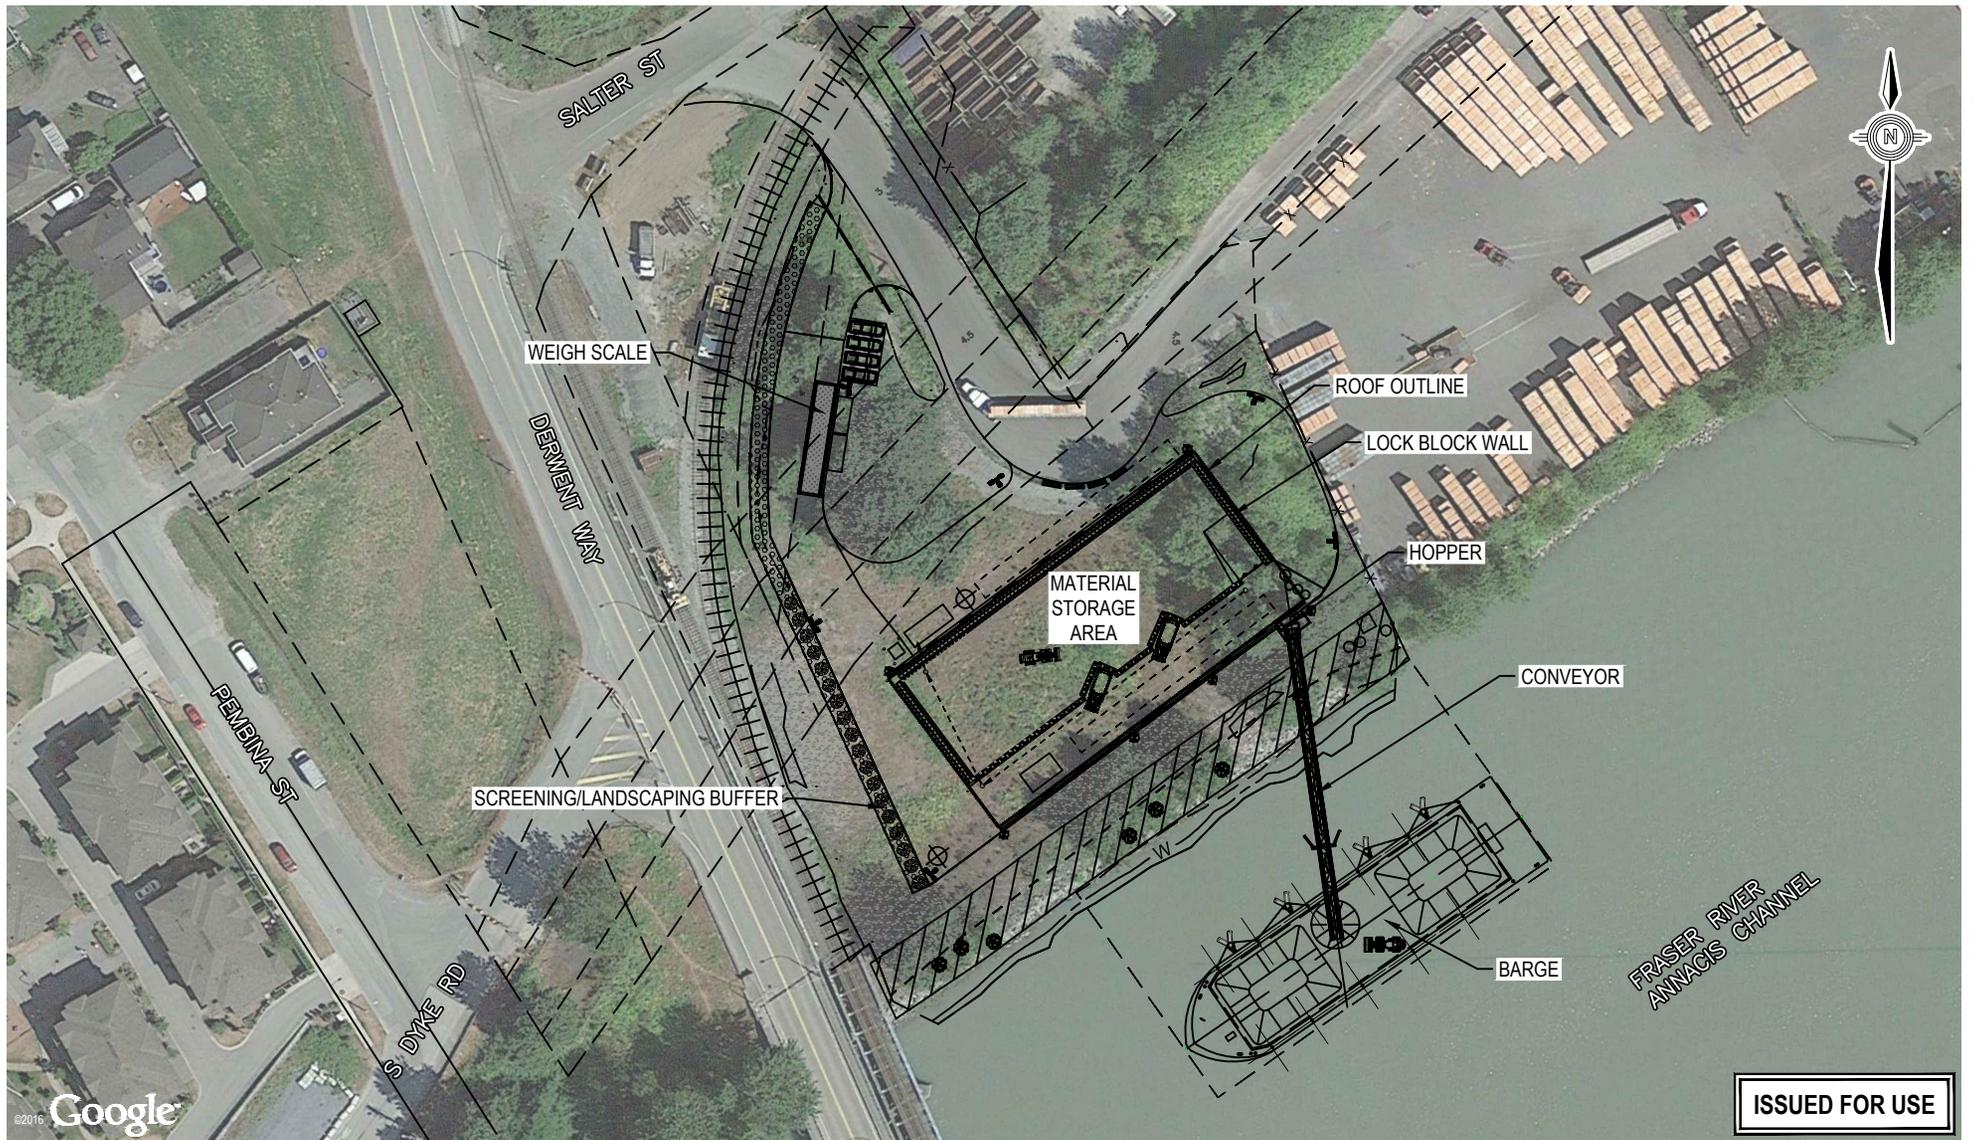
Clearing work will only occur within the conveyor structure alignment over the Fraser River foreshore (Figure 3). A strip of approximately 2 to 3 m will be permanently removed to accommodate a conveyor structure.

In addition to retaining select trees on the Property, a screening/landscaping buffer will be installed along the western Property boundary (Figure 3). The purpose of this buffer is to provide a visual screen of the cleared area and help reduce or maintain current noise levels that may affect neighbouring residences to the west of the Property.

Tetra Tech recommends allowing for a 2 – 3 m wide planting area along the western boundary of the Property at the toe of the proposed berm. Trees should be planted approximately 3 m apart in a linear windrow design (Figure 3). It is anticipated that approximately 50 trees will be required. In addition, trees should be planted in similar design (i.e., 3 m apart and linear windrow) along the top of the rip rap bank along the Fraser River where clearing is required to accommodate the conveyor structure installation (Figure 3). Based on the width of the clearing area, it is anticipated that approximately 2 – 3 trees will be required. In addition, Tetra Tech recommends staking the entire length of the rip rap bank (excluding the conveyor structure location) with willow stakes (*Salix sp.*), as this will provide additional screening/buffering for the Property and improve habitat along the armoured foreshore of the Fraser River. It is expected that over time the trees will grow to provide a suitable aesthetic screen/buffer for the Property.
