40600-RE-RPT-55084

Terrestrial Resources Assessment
Report

BHP Potash Export Facility at Fraser Surrey Docks

Prepared by:
Hemmera Envirochem Inc.
18th Floor, 4730 Kingsway
Burnaby, BC V5H 0C6

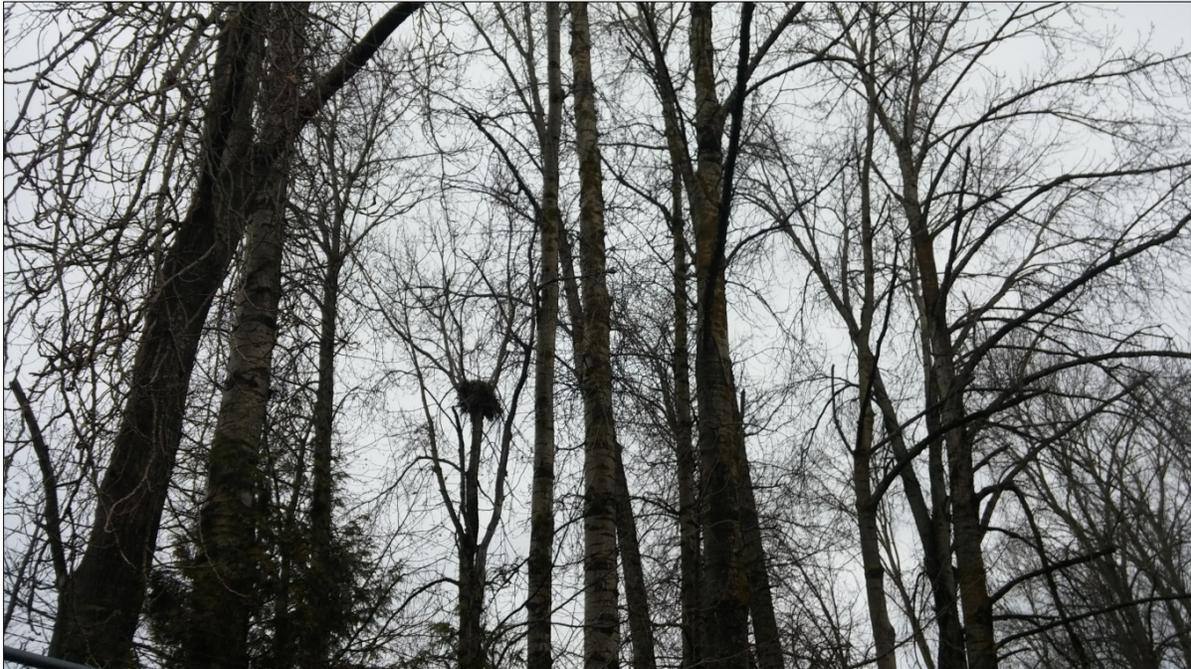
Photo 5: Potential bald eagle nest located in cottonwood trees north of project development area.

- A potential bald eagle nest is located in a strip of black cottonwood trees approximately 100 m north of the PDA and Shed 6 (scheduled for demolition) (**Appendix A: Photos 5 - 6**). Although no nesting activity was observed during standwatches (June 2016 and May 2017), the presence of bald eagles within 250 m of the nest suggests that it may be used as an alternate site (U.S. Fish and Wildlife Service 2007).

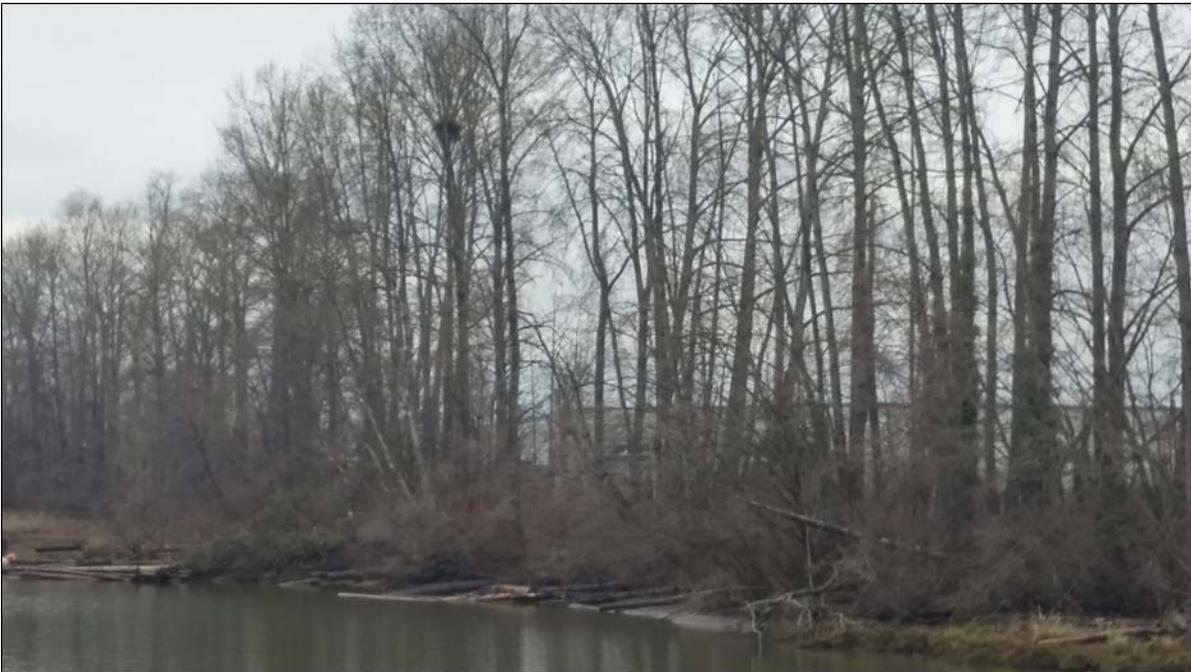
Photo 6: East bank of Fraser River, looking north from Berth 9. Potential bald eagle nest evident in cottonwood trees.

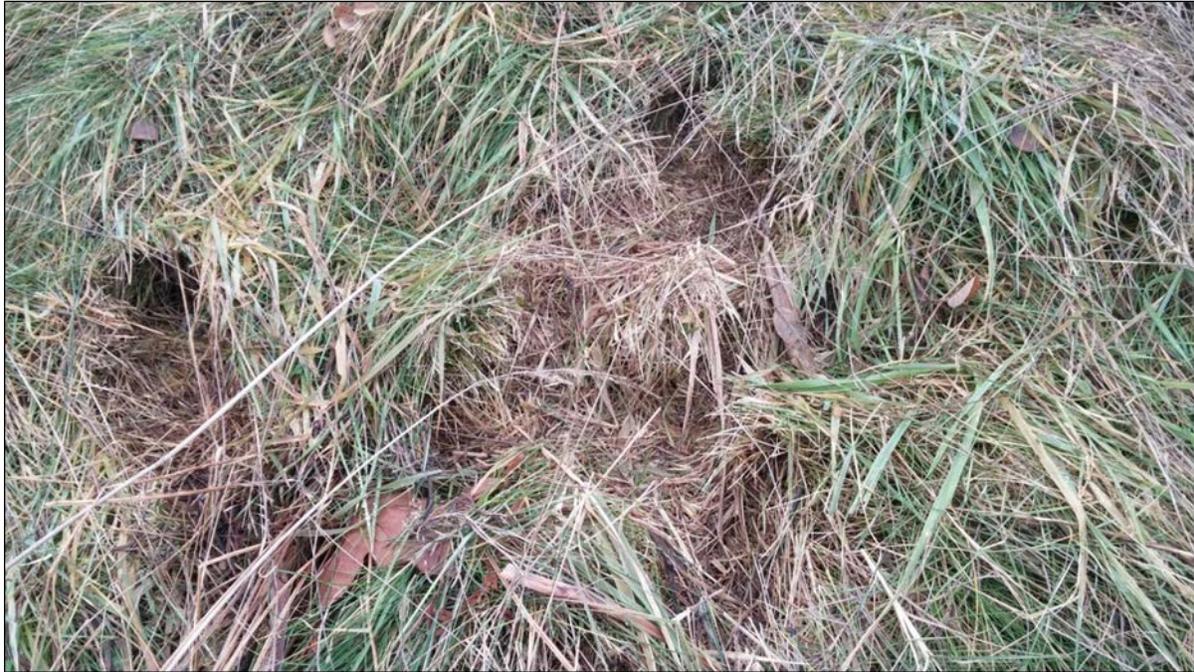
Photo 7: Evidence of small mammal activity (i.e., burrows and runways), possibly Townsend's vole, in Elevator Road roundabout.

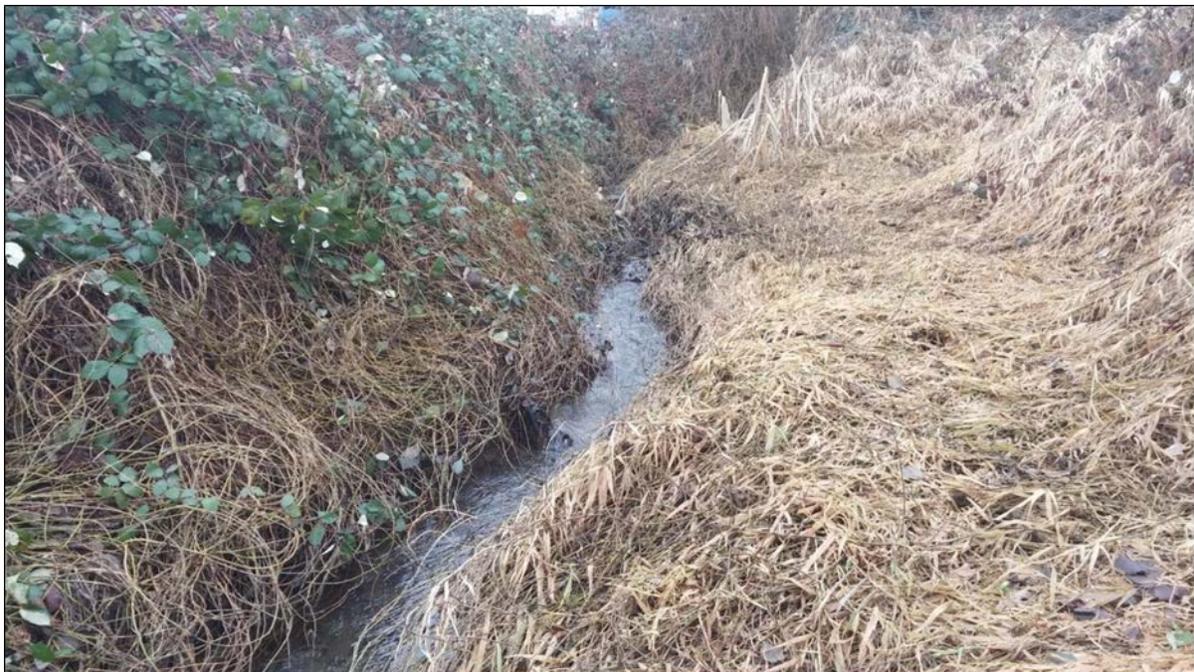
Photo 8: Shadow Brook, located in Elevator Road roundabout, characterized by sandy substrate and steep banks.

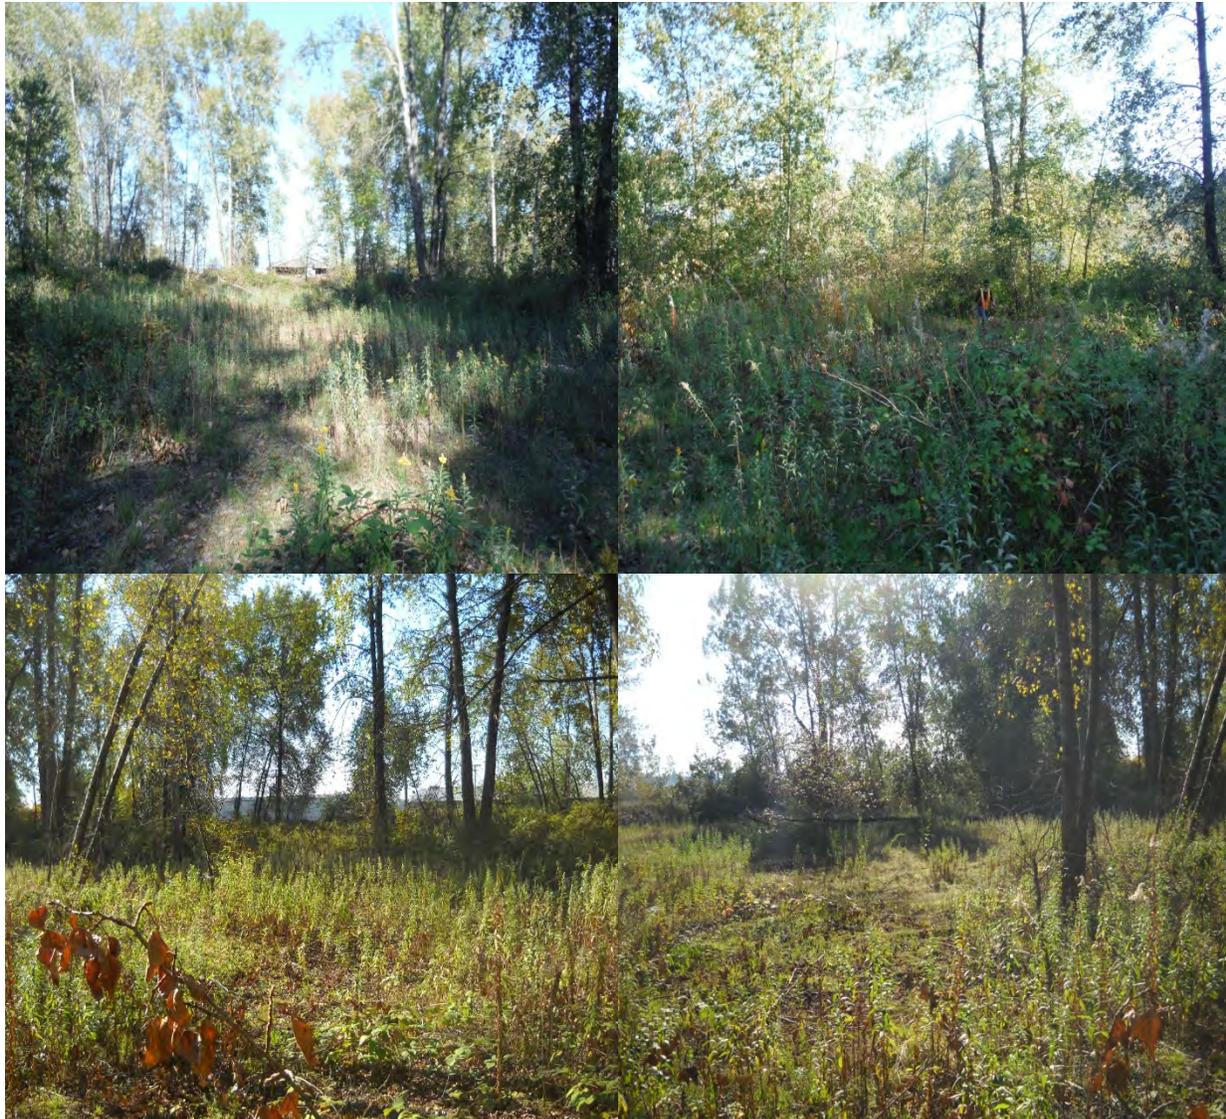
Figure 5 Streambank lupine Critical Habitat area 2b, summer 2016

Critical Habitat area 2b is not optimal streambank lupine habitat. There are no nutrient-poor and dry river or creek banks composed of gravel, cobble, riprap, sand or silt, or artificial surrogates, that through natural events (floods) or human activities provide the disturbances that give streambank lupine a competitive advantage over other plants (Environment Canada 2016). In disturbed areas streambank lupine can germinate and grow despite these stochastic disturbances (Envirowest 2006, Ministry of Environment 2014) because, like other lupines, it does not require nitrogen, allowing it to outcompete other plants in a post-disturbance situation. Disturbed railbeds and road verges, locations where streambank lupine is now frequently found, can offer an artificial surrogate for natural habitat with the requisite free-draining low fertility substrate that is free from vegetative competition. Critical Habitat area 2b does not have these characteristics, and dense vegetation has proliferated as a result.

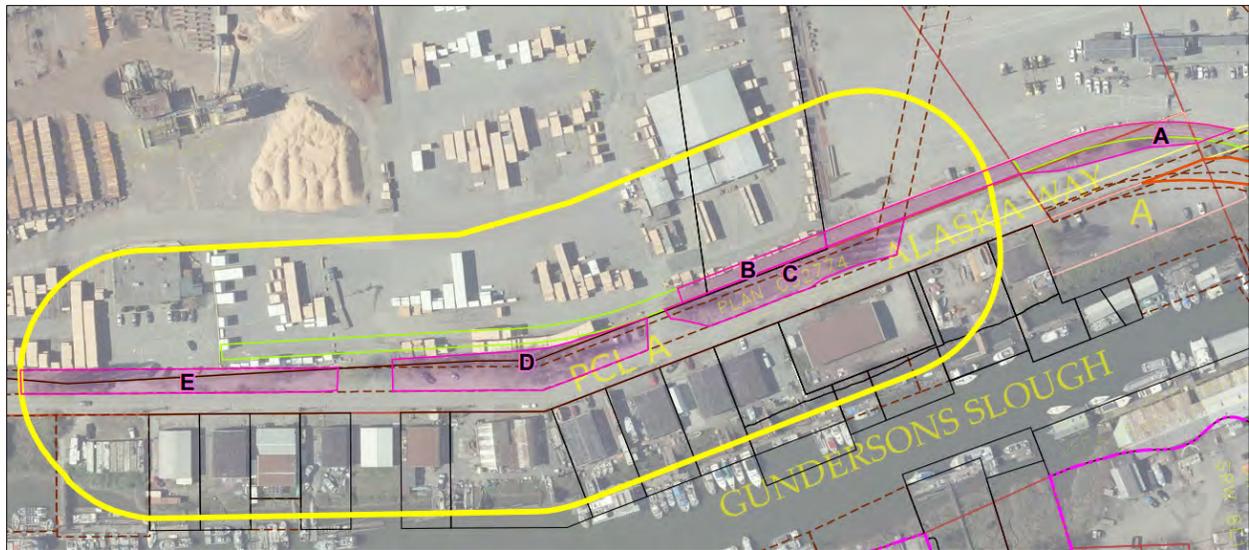
Figure 8 Naturalised portions of Critical Habitat Area 2a considered for enhancement activities

Management and enhancement activities in Areas B and C (the Interfor railway spur and the Corporation of Delta road verge) are considered to have the most potential to successfully establish a stable population. The current population (2 mature plants, 6 -8 seedlings) is down from that recorded in previous years, but in general the population varies year to year in respect of the level of disturbance and the extent of monitoring efforts. The extant population in Areas B and C is mostly physically protected, but not managed for long-term maintenance of the population. With modest efforts to remove ground cover and overhead tree cover, supported by an adaptive management approach to test the optimal management regime, success is considered likely. The presence of a strong seed bank has been proved in both areas after disturbance by Metro Vancouver in 2005 created conditions for upwards of 500 seedlings to establish (**Figure 8**). Area C is managed by the Corporation of Delta as a portion of their road right-of-way, and a portion of the area overlaps a Metro Vancouver water main. As such a legal restrictive covenant for conservation purposes in Area C is not possible, but a maintenance agreement is possible.

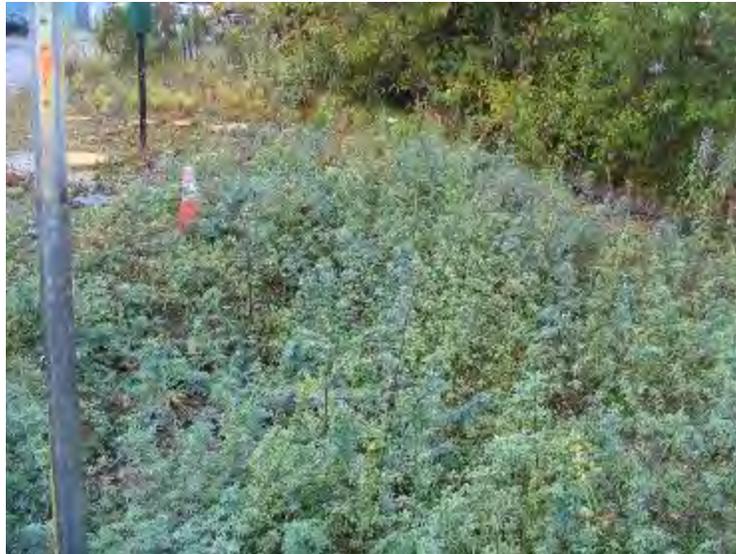
Figure 9 Corporation of Delta Alaska Way road verge (Area C) in 2005 after Metro Vancouver water main maintenance caused surface disturbance (CoD M. Brotherston photograph).

Critical Habitat area 2a, the site of proposed enhancement activities, is the only viable part of Population #2. There are extant plants, the substrate is relatively mobile, and infrequent and low intensity disturbances appear to mobilise seed and allow it to germinate. Vegetation cover at ground and canopy levels is becoming dense, but is currently open enough to allow germination and growth (**Figure 9**, **Figure 11**, **Figure 12**, and **Figure 17**).

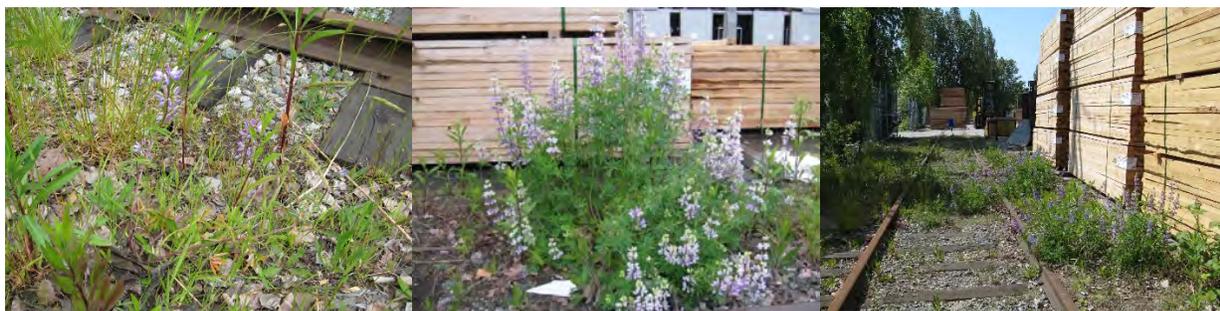
Figure 10 Streambank lupine in the Interfor rail spur (Area B) in, left to right, 2010, 2011 and 2012 (VFPA K. Keskinen photographs)

In Area B, managed by Interfor, there has in the past been a healthy population (140 plants in 2005, Envirowest 2006) including mature plants (**Figure 10**). None were observed in 2017. Similar management to Area C is proposed. VFPA has provided approval in principle to use Area B, but consultation will have to occur with VFPA and Interfor regarding the proposed use. A restrictive covenant (tenure) for conservation purposes between FSD and the owner (VFPA) can be arranged for long-term (perpetual) physical and legal protection.

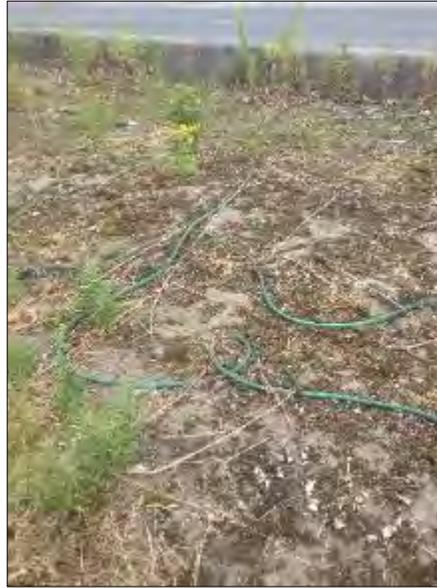
Figure 11 Garbage in Area C (see Figure 8) of Critical Habitat area 2a

The SARA Recovery Strategy considers garbage and dumping of materials (sand/gravel fill) to be a threat to streambank lupine at Critical Habitat area 2a (ECCC 2017). As noted in the SARA Recovery Strategy “debris ... can alter, destroy and disturb habitat” (ECCC 2017). Garbage removal in all areas is proposed to improve streambank lupine survival. Garbage removal activities are proposed to occur four times a year over a five-year period. Garbage removal is necessary in all areas of Critical Habitat area 2a (**Figure 11**).

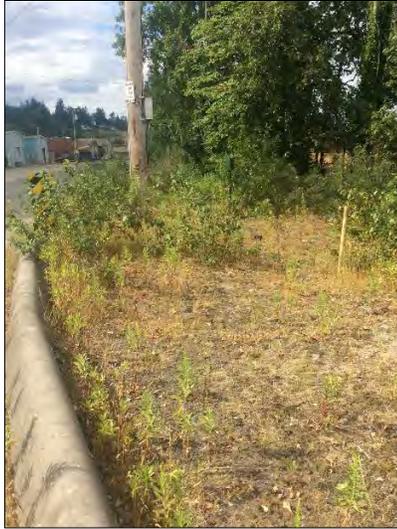
Figure 12 Barriers used by the Corporation of Delta to physically protect streambank lupine in Area C of Critical Habitat area 2a.

Physical protection for the enhancement areas is considered necessary to prevent accidental intrusion, particularly from vehicles operating on the adjacent Alaska Way roadway. Jersey barriers have been used in a portion of Critical Habitat area 2a by the Corporation of Delta (**Figure 12**), and chain link fencing in the Interfor area is in place (**Figure 13**). The area adjacent to the roadway and in the road right-of-way is used for vehicle parking and truck (**Figure 14** and **Figure 15**). Intrusion of vehicles into the enhanced portion of Critical Habitat area 2a compacts the substrate (preventing germination and root extension) and physically damages plants that do establish. Streambank lupine in Critical Habitat area 2a is threatened by trampling by people and damage from vehicles because the area is easily accessible (ECCC 2017). While disturbance is necessary for the germination and establishment of streambank lupine, the physical damage from tires is considered too intense for streambank lupine. Continued physical protection such as Jersey barriers and fencing avoid and minimise the threats from roadway expansion cited in the SARA Recovery Strategy (ECCC 2017).

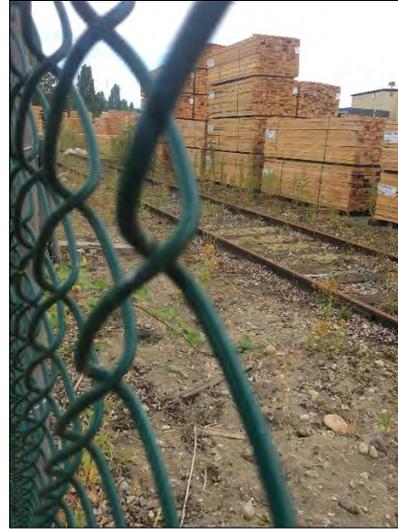
Figure 13 Chain link fence separating the Interfor railspur from Alaska Way (at Area B see Figure 8) of Critical Habitat area 2a

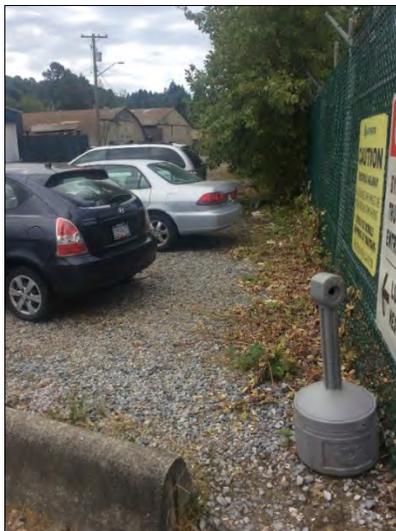
Figure 14 Area D (see Figure 8) of Critical Habitat area 2a, affected by gravel fill and now used for vehicle parking.

A portion of Critical Habitat area 2a is noted in the Recovery Strategy as having been affected by gravel fill (ECCC 2017), this is thought to be the areas adjacent to Alaska Way noted as Areas D and E in Figure 8, and now used for parking and semi-trailer staging prior to unloading (Figure 14 and Figure 15).

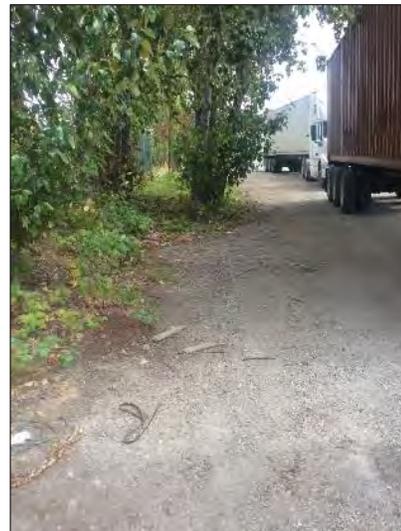
Figure 15 Area E (see Figure 8) of Critical Habitat area 2a, affected by gravel fill and used for semi-trailer staging

- Area E: Corporation of Delta road verge 3 (Interfor parking / staging area). No current streambank lupine presence. Highly compacted substrate with no mobile sands or gravel. Competing vegetation minimal, but overhanging trees. Management costs for enhancement are high because soil compaction needs to be addressed and substrate augmented. Ownership is Corporation of Delta, no protective covenant is possible, but a Roadside Use Agreement is possible. Underlying Metro Vancouver water main right-of-way and informal Interfor parking and staging use would require negotiation in association with the Roadside Use Agreement before use. See **Figure 15**.

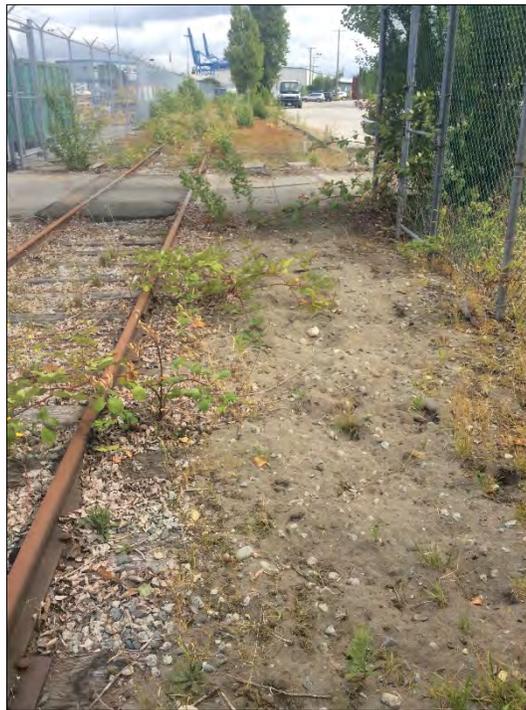
Figure 16 Rails, ties and ballast in Area B (see Figure 8) of Critical Habitat area 2a, removal of which will provide greater area for streambank lupine enhancement. Note the dry sand and gravel substrate with little vegetation cover, seemingly suitable for streambank lupine but with no plants currently growing – despite close proximity to extant plants. Area A in the background.

Rails, ties and ballast in Area B (Figure 16) will be removed, if removal avoids affecting any existing streambank lupine plants. This will provide a greater area for streambank lupine establishment and removes any future potential for the rail spur to be used.

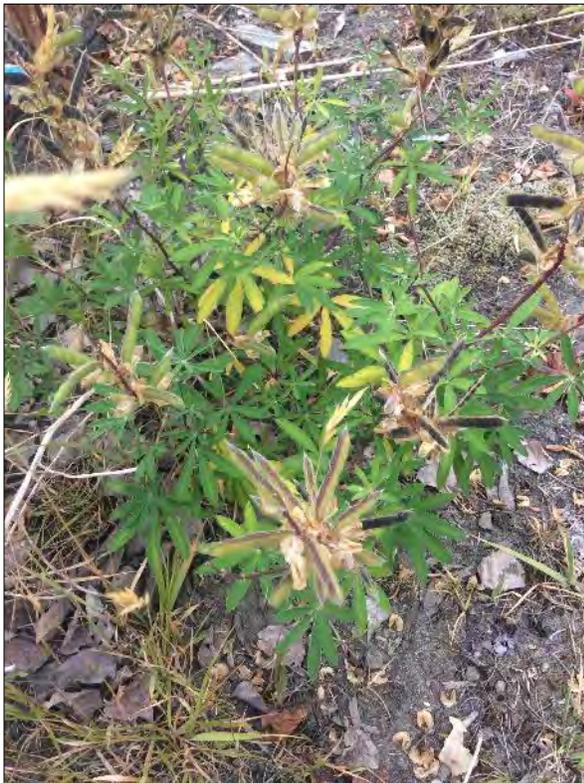
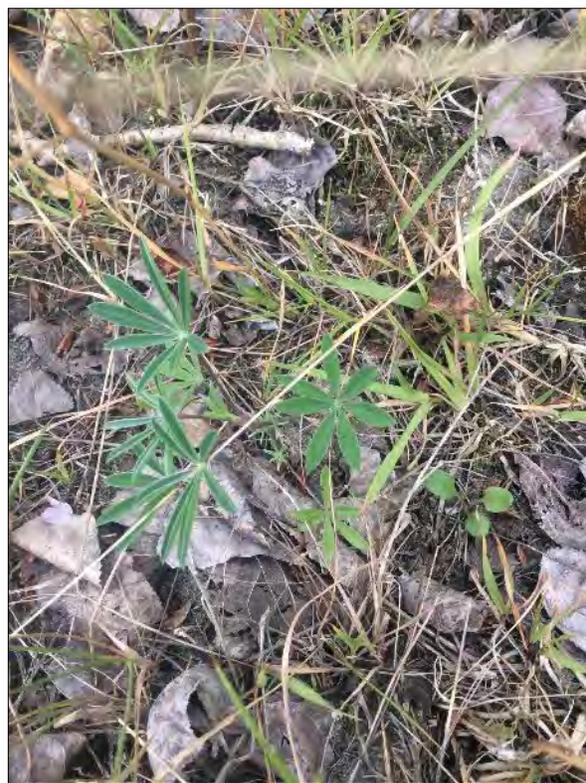
Figure 17 Streambank lupine plants (L) and seedlings (R) in Area C of Critical Habitat area 2a, July 2017
