Salt Marsh Restoration Site 3.2

Description, location and size

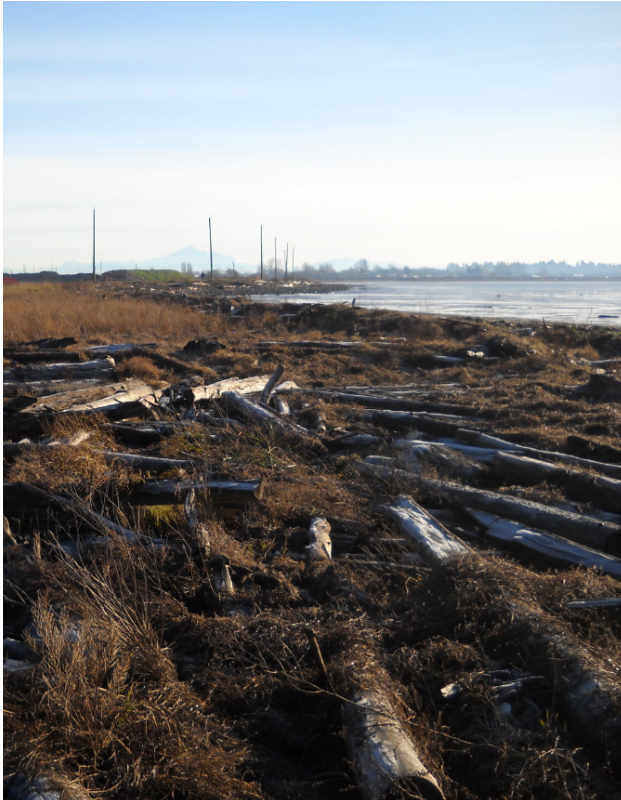
Pre-restoration site conditions, looking southeast (2012)

Prior to restoration works, the site was characterized by dense accumulations of historically deposited woody debris, mostly composed of saw-cut logs from the forestry sector. Based on aerial photo reviews, the vast majority of the woody debris had been present for 25 to 70 years before restoration works were undertaken. The debris was observed to be smothering underlying salt marsh vegetation and had compacted the sediments preventing the associated salt marsh from achieving its full productive capacity.

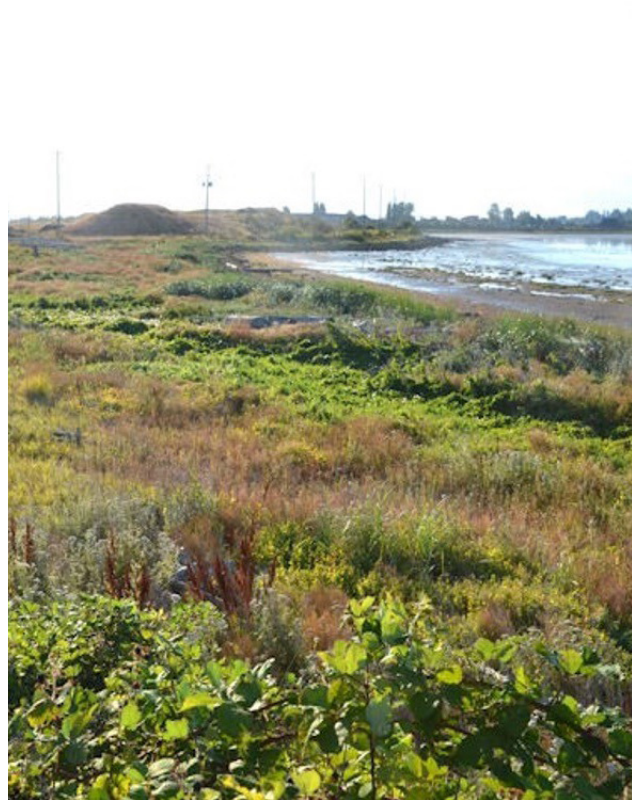
Site conditions, looking southeast (2021)

The restoration works were undertaken in January 2014 with support from the Tsawwassen First Nation and were completed through efforts from the Tsawwassen First Nation/Matcon Joint Venture. Work involved the careful removal of woody debris and litter. Wildlife snags were installed to provide enhanced wildlife habitat features, including perching and roosting habitat for raptors.
