Re: Katzi First Nation Bonson Road Stormwater Outfall Design

EPTA Development Corp. - Katzie First Nation Bonson Road Stormwater Outfall Design

EPTA DEVELOPMENT CORPORATION BONSON ROAD OUTFALL

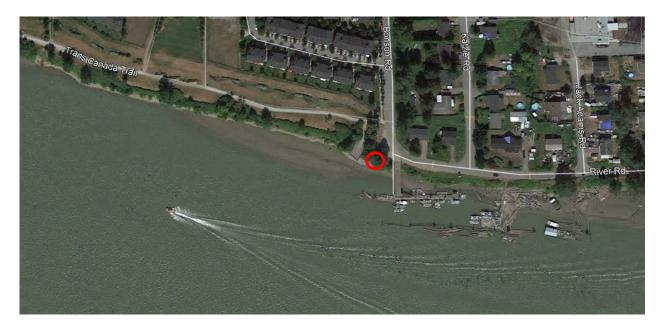
Figure 3. Satellite image showing the sediment bench along the base of the bank (Google, 2020).

A shallow sloping bench of sediment (roughly 1% slope) with a width of 6 to 30 m extends from the bank towards the centre of the channel. This bench is present from Golden Ears Bridge to 2.5 to 3 km downstream of the site (Figure 3). At the proposed outfall site, the bench is fairly narrow (close to 6 m) with a 5 m wide apron of angular shot rock (150 mm minus) 4 to 5 m wide. The bank projects up from the apron with a slope of roughly 1.5H:1V and appears to be 2.5 to 3 m high. Ageing rock riprap (D50 = 300 to 400 mm) provides limited protection of the bank; mainly the lower portion of the bank, with dense vegetation and signs of limited ongoing erosion higher up the slope (Photo 1 and Photo 2). The underlying material appears to be consolidated silty clay river deposits.
