Guidelines - Shoreline Protection  
(Fraser River)  
Inspection,  
Maintenance, Design  
and Repair

Version 1.0

Vancouver Fraser Port Authority

*January 2020*

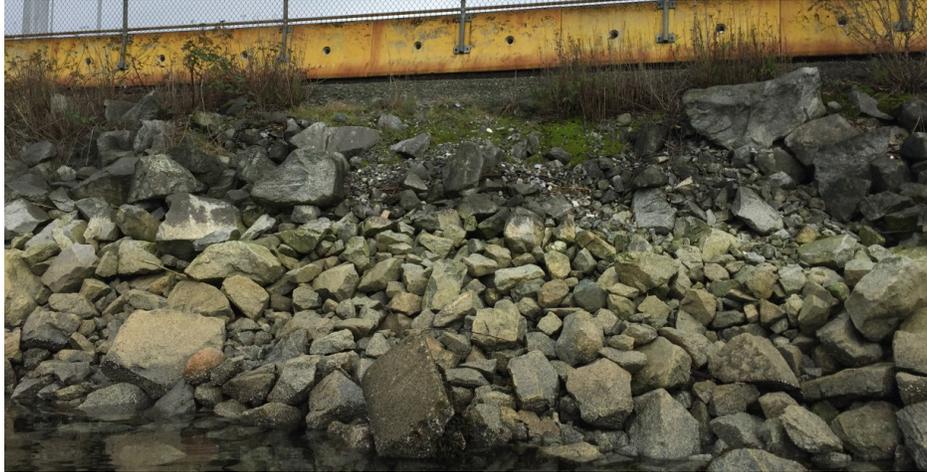
*Figure 3.1: Minor Damage of Upper Crest of a Rock Armour Slope*

Figure 3.1 shows an area with localized damage at the crest of the slope protection. Poor construction may have been a contributing factor as there is no visible filter layer material on the upper slope. Such an area is susceptible to further erosion if exposed to waves or currents at high water conditions, or during intense surface drainage events.

In the event of minor and localized erosion of the crest, emergency placement of rock material as a temporary measure to halt erosion is recommended.

Longer term solutions may include increasing the surface setback of the concrete barrier wall, improvement to surface drainage, and the planting of a riparian strip to help reduce erosion during either high water level and wave events or during heavy rainfall events. Alternatively, the replacement of the upper slope materials to provide protection against wave runup and also provide a free drainage path within the rock matrix may be appropriate.

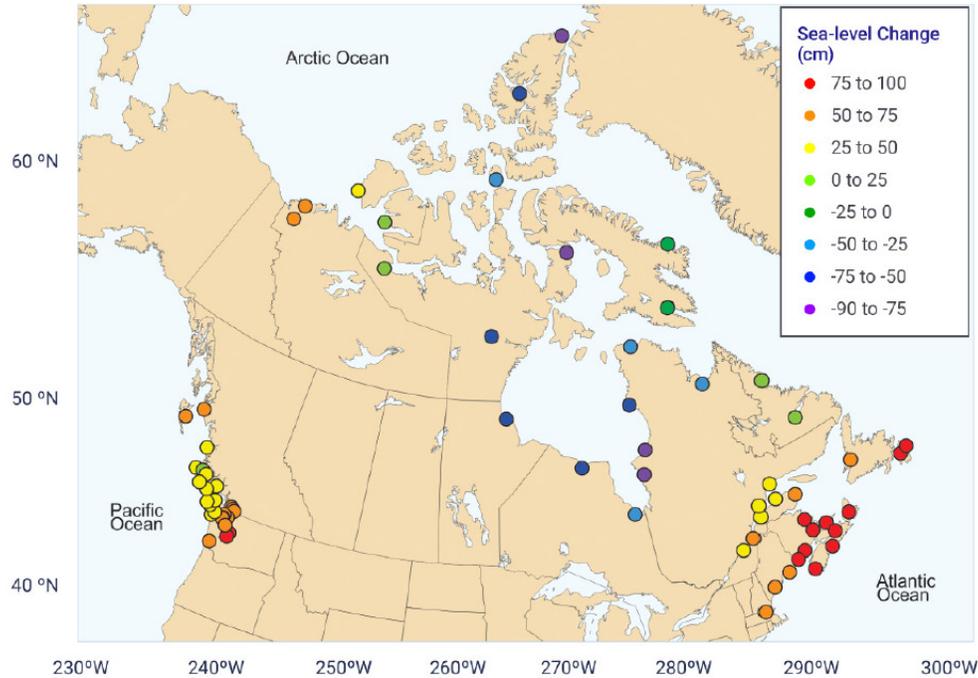
Figure 7.16: Projected relative sea-level change along Canadian coastlines at the end of the century

the relative sea level rise in Pacific Northwest Region is less than the global average SLR partially due to rising ground elevations. “Canada’s Changing Climate Report” shows that in Vancouver, the projected relative sea level change at the end of the century is 0.5 m to 0.75 m (see Figure 4.1).

Figure caption: Projected relative sea-level changes shown at 2100 for the median of a high emission scenario (RCP8.5) at 69 coastal locations in Canada and the northern United States. Values range from a sea-level fall of 84 cm to a sea-level rise of 93 cm and are relative to the average conditions in the 1986–2005 period. For comparison, the projected median global sea-level change at 2100 for the high emission scenario is 74 cm.

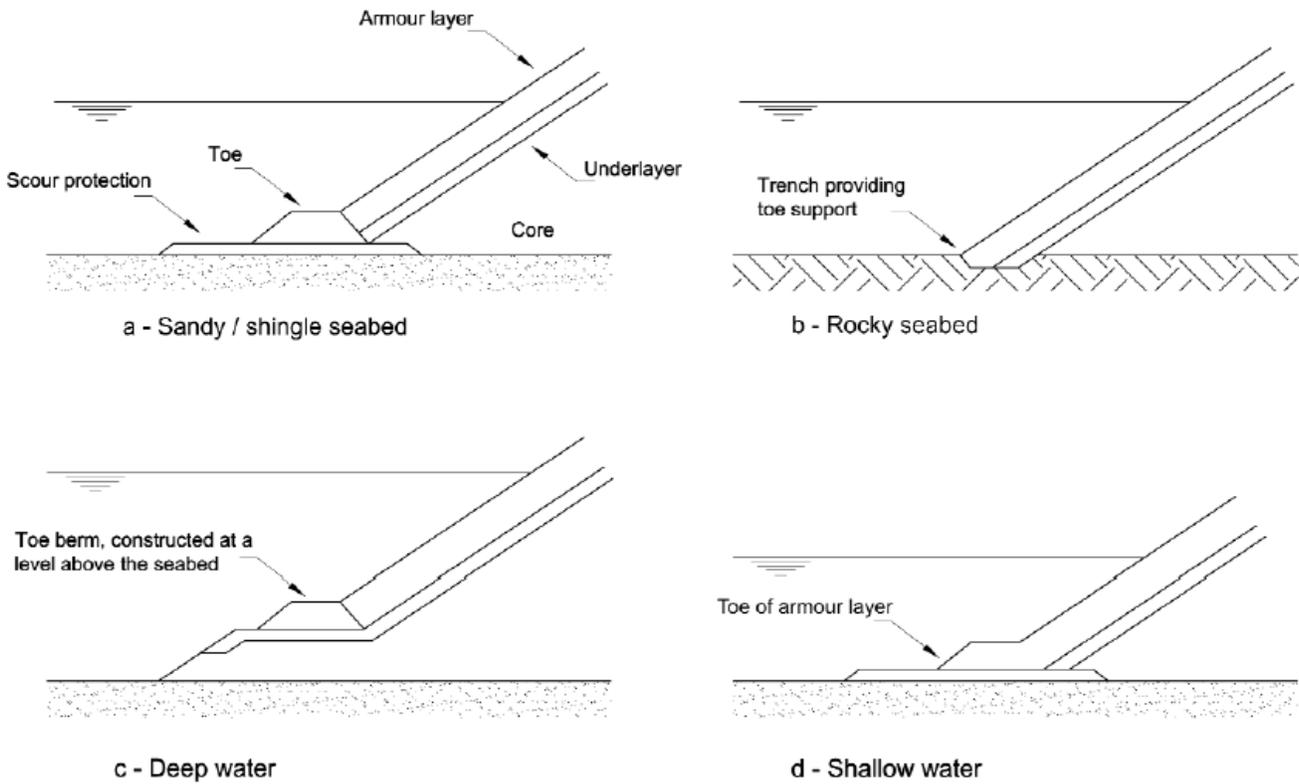
Figure 5.1: Toe Protection Examples  
 Source: Ref. [9]

It is a recommended design practice that a shoreline protection system should include specific toe protection at the toe of the slope. Some examples of toe protection systems are provided in Figure 5.1. A typical standard toe is three to five stones wide with a thickness of two or three stones. If the seabed material is erodible, an underlying scour protection mat should also be included in the toe detail unless the toe of the protection system is buried.

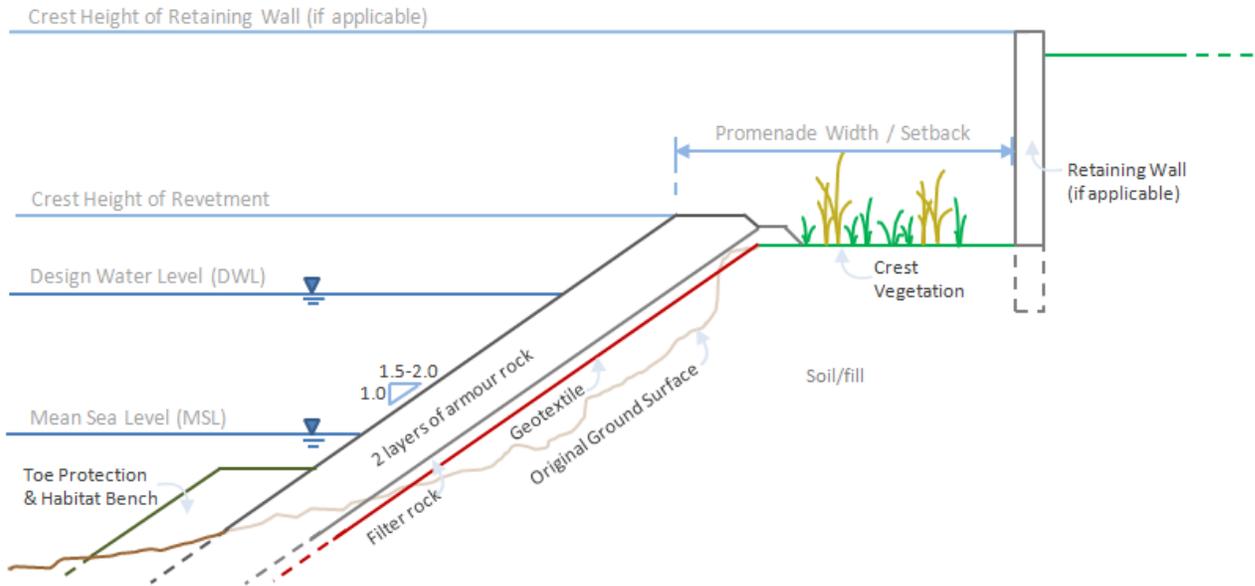
Figure 6.1: Potential Habitat Improvements (Habitat Bench and Crest Vegetation)

An example of a habitat bench is shown in Figure 6.1, which includes a bench that also provides toe protection for a rock armour or riprap revetment. The objective of the habitat component should be stated in advance of design and adequate consideration should be given in the design to ensure that self-launching scour or propeller induced scour does not remove the habitat objectives.

Habitat benches can be either continuous along the entire length of shoreline, or can be discontinuous, with variations in width, to create a more natural undulating shoreline. An undulating bench reduces the overall volume of materials and provides a cost benefit.
